AIRPROX REPORT No 2022173

Date: 30 Jul 2022 Time: ~1536Z Position: 5142N 00208W Location: Aston Down

PART A: SUMMARY OF INFORMATION REPORTED TO UKAB

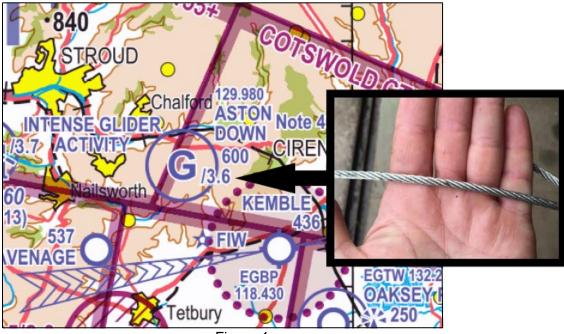
UK glider launch sites are listed in UK AIP ENR 5.5 and labelled on the CAA 1:500,000 and 1:250,000 charts with a "G" symbol, as shown below. Where winch launching is used, the maximum winch launch altitude is listed in the AIP and marked on the chart; this is 3600ft AMSL at Aston Down, as indicated by the black arrow, Figure 1.

A glider being winch-launched has an initial climb rate in excess of 4000ft/min, and (under the right conditions) takes about a minute to climb to 2500ft AGL. Aircraft overflying a winch site below its maximum winch altitude will have little warning of a launching glider that suddenly appears at or above their level, possibly after climbing towards them unsighted, from below.

Winch-launch ground crew will not initiate a launch if they see a powered aircraft about to overfly the active runway. However, an aircraft flying towards the site at 150kt, and which will arrive overhead at the same time as the winch launch finishes, could still be over 2 NM away at the moment the launch starts, and hence out of sight of the ground crew.

Flying below a winch-launching glider also risks encountering high tensile strength steel cable (as pictured) connecting the glider to the winch on the ground.
