AIRPROX REPORT No 2022176

Date: 13 Aug 2022 Time: 1449Z Position: 5213N 00045E Location: IVO Bury St Edmunds

PART A: SUMMARY OF INFORMATION REPORTED TO UKAB

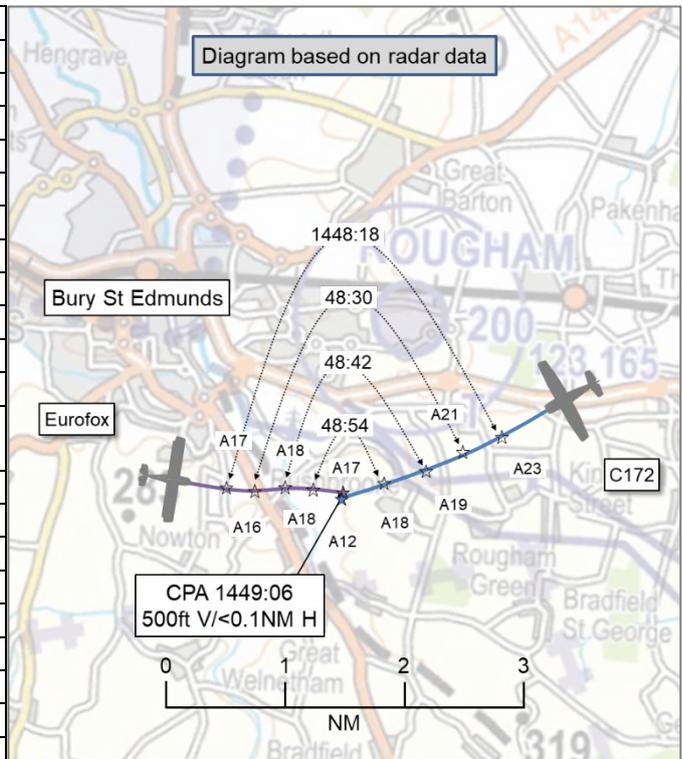
Recorded	Aircraft 1	Aircraft 2
Aircraft	C172	Eurofox
Operator	Civ FW	Civ FW
Airspace	London FIR	London FIR
Class	G	G
Rules	VFR	VFR
Service	Basic	None
Provider	Lakenheath	N/A
Altitude/FL	1200ft	1700ft
Transponder	A, C, S	A, C, S
Reported		
Colours	White, blue	Yellow
Lighting	Strobes, landing beacon	Strobes, landing beacon
Conditions	VMC	NK
Visibility	>10km	NK
Altitude/FL	~3200ft	NK
Altimeter	QNH (1014hPa)	NK (NK hPa)
Heading	245°	NK
Speed	~110kt	NK
ACAS/TAS	Not fitted	SkyEcho
Alert	N/A	None
Separation at CPA		
Reported	~50ft V/~500ft H	Below and just behind
Recorded	500ft V/<0.1NM H

A track showing [Eurofox C/S] was observed on the radar recording to be tracking outside and along the southern CMATZ boundary less than 1 mile outside in a consistent easterly direction, level consistently indicating [1700ft]. No deviation was observed as the two tracks merged.
