AIRPROX REPORT No 2022199

Date: 29 Aug 2022 Time: 1255Z Position: 5142N 00207W Location: 1NM SE Aston Down

PART A: SUMMARY OF INFORMATION REPORTED TO UKAB

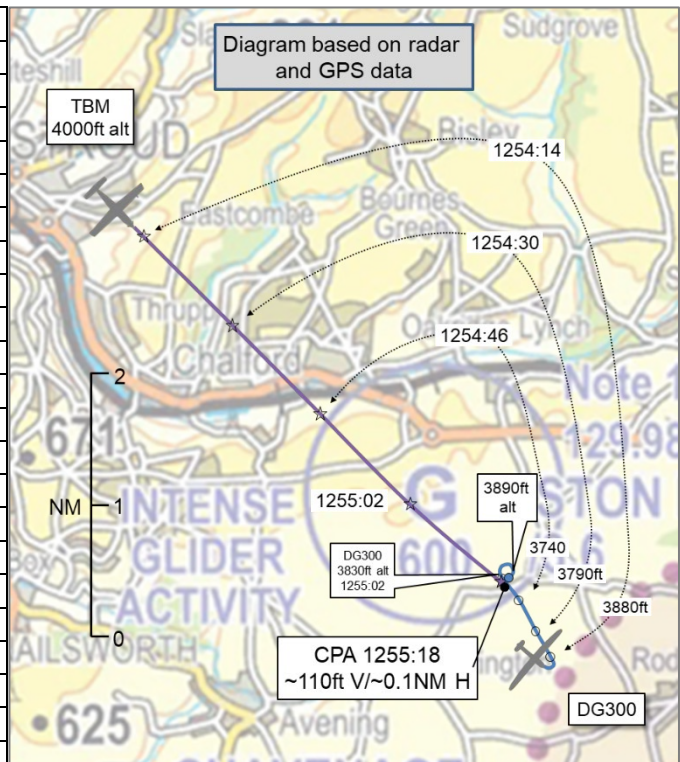
An analysis of the NATS radar replay was undertaken and only the TBM930 was detected and it was identified using Mode S data. The DG300 pilot kindly supplied the UKAB Secretariat with a GPS data file which has been combined with the radar data to produce the diagram and measure CPA. However, due to the necessity to combine two differing data sources, the measured separation has been recorded as an approximation.

An Airprox was reported when a DG300 and a TBM930 flew into proximity 1NM southeast of Aston Down at 1255Z on Monday 29th August 2022. Both pilots were operating under VFR in VMC, neither pilot in receipt of an ATS.
