AIRPROX REPORT No 2022256

Date: 29 Oct 2022 Time: 1425Z Position: 5206N 00123W Location: Shotteswell

PART A: SUMMARY OF INFORMATION REPORTED TO UKAB

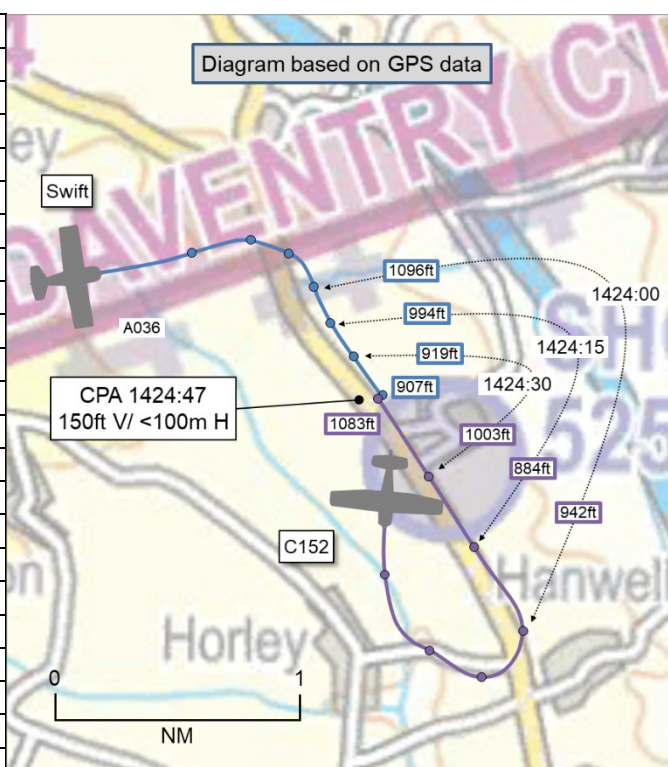
Recorded	Aircraft 1	Aircraft 2
Aircraft	Skyranger Swift	C152
Operator	Civ FW	Civ FW
Airspace	London FIR	London FIR
Class	G	G
Rules	VFR	VFR
Service	Listening Out	Listening Out
Provider	SafetyCom	SafetyCom
Altitude/FL	907ft	1083ft
Transponder	A, C, S	A, S
Reported		
Colours	Red, white	Red, white
Lighting	None	Strobes
Conditions	VMC	VMC
Visibility	>10km	>10km
Altitude/FL	400ft	500ft
Altimeter	QNH (1011hPa)	QNH (1009hPa)
Heading	150°	330°
Speed	50kt	60kt
ACAS/TAS	Not fitted	TAS
Alert	N/A	None
Separation at CPA		
Reported	0ft V/50m H	100ft V/0m H
Recorded	150ft V/ <100m H

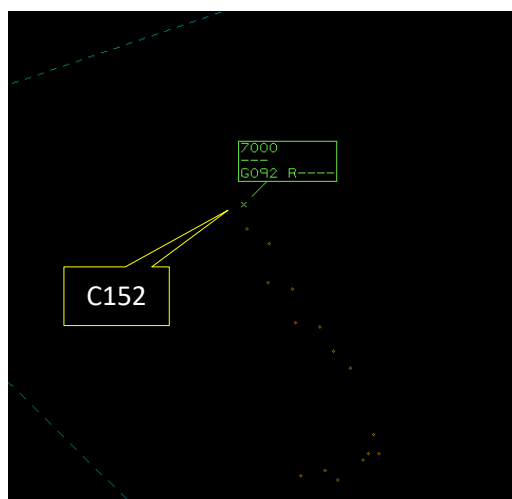
Figure 1 – CPA at 1424:47

An analysis of the NATS radar replay was undertaken and the C152 was identified in the vicinity of Shotteswell from Mode S data. The radar returns suffered from jitter and were considered unusable to plot the position of the C152 accurately. Mode C data for the C152 was not available throughout the radar recording. The Swift was not observed on radar at the time of CPA (see Figure 1).

Both pilots kindly supplied GPS track data from their respective flights and it is with that data that the diagram was constructed and the CPA assessed.
