AIRPROX REPORT No 2023017

Date: 15 Feb 2023 Time: 1259Z Position: 5110N 00105W Location: 2NM SW Lasham

PART A: SUMMARY OF INFORMATION REPORTED TO UKAB

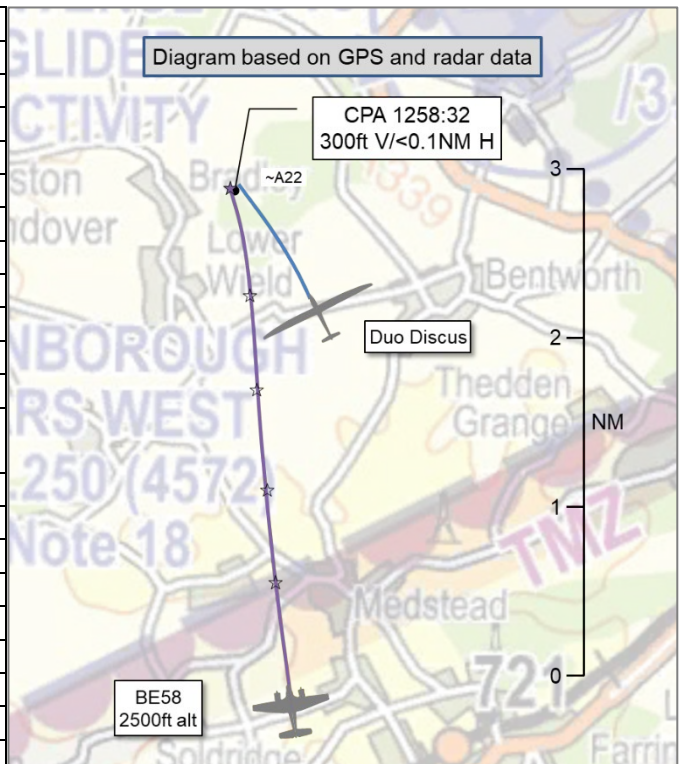
Recorded	Aircraft 1	Aircraft 2
Aircraft	Duo Discus	BE58
Operator	Civ Gl'd	Civ FW
Airspace	London FIR	London FIR
Class	G	G
Rules	VFR	VFR
Service	Listening Out	Listening Out
Provider	Lasham	Solent
Altitude/FL	2200ft	2500ft
Transponder	Off	A, C, S+
Reported		
Colours	White	White, blue, red
Lighting	Not fitted	Nav, strobe, anti-col
Conditions	VMC	VMC
Visibility	5-10km	>10km
Altitude/FL	2150ft	2500ft
Altimeter	QFE (NK hPa)	RPS (NK hPa)
Heading	~355°	350-280°
Speed	~60kt	170kt
ACAS/TAS	FLARM	TCAS I
Alert	None	None
Separation at CPA		
Reported	100-200ft V/0m H	Not seen
Recorded	300ft V/<0.1NM H

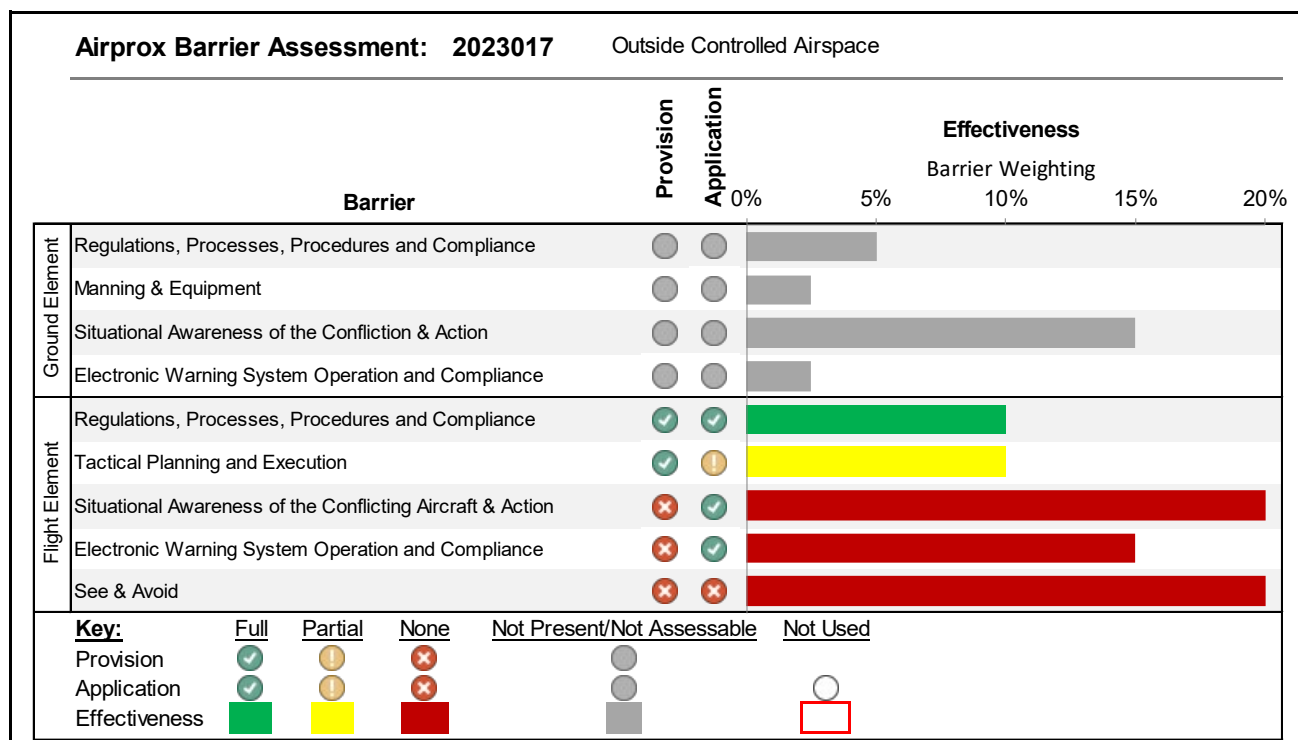
Tactical Planning and Execution was assessed as **partially effective** because the BE58 pilot did not obtain a FIS that might have given them Traffic Information or broadcast their intentions to Lasham and the Duo Discus pilot had selected the transponder off, thereby negating the EC barrier.

Situational Awareness of the Conflicting Aircraft and Action were assessed as **ineffective** because neither pilot was aware of the other closing aircraft until the Duo Discus pilot heard and then sighted the BE58.

Electronic Warning System Operation and Compliance were assessed as **ineffective** because the BE58 TCAS could not alert on the Duo Discus, which had its transponder selected off.

See and Avoid were assessed as **ineffective** because the BE58 pilot did not see the Duo Discus and the Duo Discus pilot did not see the BE58 until at about CPA, effectively a non-sighting.
