## **AIRPROX REPORT No 2023028**

Date: 07 Mar 2023 Time: 1440Z Position: 5338N 00258W Location: Southport

### **PART A: SUMMARY OF INFORMATION REPORTED TO UKAB**

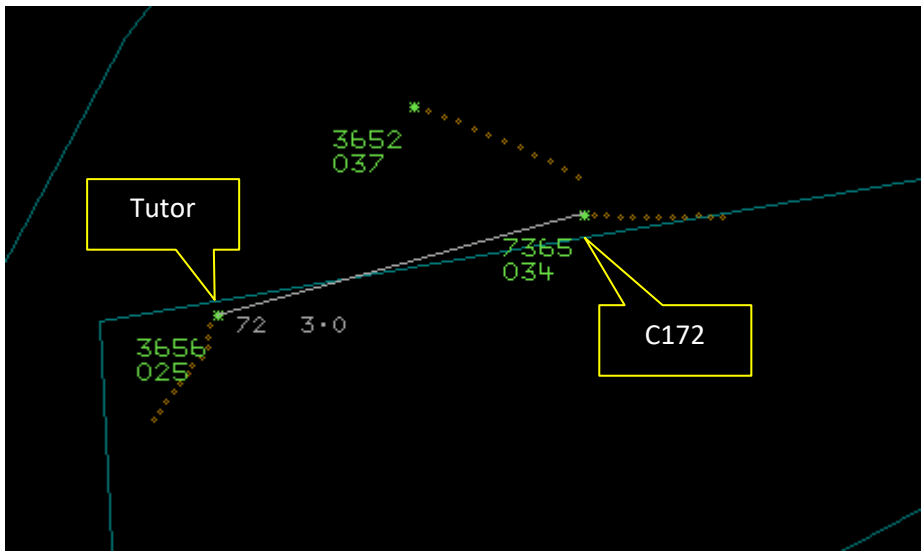
Figure1 - 1438:44, Tutor squawk changed to Warton squawk

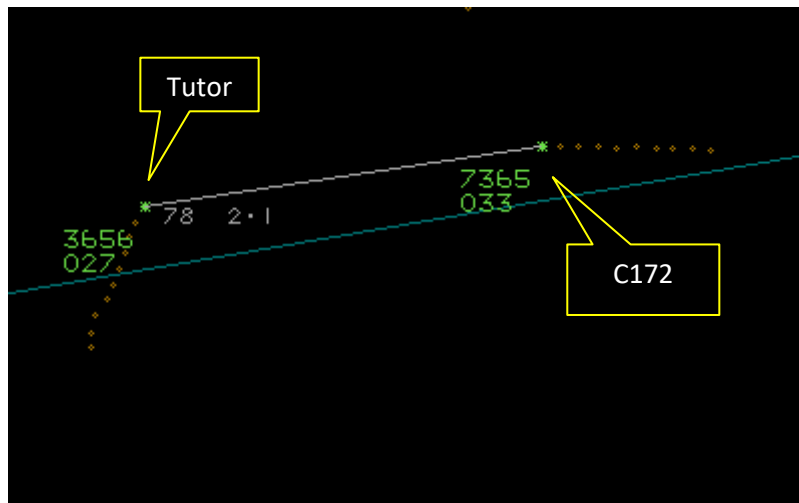
At 1439:10 the controller asked the Tutor pilot for the rest of their details which were passed.

Figure 2 – 1439:10

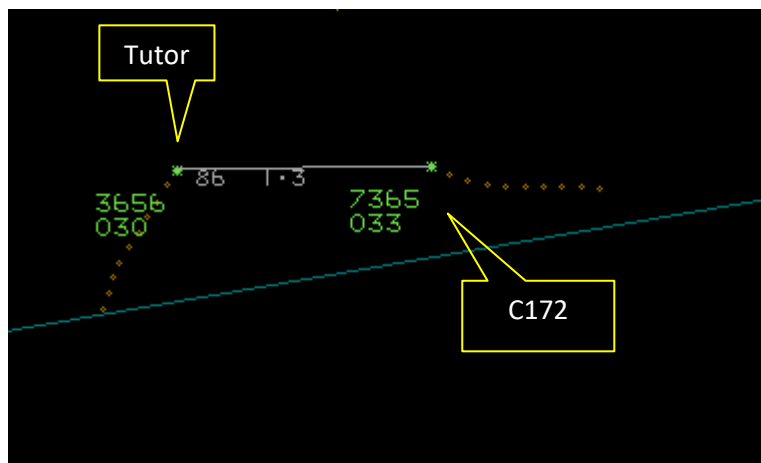
The Tutor pilot ended their transmission at 1439:29, the controller did not reply, but appeared instead to be speaking to another aircraft whose transmissions could not be heard on the RTF.

Figure 3 – 1439:29

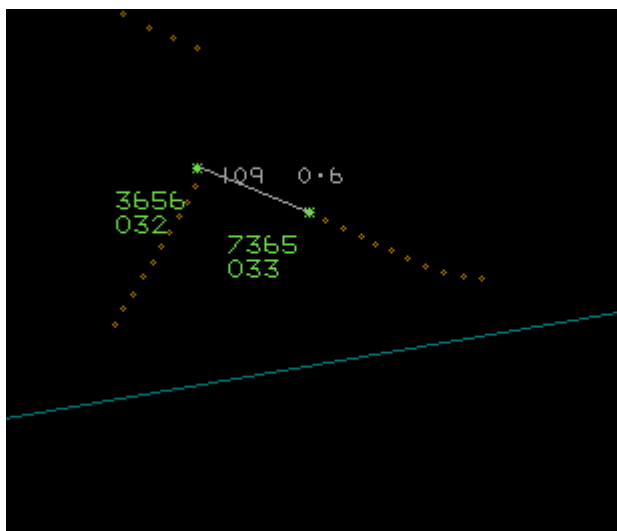
Figure 4 : 1439:52  
Tutor passing ahead of C172

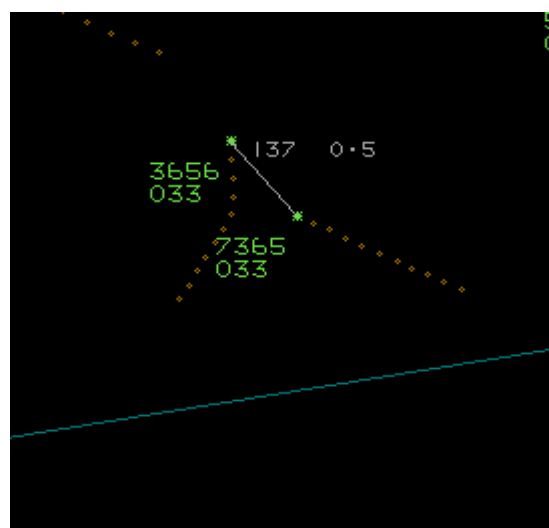
Figure 5 : 1440:04  
Radar CPA

At 1440:23 the Tutor pilot reported being visual with the C172, stating they got within half a mile at the same altitude. The controller reminded them that Traffic Information had been previously passed. The Tutor pilot went on to opine that the C172 pilot did not appear to be looking out.

Updated Traffic Information should have been passed but the controller appeared to be occupied with another aircraft at the crucial point and prioritised that instead.
