## AIRPROX REPORT No 2023035

Date: 27 Mar 2023 Time: 1153Z Position: 5227N 00107W Location: 4NM W Husbands Bosworth

### PART A: SUMMARY OF INFORMATION REPORTED TO UKAB

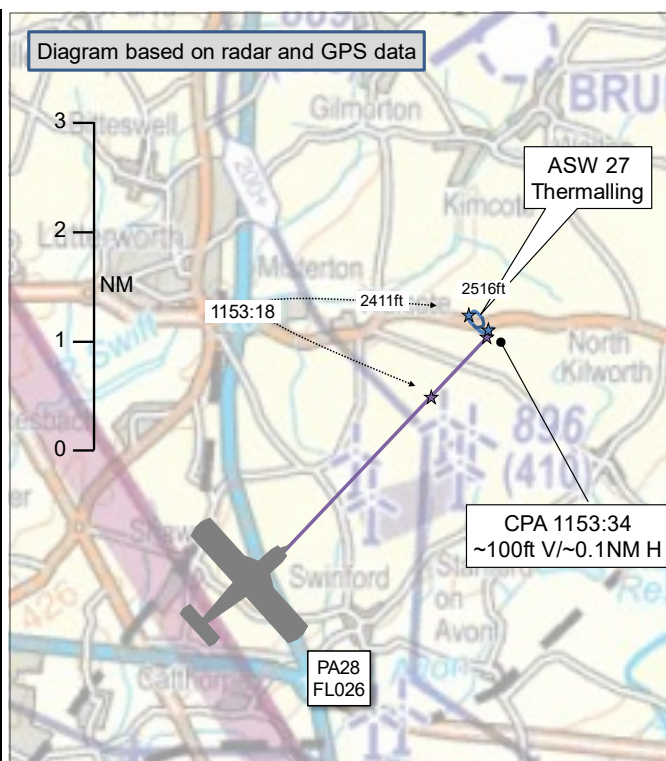
Recorded	Aircraft 1	Aircraft 2
Aircraft	ASW 27	PA28
Operator	Civ Gld	Civ FW
Airspace	London FIR	London FIR
Class	G	G
Rules	VFR	VFR
Service	None	None <sup>1</sup>
Provider	N/A	N/A
Altitude/FL	~2500ft	FL026
Transponder	Not fitted	A, C, S+
<b>Reported</b>		
Colours	White	White, Blue
Lighting	Nil	Strobes, Nav, Beacon
Conditions	VMC	VMC
Visibility	>10km	>10km
Altitude/FL	2500ft	3000ft
Altimeter	QNH (1026hPa)	QNH (1023hPa)
Heading	Circling	045°
Speed	50kt	135kt
ACAS/TAS	SkyEcho, <sup>2</sup> PowerFLARM	SkyEcho
Alert	None	Information
<b>Separation at CPA</b>		
Reported	Not Seen	100ft V/0.5NM H
Recorded	~100ft V/~0.1NM H

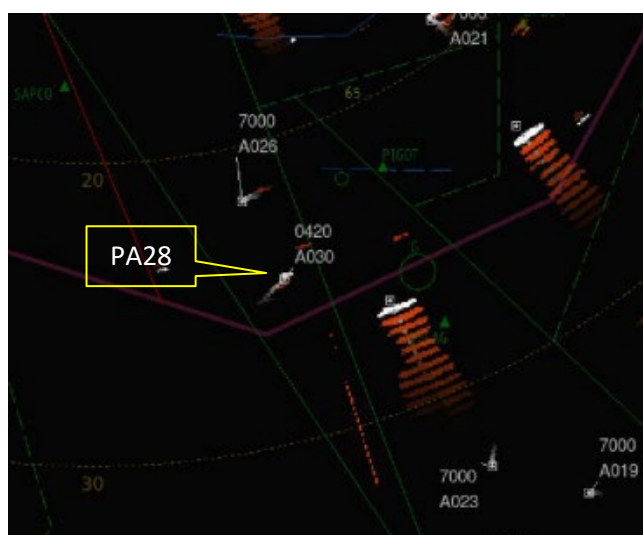
Figure 1

1153:05 [PA28 C/S] (displaying a 0420 SSR code) was seen in the vicinity of the reported Airprox, Figure 1.

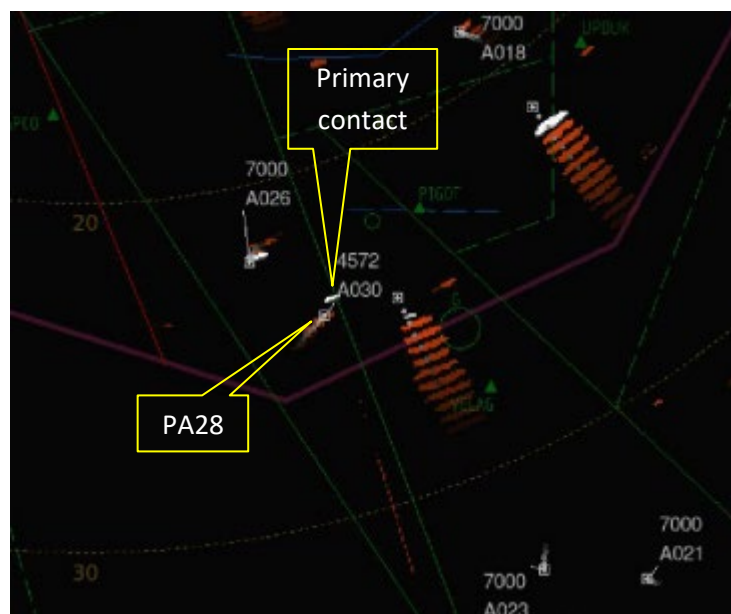
Figure 2

1153:26 An unknown primary-only contact, very intermittent, was seen briefly in the vicinity of the aircraft. At this point the pilot was just in the process of changing their squawk to 4572, (the EMA FMC squawk).

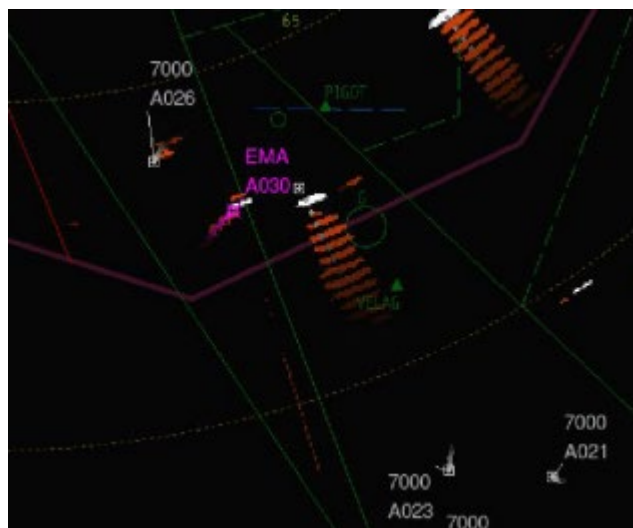
Figure 3

3sec later at 1153:29, the radar display converted the 4572 squawk to display EMA (the conversion for traffic listening-out only to EMA Radar). The previously seen primary-only contact had disappeared from the display.

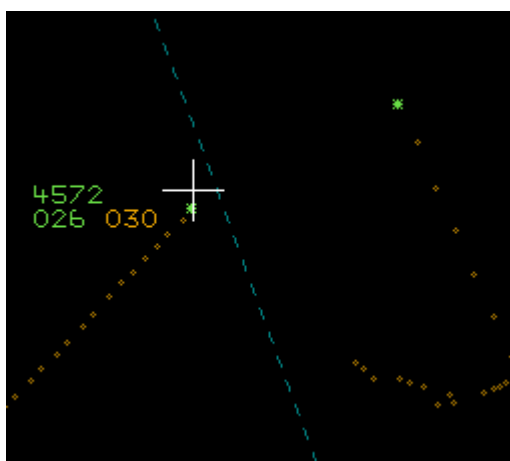
Figure 4 - 1153:34

An analysis of the NATS radar replay was undertaken and the PA28 could be identified using Mode S information. The ASW 27 could not be seen on the radar, however, the pilot supplied the UKAB Secretariat with a GPS logger file which was used to compile the diagram at the top of this report. At Figure 4 is the PA28 at 1153:34, as seen on the NATS radar, with the position of the Airprox marked by a white cross.
