## AIRPROX REPORT No 2023037

Date: 30 Mar 2023 Time: 0901Z Position: 5251N 00047E Location: Sculthorpe

### PART A: SUMMARY OF INFORMATION REPORTED TO UKAB

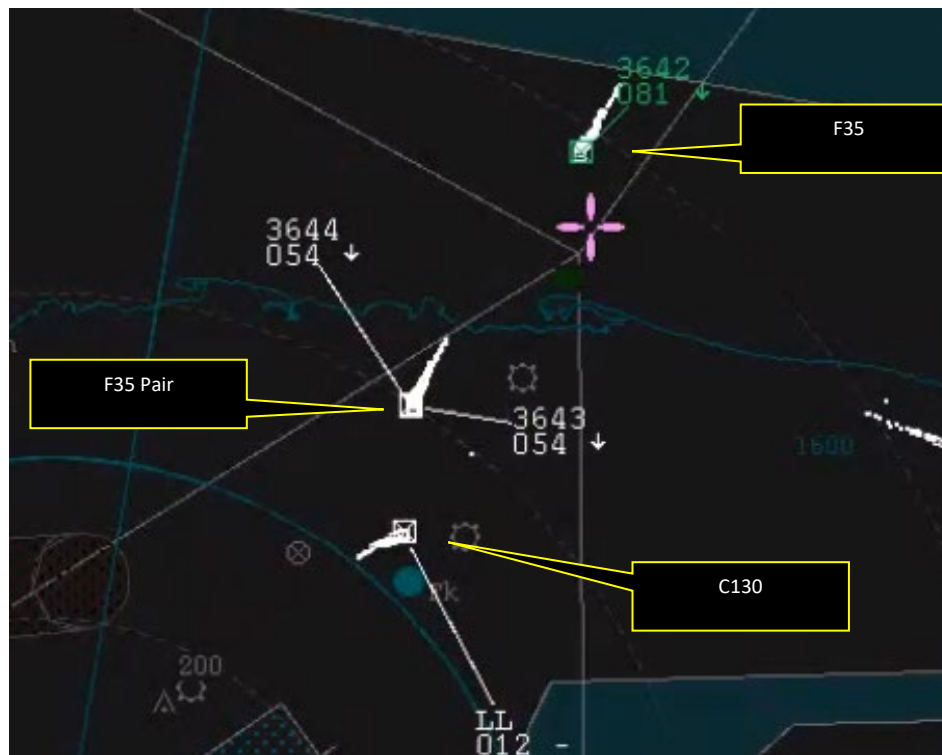
Figure 1 (0858:32): Traffic information provided by the Marham Approach controller (Unit radar)

Following the lead F35 pair reporting visual with the C130, at 0858:32 the Marham Approach controller provided Traffic Information to the trailing F35 singleton *“traffic, southwest 10 miles, tracking northeast, indicating 1300ft”*. The F35 [pilot] reported the C130 as *“not sighted”*. Between 0859:00 and 0900:00<sup>3</sup> the C130 [crew] free-called the Swanwick Military controller requesting a *“FL140 transit over to the Lichfield Corridor”*. This request was subsequently acknowledged, a Swanwick Military SSR code (3316) issued and, following identification, a climb to FL140 with Traffic Service issued. No Traffic Information was provided by the Swanwick Military controller to the C130 [crew] on either the F35 pair or singleton, with the Swanwick Military controller’s attention then moving to the Typhoon formation following their request to transit north due to weather.

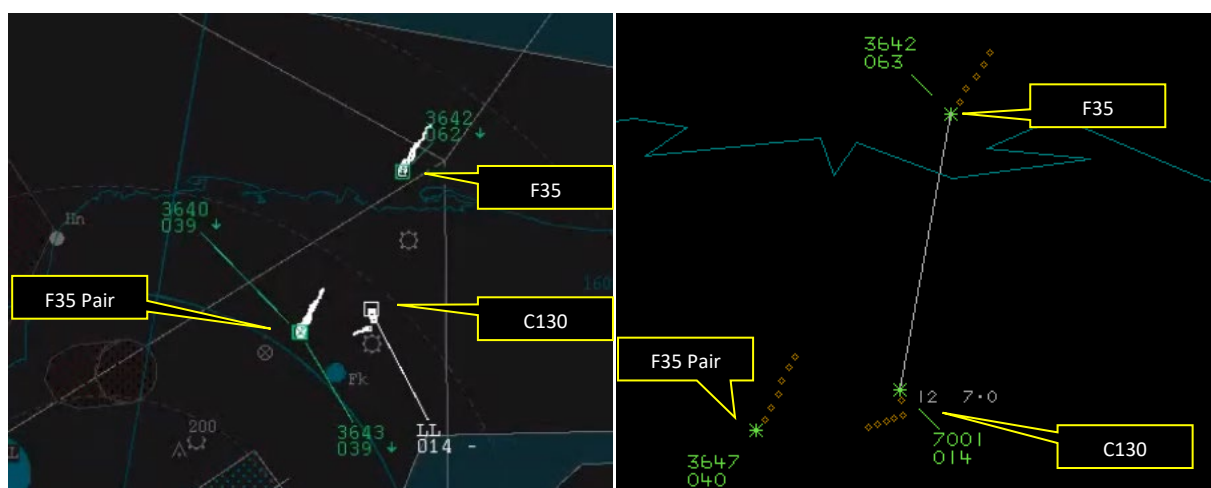
Figure 2 (0859:18): Updated Traffic information provided by the Marham Approach controller. (Separation 7.0NM) (unit radar left, NATS radar right)

At 0859:18 the Marham Approach controller provided updated Traffic Information to the [singleton] F35 on the C130, “*previously called traffic now south 4 miles, manoeuvring, indicating 1400ft, if not sighted stop descent height 2500ft*”. The F35 [pilot] reported the C130 as “*sighted*” and continued in the descent. At 0859:41 the Marham Zone controller issued the C130 with a Marham Zone SSR Code (3660) to facilitate the requested climb from low-level and transit to the Lichfield Radar Corridor. On observing the Swanwick Military SSR code (3316) the Marham Zone controller questioned the incorrect SSR code. At 0900:17 the C130 [pilot] informed the Marham Zone controller that they were in contact with Swanwick Military and established in the climb to FL140.

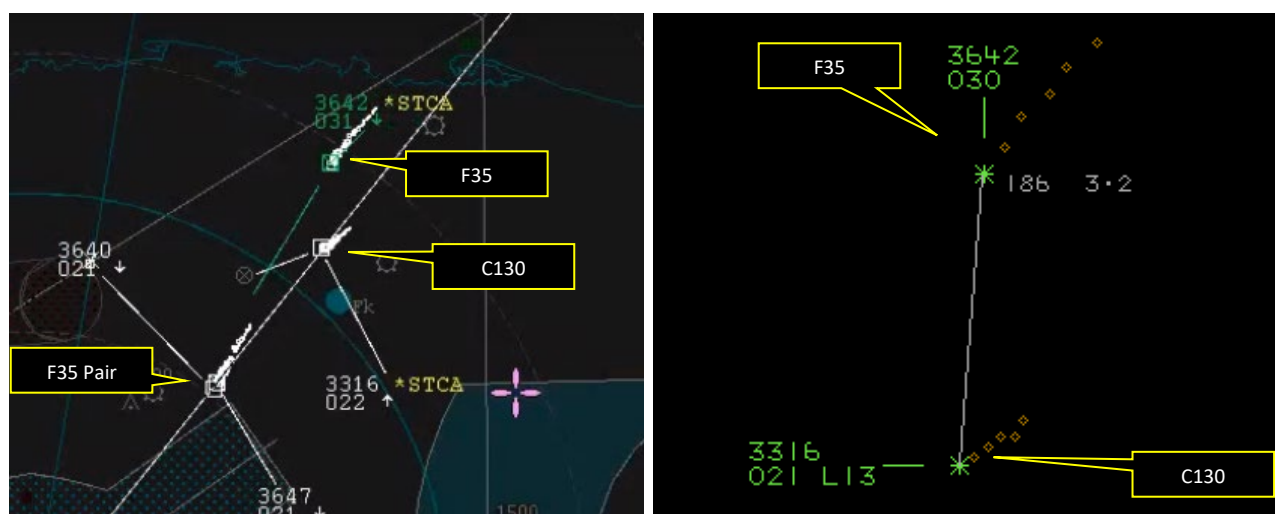
Figure 3 (0900:22): Short-Term Conflict Alert (STCA) received by both the Marham Approach controller and Marham Zone controller. (Separation 3.2NM) (unit radar left, NATS radar right)

At 0900:22, Short-Term Conflict Alerts (STCA) were received by both the Marham Approach and Marham Zone controllers. Simultaneously with the STCA, at 0900:25 the F35 [pilot] reported the C130 as now “*un-sighted*” and requested an update. At 0900:31, the Marham Approach controller provided updated Traffic Information to the F35 on the C130, “*traffic is now south by 2 miles, similar direction, indicating 600ft below*”. The F35 [pilot] elected to hold at 2500ft, to which the Marham Approach controller provided further Traffic Information “*the traffic is now climbing through your level*”. Concurrently at 0900:28, the Marham Zone controller provided Traffic Information to the C130 [crew] on the F35, “*traffic believed to be you has traffic, north 2 miles, tracking southwest, indicating 600ft above*”. The C130 [pilot] reported the traffic “*in-sight*” and about to go into cloud.

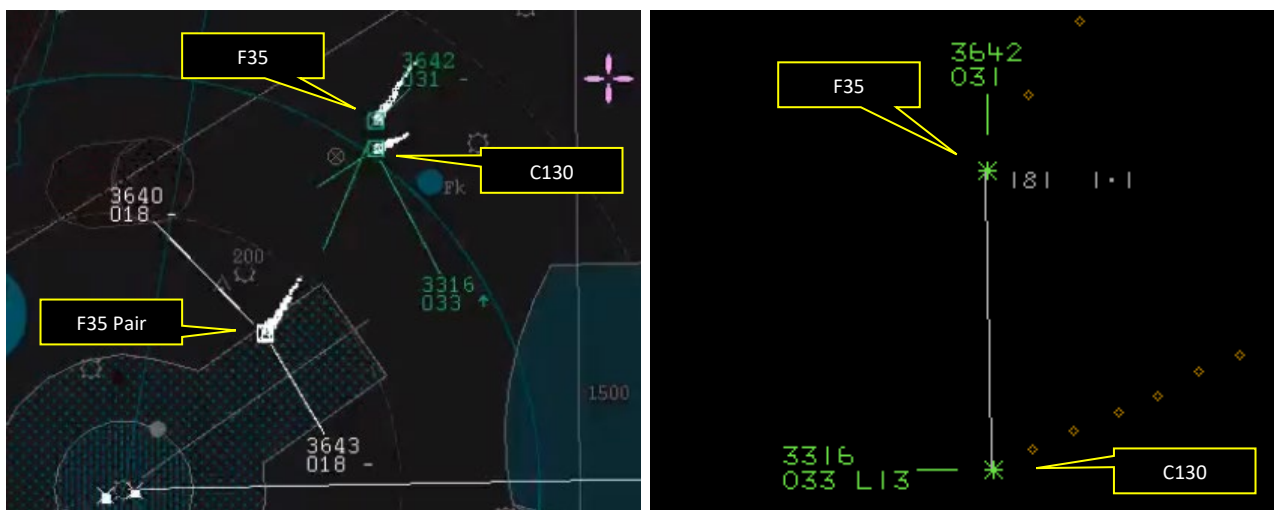
Figure 4 (0900:58): Updated Traffic information provided by the Marham Approach controller. (Separation 1.1NM) (unit radar left, NATS radar right)

At 0900:58, the Marham Approach controller provided further updated Traffic Information to the F35 [pilot] on the C130, “*previously called traffic now, south 1 mile, similar height, indicating 200ft above*”. The F35 [pilot] reported the C130 as “*visual*” and continued in the descent. At 0900:59, the Marham Zone controller provided updated Traffic Information to the C130 [crew] on the F35, “*previously called traffic is, north 1/2 mile, indicating 500ft below*”. Again, the C130 [pilot] reported the traffic “*in-sight*”.

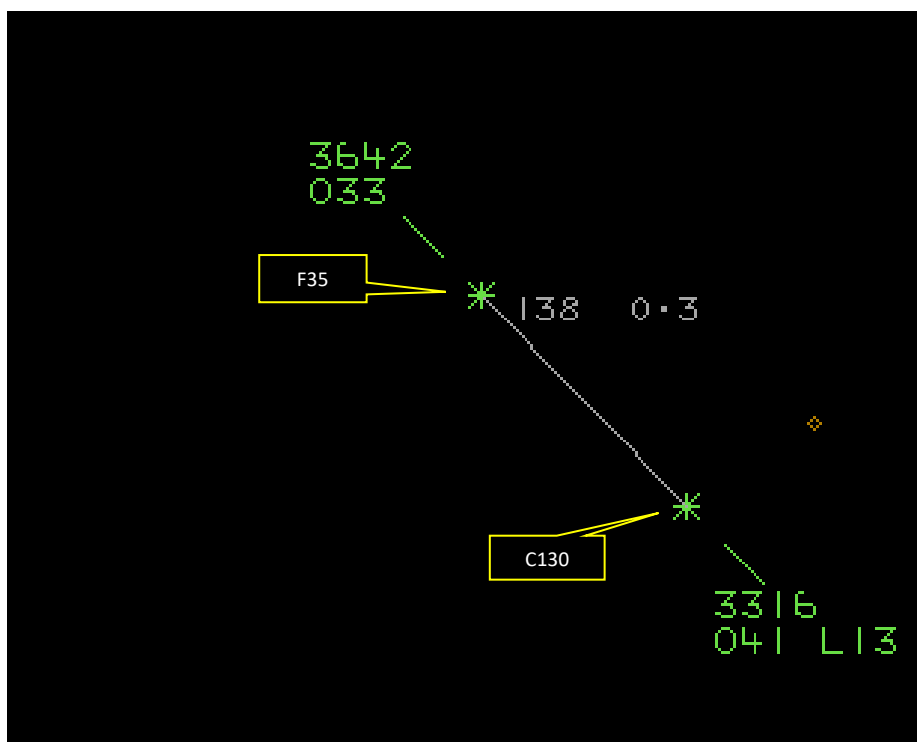
Figure 5 (0901:16): CPA, measured at 0.3NM and 800ft separation (NATS radar)
