AIRPROX REPORT No 2023044

Date: 02 Apr 2023 Time: 1334Z Position: 5316N 00046W Location: 6NM E of Retford/Gamston

PART A: SUMMARY OF INFORMATION REPORTED TO UKAB

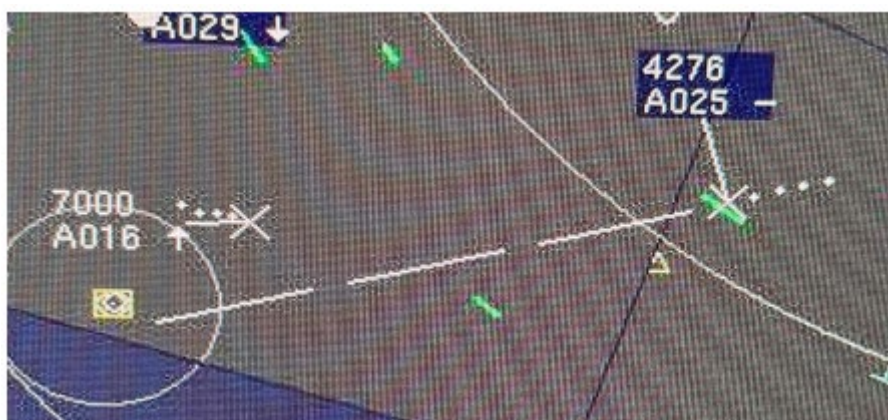
At 1332 [the King Air] pilot requested a change of frequency to Gamston radio. This was acknowledged, approved, instructed to squawk conspicuity and the Radar Service was terminated. An aircraft registration [the RV6] was 4 miles east of Gamston tracking approximately 105°.

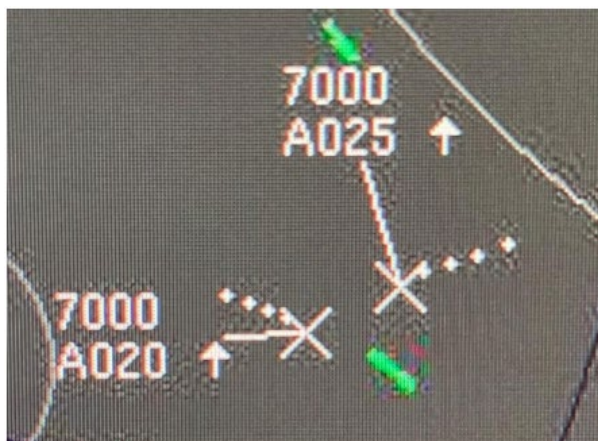
At 1333 [the RV6] was in the twelve o'clock of [the King Air] indicating 500ft below with the PSR contact to the South. [The King Air] was observed turning and climbing to overfly [the RV6] and merging with the PSR contact.

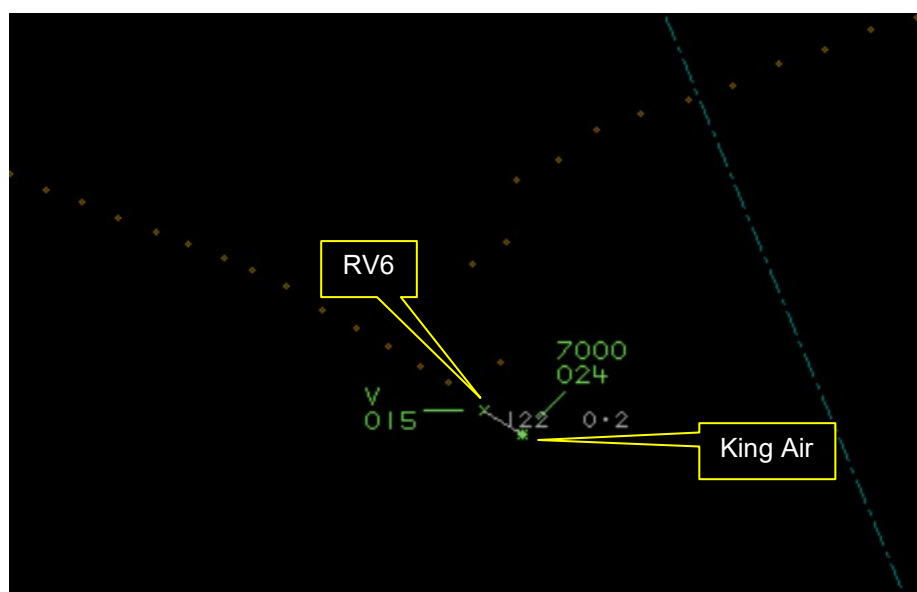
CPA 1333:37 900ft V/0.2NM H

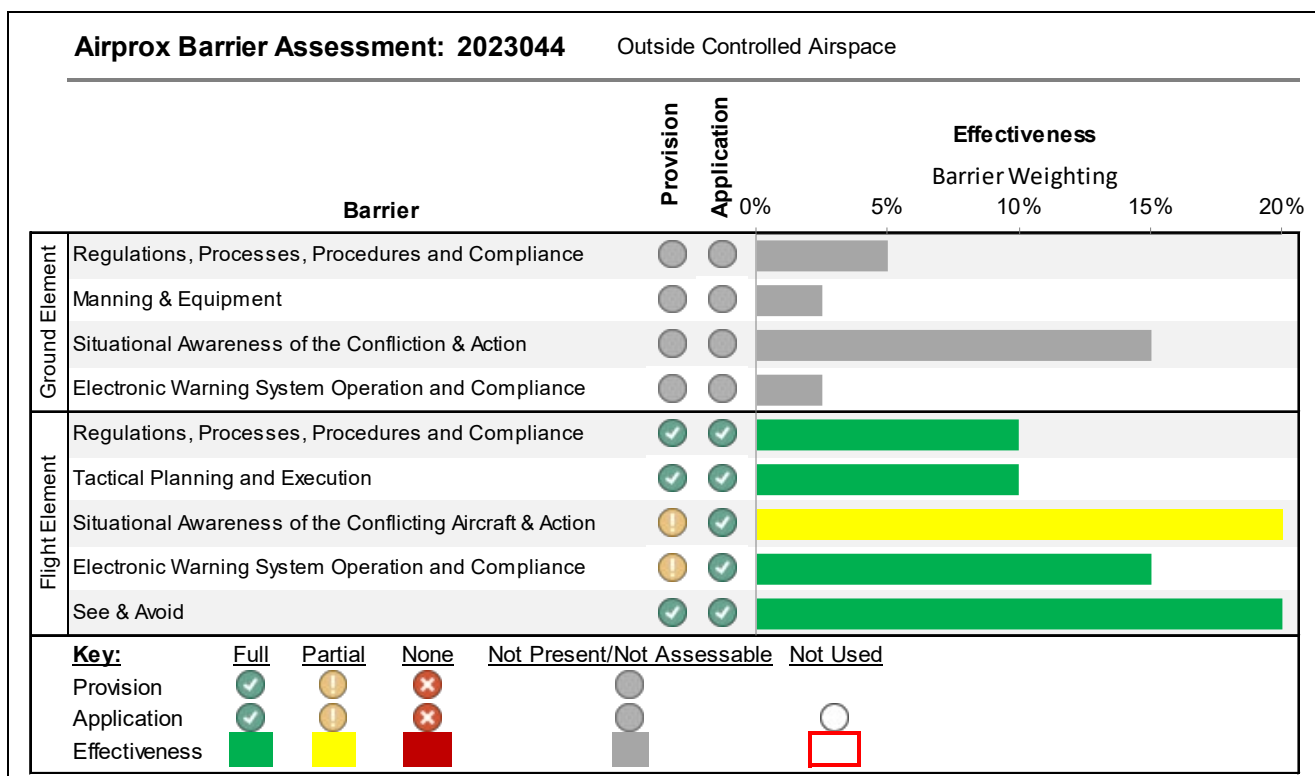
Situational Awareness of the Conflicting Aircraft and Action were assessed as **partially effective** because, although the King Air pilot had generic situational awareness, they had received a TCAS alert which they interpreted to initiate a left turn, bringing them closer to the RV6 and resulting in increased concern of the proximity between the 2 aircraft.
