AIRPROX REPORT No 2023055

Date: 17 Apr 2023 Time: 1526Z Position: 5305N 00013W Location: Coningsby

PART A: SUMMARY OF INFORMATION REPORTED TO UKAB

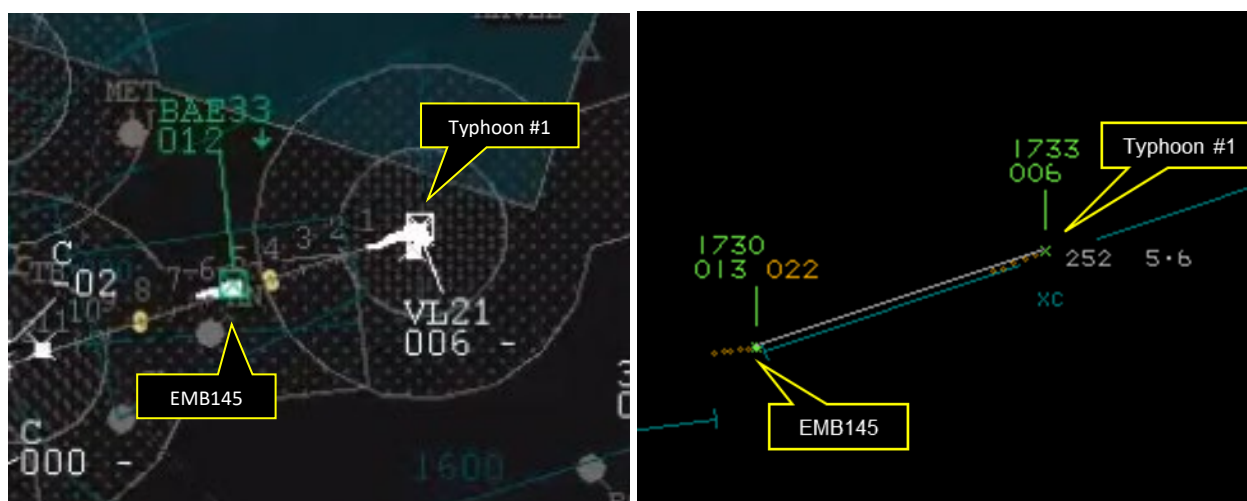
Figure 1 (1523:39). Typhoon #1 [pilot] informed Coningsby Tower of an issue and requested priority to Land from the next approach. (Separation 5.6NM)

At 1523:39, on completion of a go-around, [the pilot of] Typhoon #1 informed Coningsby Tower of an issue and requested priority to land from the next approach due to fuel. Whilst a PAN was not declared, which would have automatically given Typhoon #1 priority over the instrument traffic, the Coningsby Tower controller did prioritise Typhoon #1.

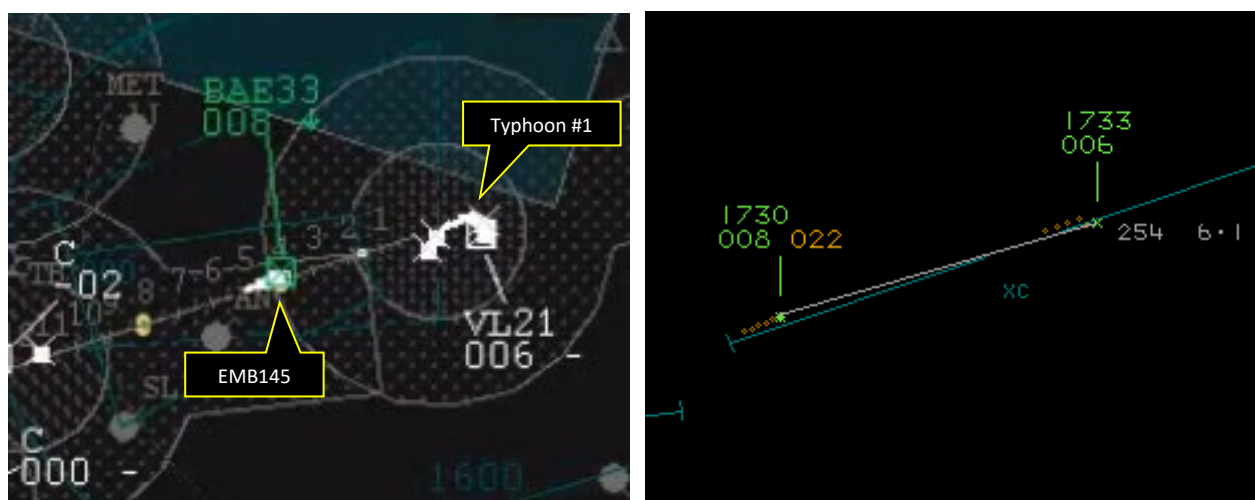
Figure 2 (1425:12). The Coningsby Surveillance Radar Approach controller broke off the EMB145 in accordance with the Coningsby Tower controller instruction. (Separation 6.1NM)

With the EMB145 at 4NM the Coningsby Surveillance Radar Approach controller requested a clearance from the Coningsby Tower controller. With Typhoon #1 having priority, the Coningsby Tower controller instructed the Coningsby Surveillance Radar Approach controller to break off the approach. At 1425:12, this instruction was passed to the EMB145 "*break off the approach, priority aircraft ahead*". The EMB145 pilot requested the clearance to be repeated to which the Coningsby Surveillance Radar Approach controller repeated the break-off instruction again at 1525:22.

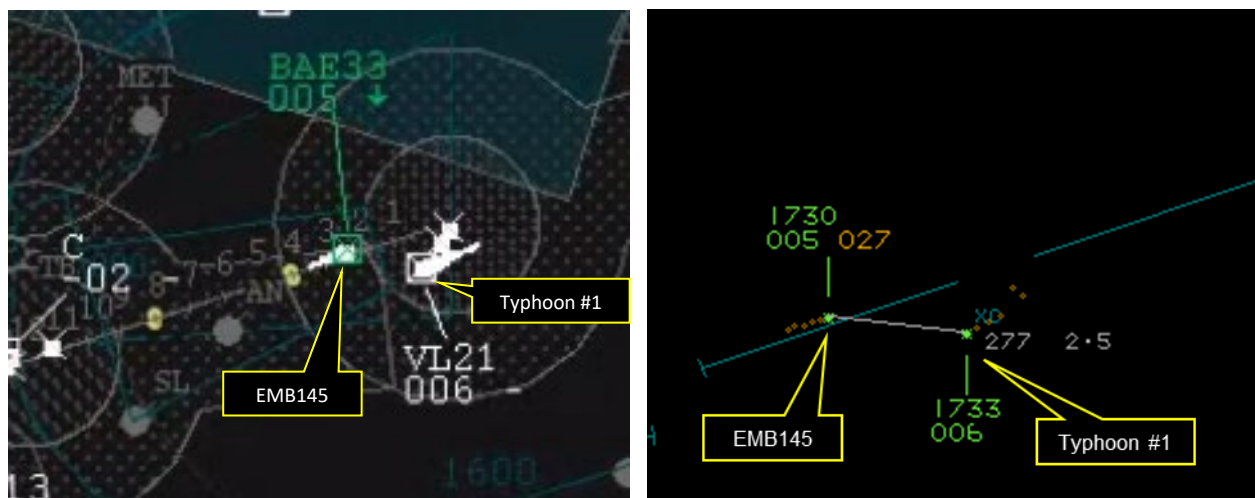
Figure 3 (1425:53). The Coningsby Director controller issued the EMB145 [pilot] with a climb instruction in accordance with the break-off. (Separation 2.5NM)

At 1525:53, the Coningsby Director controller reaffirmed the Traffic Service and issued the EMB145 [pilot] with a further climb “*identified traffic service climb to 2200 feet QFE 1028*” and heading “*on passing 1600ft turn left heading 350 degrees*”. Both instructions were acknowledged by the EMB145 pilot.

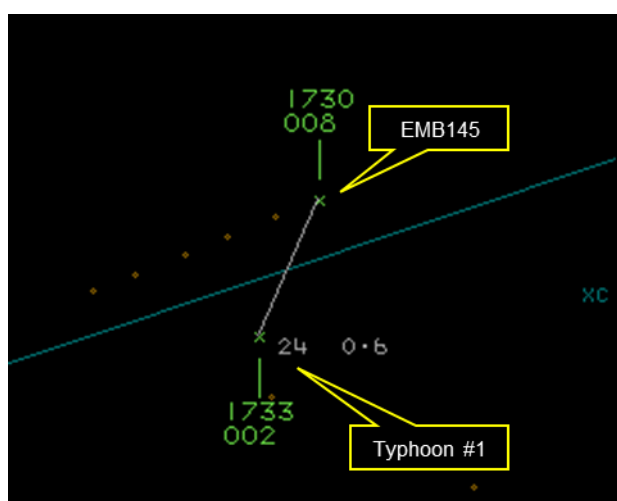
Figure 4 (1526:21): CPA.

CPA was measured at 0.6NM and 600ft separation.

The local investigation conducted by RAF Coningsby identified the cause of the Airprox as a loss of safe separation between non-co-operating aircraft due to a delay in implementation of the break-off by the EMB145 [pilot]. This delay subsequently decreased the anticipated separation between the EMB145 and prioritised Typhoon making the approach. Several BM-related causal/aggravating factors were then identified that were believed to have contributed to the Airprox:

Restriction imposed as a result of Airprox 2023050 on 3 Apr 23, not fully understood by the EMB145 pilot which led to them questioning and subsequently delaying the break-off action.

As a result of the causal factors identified the following mitigation for local action was proposed by RAF Coningsby:

Amendment and re-issuing of the Letter of Agreement between RAF Coningsby and the EMB145 operator, to provide clarity regarding the break-off procedure.
