## AIRPROX REPORT No 2023072

Date: 13 May 2023 Time: 1443Z Position: 5138N 00007E Location: 2NM SW Stapleford

### PART A: SUMMARY OF INFORMATION REPORTED TO UKAB

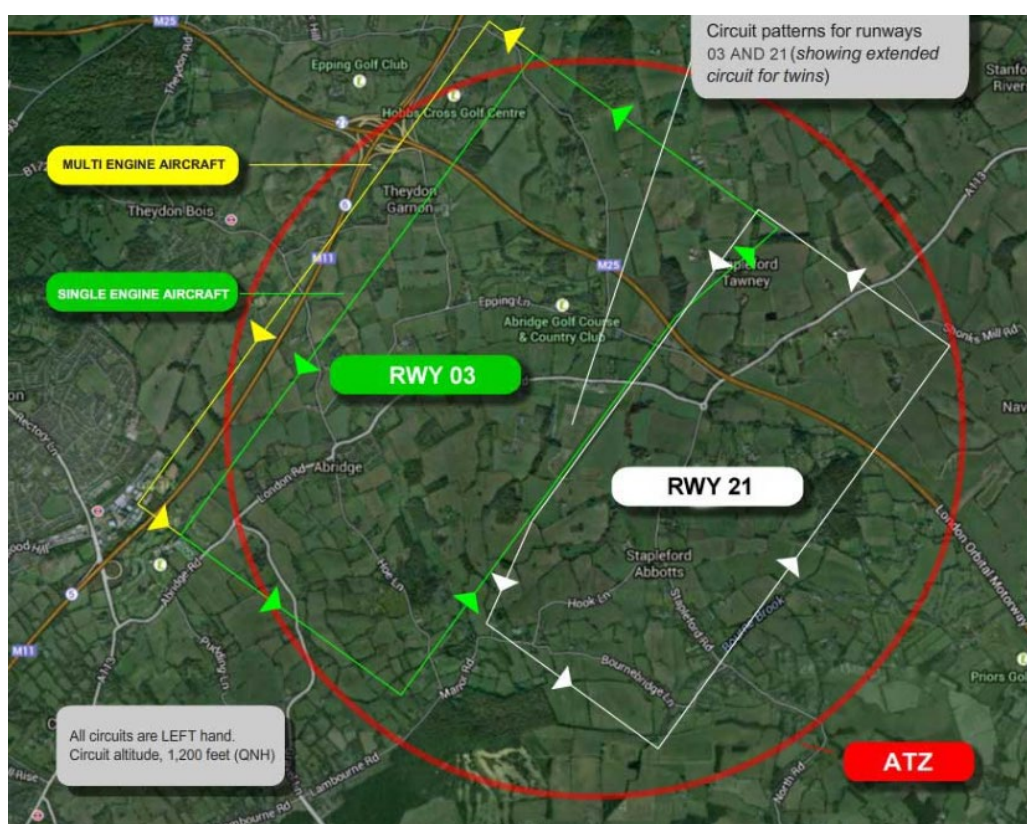
The website for Stapleford Airfield provides the following circuit diagram:

Turning their attention to the diagram provided on the Stapleford website, members noted that the circuit pattern is depicted as extending beyond the ATZ boundary. It was suggested that the pilot of the Magni M24 had not been aware that this had been the accepted positioning of traffic operating in the circuit at Stapleford, and surmised that they had not expected to have encountered circuit traffic at that location. Notwithstanding, members were keen to emphasise that a thorough scan and effective lookout had been of paramount importance in such a busy area. Members agreed that the pilot of the Magni M24 had not had situational awareness of the presence of the C152 until it had been visually acquired (**CF4**). It was further agreed that the pilot of the Magni M24 had, essentially, not avoided the pattern of traffic in the circuit (**CF3**), although members appreciated that that had been somewhat inadvertent. It was noted that, once the C152 had been visually acquired, albeit late (**CF5**), avoiding action had been taken which had increased the separation between the aircraft.

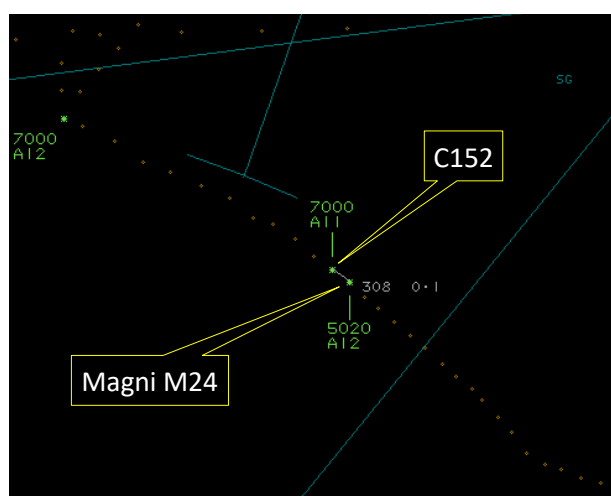
Figure 1 – 1442:30

An analysis of the NATS radar replay was undertaken and both aircraft could be positively identified from Mode S data. It was determined that CPA had occurred between the radar sweeps at 1442:30 and 1442:34 (see Figures 1 and 2). The Magni M24 was observed to have been at 1200ft before CPA and at 1100ft afterwards. Therefore, the altitude separation at CPA has been recorded as an approximation.
