## AIRPROX REPORT No 2023079

Date: 18 May 2023 Time: 1342Z Position: 5336N 00042W Location: 2NM NW Scunthorpe

### PART A: SUMMARY OF INFORMATION REPORTED TO UKAB

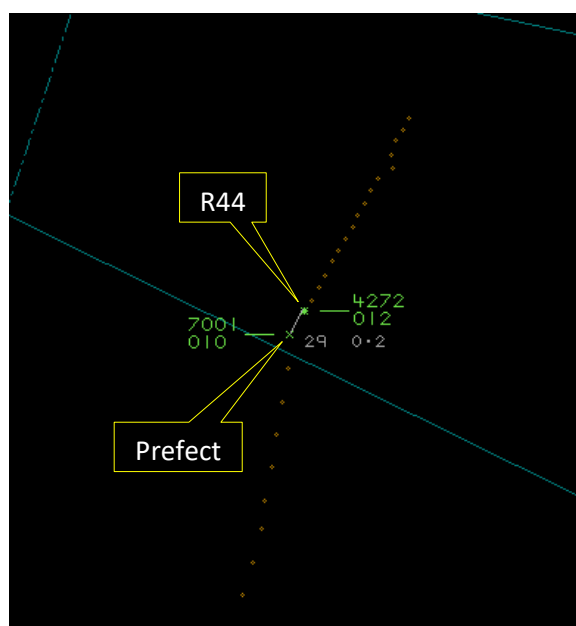
Figure 1 – 1341:42

The moment of CPA was determined to have occurred between the radar sweeps at 1341:42 and 1341:46 (see Figures 1 and 2). It was observed that pilot of the Prefect had turned sharply to the right approximately at the moment of CPA, but it could not be determined whether this turn had been initiated in the moments before or after CPA had occurred.
