AIRPROX REPORT No 2023088

Date: 18 May 2023 Time: 0949Z Position: 5359N 00355W Location: 26NM ESE Isle of Man Airport

PART A: SUMMARY OF INFORMATION REPORTED TO UKAB

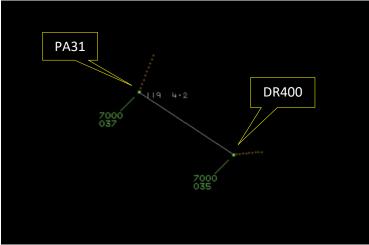
Figure 1 – 0947:38

The RT confirms the controller's report, who, having received the initial call from [the pilot of the DR400], immediately passed Traffic Information (at 0947:38) to them on [the PA31]; "*Traffic for you, believed to be in your area, is a Navajo operating on a survey very similar level*", before then continuing to take the rest of the pilot's details. The aircraft were 4.2NM apart, and converging (Figure 1).

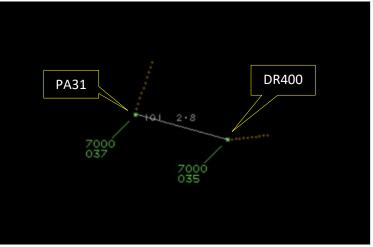
Figure 2 - 0948:20

At 0948:20, with the aircraft 2.8NM apart (and 200ft vertically), the pilot of [the DR400] reported visual; "in my 2 o'clock" (Figure 2).

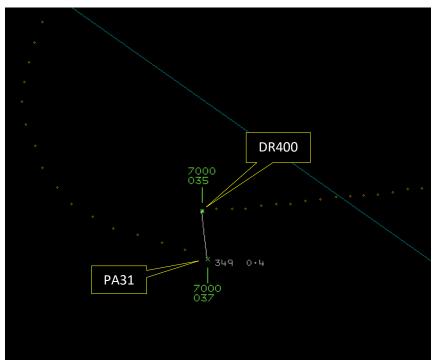
Figure 4 – CPA at 0949:07

However, the [pilot of the PA31] continued to turn towards [the DR400], with CPA at 0949:07 (Figure 4). Separation was 200ft V/0.4NM H. The manoeuvres reported by the [pilot of the PA31] were not observed on radar, and their [earlier] comment that "I was aware that the SE aircraft was in our 7-8 o'clock position" is incongruent unless the RT time injection was wrong. [This seemed not to be the case though] as the 'visual' call made by [the pilot of the DR400] at 0948:20, with [the PA31] in their 2 o'clock, matched the radar replay.
