AIRPROX REPORT No 2023094

Date: 13 May 2023 Time: 1210Z Position: 5236N 00102W Location: Leicester ATZ

PART A: SUMMARY OF INFORMATION REPORTED TO UKAB

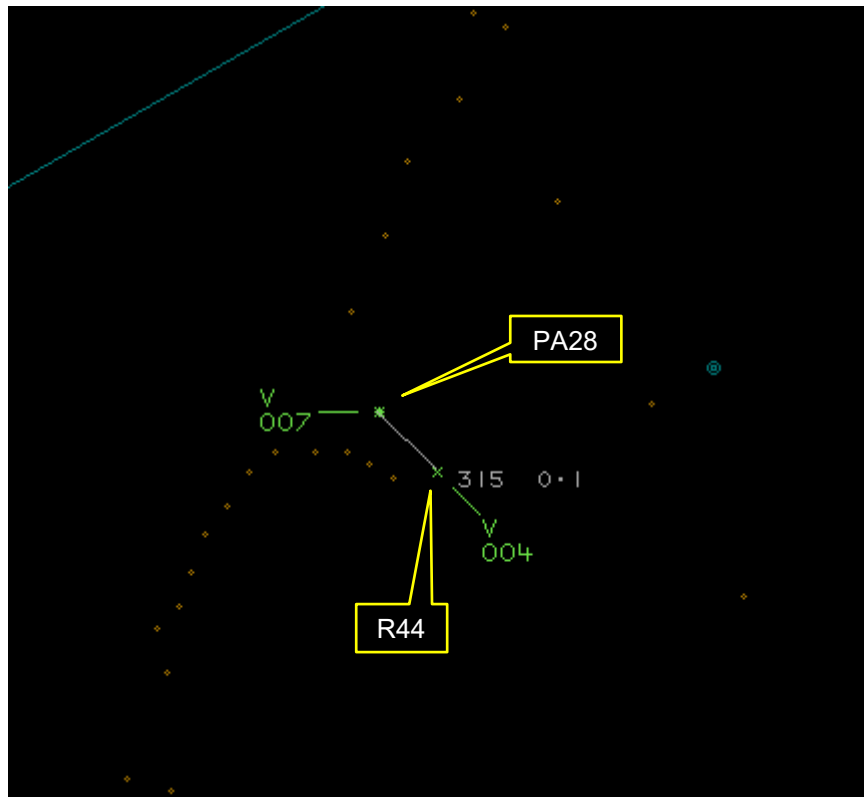
Figure 1: Radar tracked CPA 300ftV/0.1NM H 1210:26

The R44 had been equipped with an electronic warning system that had been triggered by the PA28 which, according to the R44 pilot's report, had enabled the R44 pilot to visually acquire the other aircraft at a late stage and take action to increase separation between the two. The PA28 pilot reports having been visual with the R44 throughout but, although both aircraft were on the AGCS frequency, the PA28 pilot made their initial call outside the ATZ and no further calls were heard by the Air/Ground Operator or R44 pilot until after the R44 pilot had declared an Airprox.
