AIRPROX REPORT No 2023097

Date: 23 May 2023 Time: 1614Z Position: 5223N 00007E Location: 5NM W Ely

PART A: SUMMARY OF INFORMATION REPORTED TO UKAB

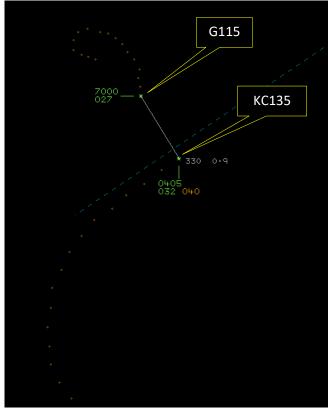
Figure 1 – CPA at 1614:02

An analysis of the NATS radar replay was undertaken and both aircraft could be positively identified from Mode S data (see Figure 1).

An Airprox was reported when a KC135 and a G115 flew into proximity 5NM west of Ely at 1614Z on Tuesday 23rd May 2023. The KC135 pilot was operating under IFR in IMC, in receipt of a Traffic Service from Lakenheath Approach, the G115 pilot was operating under VFR in VMC, listening out on the Fowlmere Radio frequency.
