AIRPROX REPORT No 2023099

Date: 28 May 2023 Time: 1308Z Position: 5205N 00130W Location: IVO Shenington

PART A: SUMMARY OF INFORMATION REPORTED TO UKAB

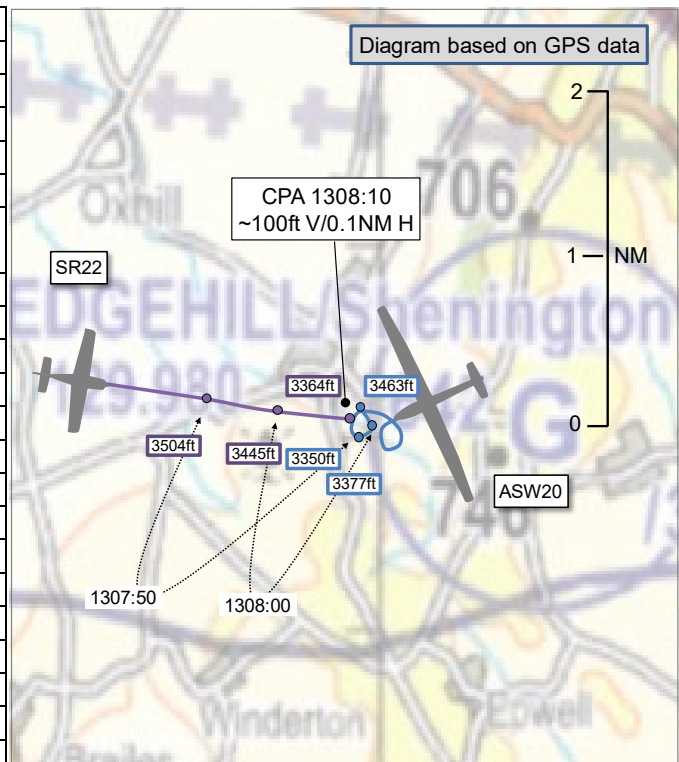
Recorded	Aircraft 1	Aircraft 2
Aircraft	ASW20	SR22
Operator	Civ Gl'd	Civ FW
Airspace	London FIR	London FIR
Class	G	G
Rules	VFR	VFR
Service	None	Establishing contact
Provider	N/A	Turweston
Altitude/FL	3463ft	3364ft
Transponder	Off	A, C, S+
Reported		
Colours	White	Silver, Red
Lighting	None	HISLs, Strobes
Conditions	VMC	VMC
Visibility	>10km	>10km
Altitude/FL	3474ft	3150ft
Altimeter	QFE	QNH (1017hPa)
Heading	Thermalling left	100°
Speed	50kt	130kt
ACAS/TAS	FLARM	TAS
Alert	None	None
Separation at CPA		
Reported	3-500ft V/500m H	200ft V/100m H
Recorded	~100ft V/0.1NM H

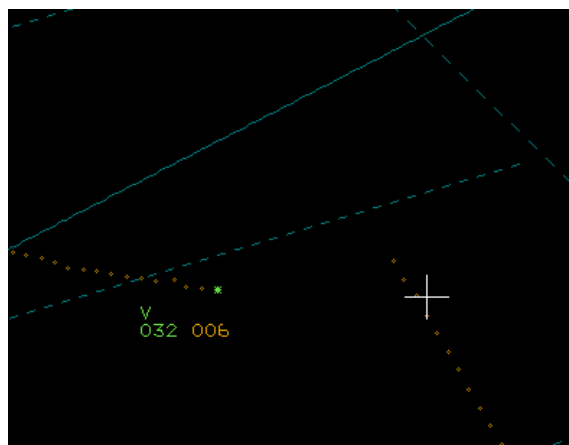
An analysis of the NATS radar replay was undertaken. The SR22 could be seen on the radar replay and at 1307 could be seen heading east, indicating FL032 (radar QNH 1023hPa, giving an approximate altitude of 3500ft) see Figure 1. The ASW20 could not be seen on the radar, however, both pilots supplied a GPS file, from which the diagram at the top of the report could be compiled.

Figure 1 – 1307:40, the white cross is the approximate position of Sherington

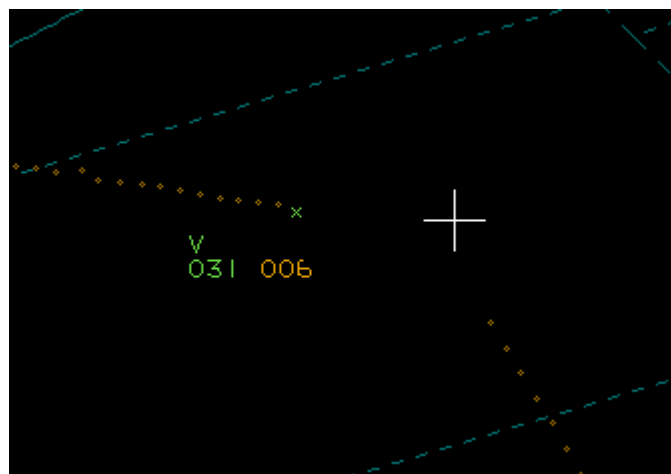
From analysis of the GPS tracks, the Airprox occurred at around 1308:10. As this time the SR22 was indicating FL031, see Figure 2.

Figure 2 1308:10 approximate CPA
