#### AIRPROX REPORT No 2023115

Date: 14 Jun 2023 Time: 1154Z Position: 5426N 00242W Location: 4NM west of Tebay

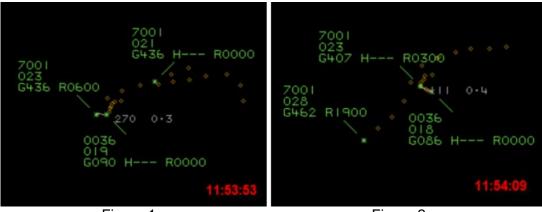
Figure 1

The closest point of approach between [the R44] and the first [F15] occurred at 1153:53 measured on multi-track radar as 0.3NM and 400ft (Figure 1). The closest point of approach between [the R44] and the second [F15] occurred at 1154:09, measured on multi-track radar as 0.4NM and 500ft (Figure 2). The incident was resolved by the existing tracks of the aircraft diverging.

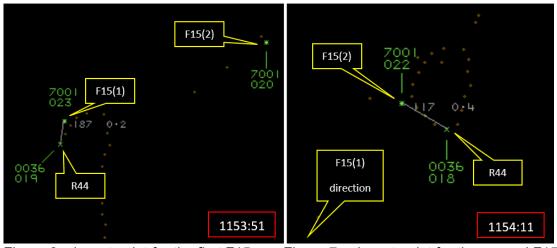
Figure 6- closest point for the first F15. Figure 7 - closest point for the second F15

The first F15 was indicated at the closest point of approach at 1153:51 with a separation from the R44 of 0.2NM and 400ft (Figure 6) and the second F15 followed 20sec later with a separation of 0.4NM and 400ft (Figure 7).
