AIRPROX REPORT No 2023121

Date: 15 Jun 2023 Time: 1804Z Position: 5246N 00008E Location: Sutton Bridge

PART A: SUMMARY OF INFORMATION REPORTED TO UKAB

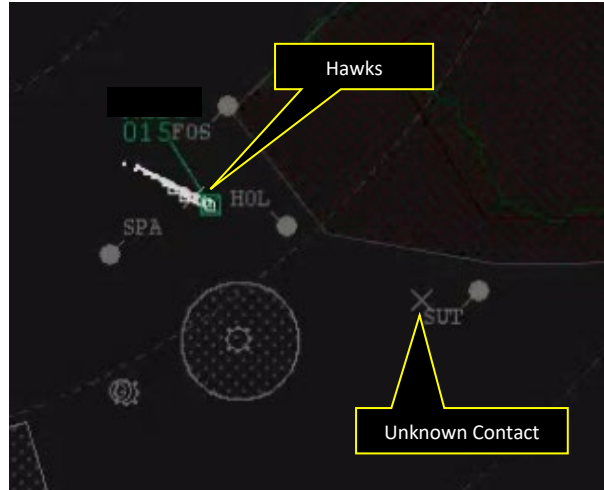
Figure 1 (1803:06). Non-cooperative contact displayed on radar.

At 1803:06, a non-cooperative lone radar contact had been displayed to the southeast of the [formation]. The radar contact had been updated twice providing an initial radar trail that indicated a slow southwest track.

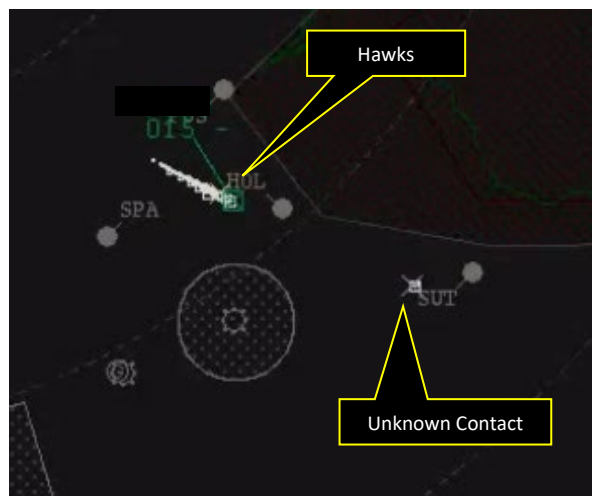
Figure 2 (1803:17). Traffic Information provided to the [formation].

At 1803:17, with the non-cooperative radar track still displaying, the Waddington Radar controller had begun to pass Traffic Information to the [formation]. However, simultaneously the radar track stopped being displayed, and the Waddington Radar controller stopped passing Traffic Information. *“Traffic... (radar track no longer displayed)...Disregard it’s faded from radar.”*

The non-cooperative radar track did not display again before the [formation] declared an Airprox with a microlight at 1805:21. It cannot be confirmed if the non-cooperative radar track temporarily shown had been the Airprox microlight.

b. Traffic Information had initially been started but then stopped as the radar contact disappeared. With the characteristics of the MARSHALL surveillance sensor equipment, and method in which radar contacts are displayed in accordance with achieving characteristics, the understanding behind radar tracks fading has changed and potentially the Traffic Information should have been continued. A review into Traffic Information provision for disappearing contacts was recommended.

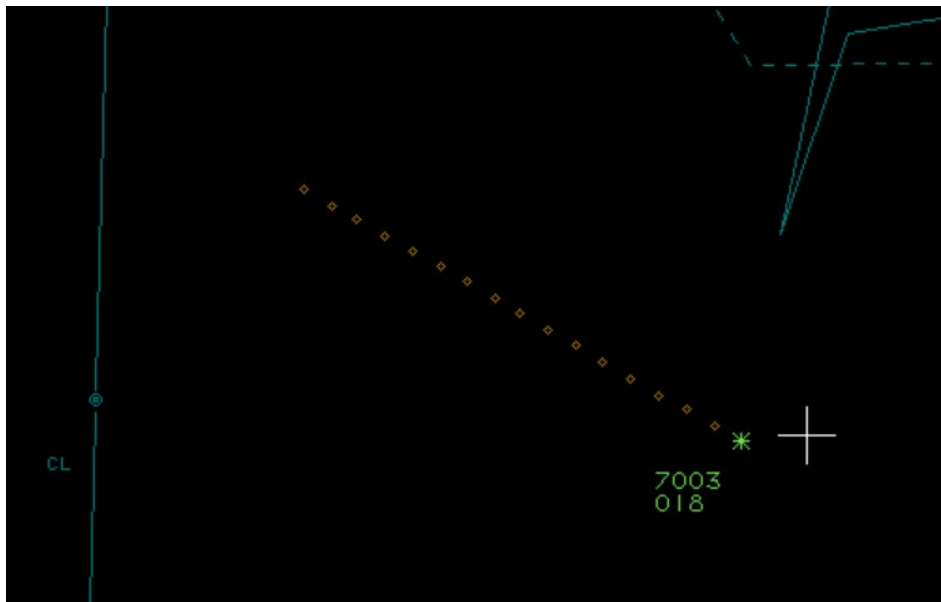
Figure 3 'CPA' 1804:21 NK V/NK H

Radar replays available for this event show the lead [formation] Hawk throughout via Mode S. The formation operated as 2 sections separated by 0.5NM (approximately 5sec) with the rear section operating 400ft below the level of the lead section. CPA is considered to have been between the unidentified microlight and the rear section. Figure 3 shows the reported position of the Airprox with the white cross indicating their ground reference point for that event (Sutton Bridge).

The Hawk and microlight pilots shared an equal responsibility for collision avoidance and not to operate in such proximity to other aircraft as to create a collision hazard.⁴ If the incident geometry is considered as head-on or nearly so then both pilots were required to turn to the right.⁵ If the incident geometry is considered as converging then the microlight pilot was required to give way to the Hawk.⁶
