AIRPROX REPORT No 2023124

Date: 21 Jun 2023 Time: ~1422Z Position: 5111N 00048E Location: 2NM south of Challock.

PART A: SUMMARY OF INFORMATION REPORTED TO UKAB

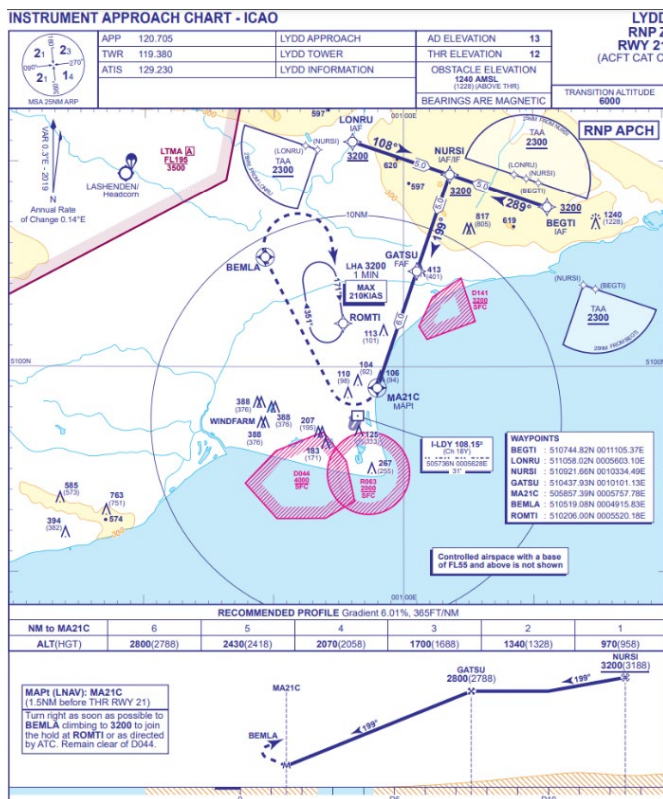
Figure 1: Approach Procedure Z to RW21

However, they believed that this was not entirely true as a review of their approach plates for the RNP approaches to RW21 indicated that the Initial Approach Fixes (IAF) LONRU & SORDI are only 4.2NM and 5.1NM to the east-southeast of Challock. Any aircraft conducting an RNP approach from the southwest, as the [DA42] pilot was, would likely be routing to within 3NM of Challock. The report from [the DA42 pilot] suggests that they had been briefed on the proximity of the gliding site.

CAA ATSI has informed the ATM Ops Inspector for Lydd who may consider asking Lydd to review their MATS Part 2 entry with a view to having controllers warn aircraft on RNP approaches to RW21 routing to either of these IAFs about the possible glider activity in the vicinity.

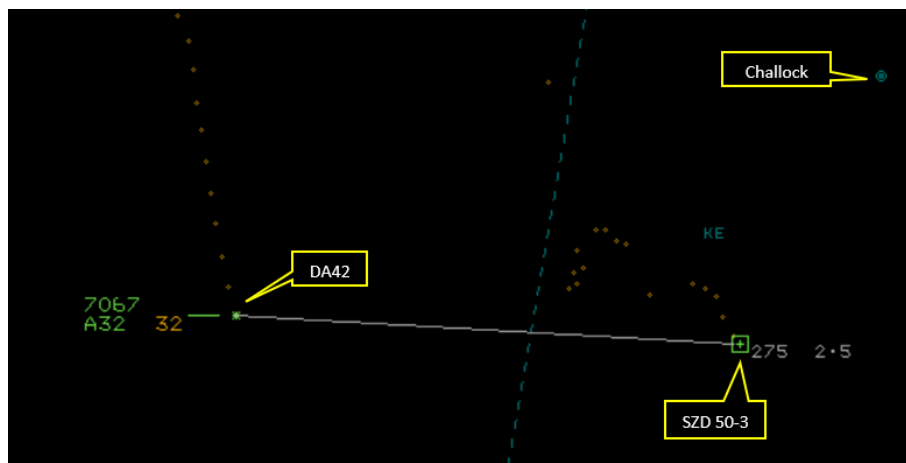
An analysis of the NATS radar replay was undertaken and, while the DA42 was visible at all times, the SZD 50-3 aircraft was visible by primary returns only. The glider pilot was manoeuvring the SZD 50-3 and the DA42 pilot had routed to the south of the gliding site when making their way to the initial approach fix of SORDI for an instrument approach procedure (Figure 3).

Figure 3 – Time 1420:33 DA42 changed track to the east.

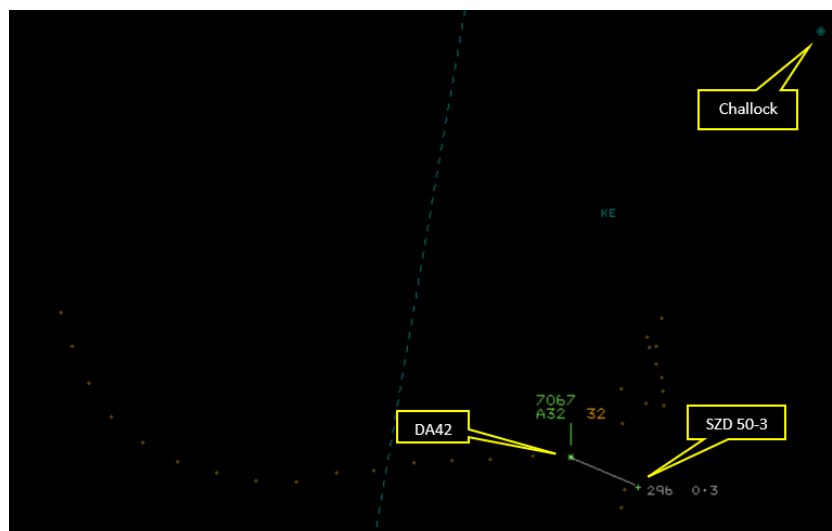
One minute after turning to track towards SORDI, the DA42 passed to the south of the glider site and close to the SZD 50-3 glider (Figure 4).

Figure 4 – Time 1421:33 with the DA42 tracking easterly.

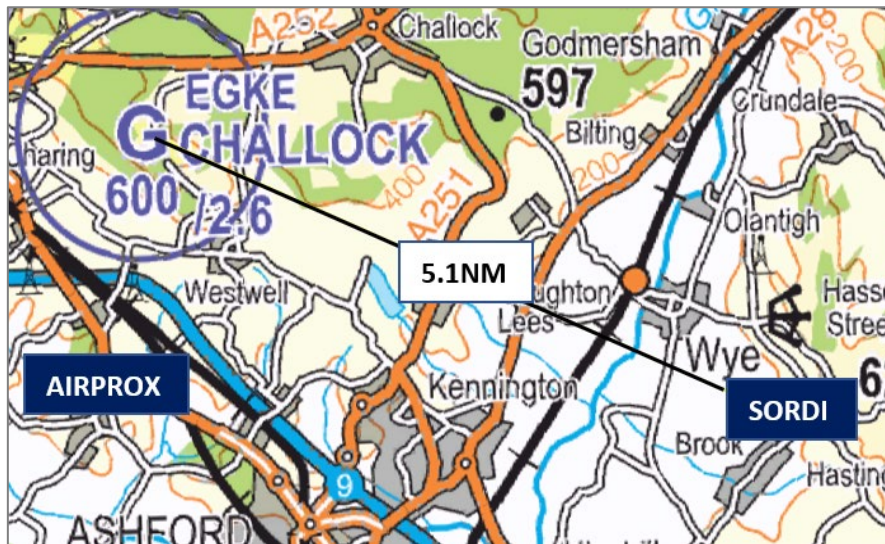
It was noted that the glider site did not significantly affect Lydd Airport operations, according to Lydd airport's manual for ATS, although the IAFs were examined and commented upon by CAA ATSI regarding their relative distances from the glider site, with SORDI being 5.1NM to the east-southeast (Figure 5).

Figure 5 – position of the initial approach fix in use

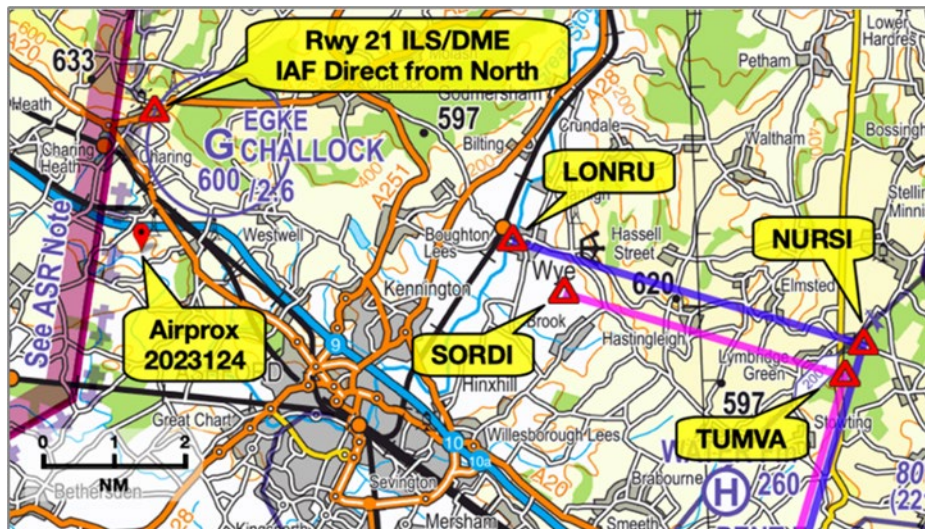
This incident has elements in common with Airprox 2022146, also near Challock airfield, between a Discus B and DA42 that was also on an IFR training detail en route to SORDI. As noted by CAA ATSI, Initial Approach Fixes (IAF) LONRU & SORDI for RNP approaches to Lydd RW21 are close to Challock Airfield. In addition, the IAF for a direct arrival from the north for an offset ILS/DME approach to Lydd RW21 is about 1NM west-northwest of Challock Airfield (Figure 6). The maximum winch launch altitude at Challock Airfield is 2600ft AMSL.

Figure 6 – Lydd initial approach fixes in the vicinity of Challock.

1. Kent Gliding Club and Lydd Airport establish a Letter of Agreement to address the risk of concurrent activities in the same volume of airspace.
2. Lydd Airport depicts Challock gliding site on the applicable Instrument Approach Charts.
