AIRPROX REPORT No 2023129

Date: 22 Jun 2023 Time: 1250Z Position: 5632N 00413W Location: Ben Lawers

PART A: SUMMARY OF INFORMATION REPORTED TO UKAB

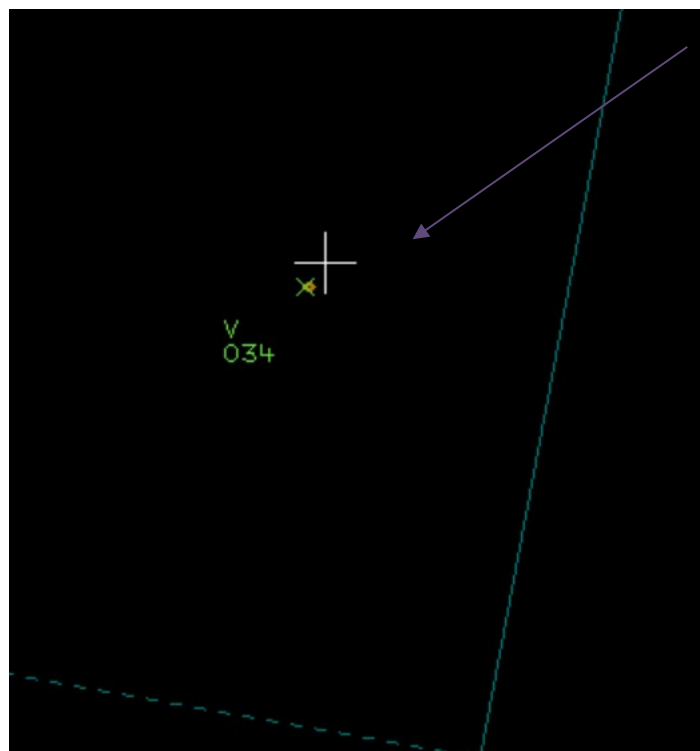
Figure 1: CPA 1250:25 700ft V/ <0.1NM H
White cross indicates summit of Ben Lawers
Purple line shows direction of approach of LS6

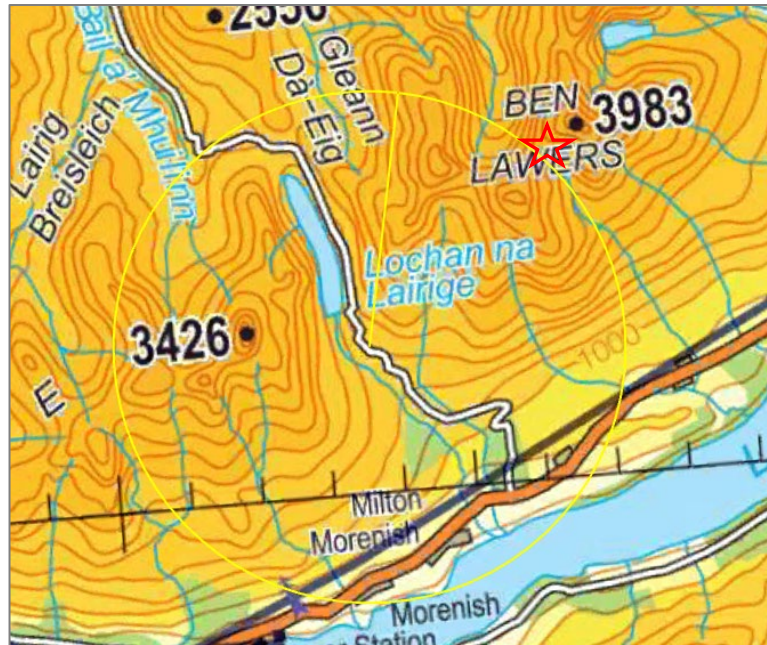
Figure 2: Yellow circle indicates the relevant NOTAM lateral limit.
Red star indicates reported position of the Airprox

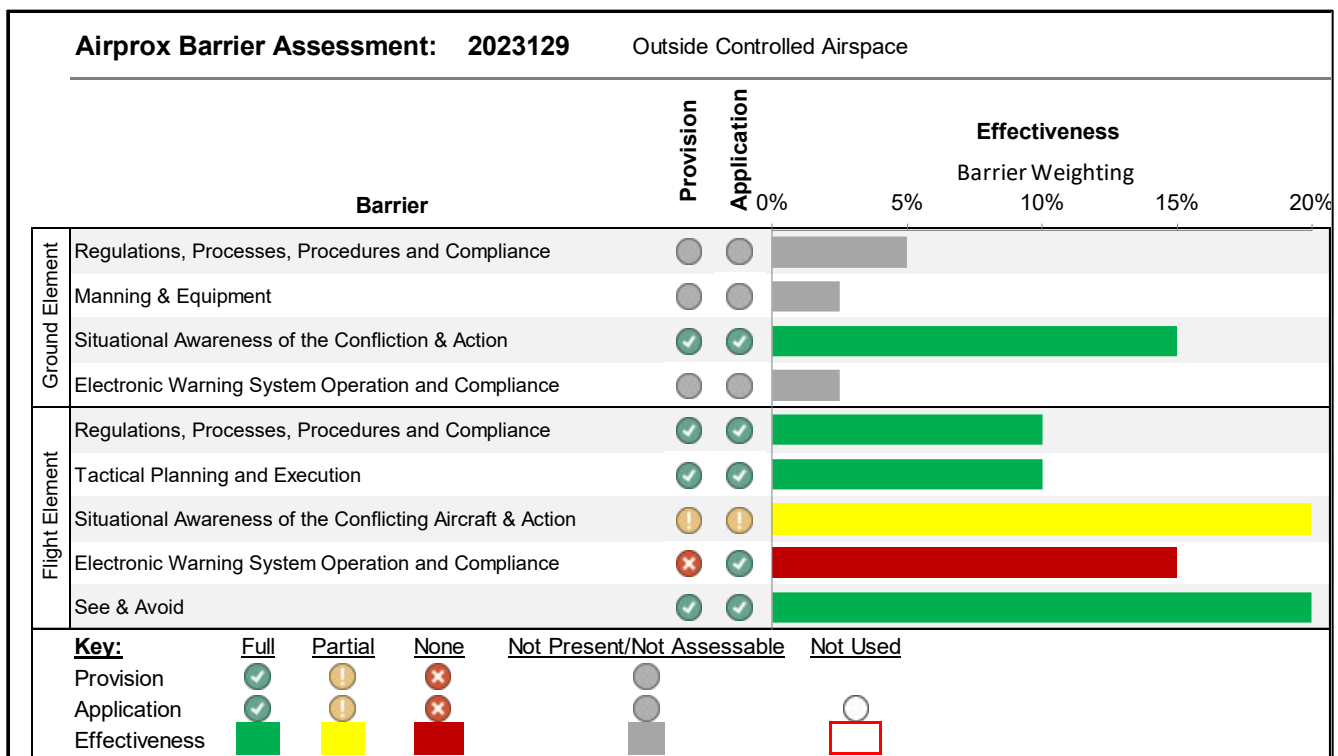
Situational Awareness of the Conflicting Aircraft and Action were assessed as **partially effective** because the AS350 pilot was alerted to the LS6 at a late stage by colleagues on the ground.

Electronic Warning System Operation and Compliance were assessed as **ineffective** because although both the AS350 and the LS6 carried compatible equipment, no interaction between the 2 was possible due to the unit on the AS350 being unserviceable.
