**AIRPROX REPORT No 2023131**

Date: 23 Jun 2023 Time: 1155Z Position: 5113N 00035W Location: 1.1NM SSW Guildford VRP

**PART A: SUMMARY OF INFORMATION REPORTED TO UKAB**

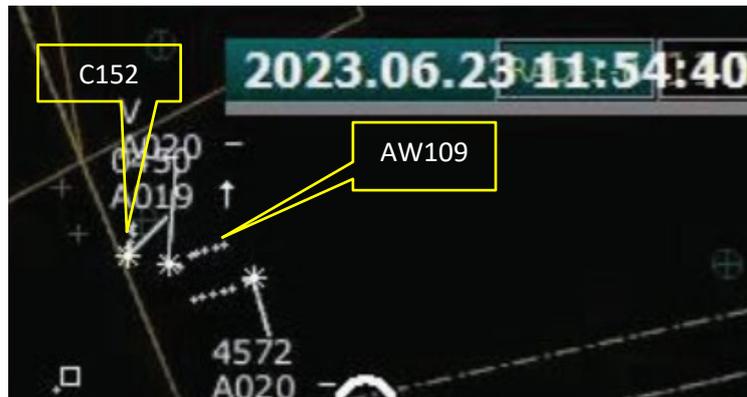
Figure 1

At 1154 a radar return squawking 7000 could be observed converging with [the C152] crossing left-to-right and indicating altitude 2000ft Mode C, unverified. Mode C of [the C152] could be observed climbing to altitude 2300ft (Figure 1).

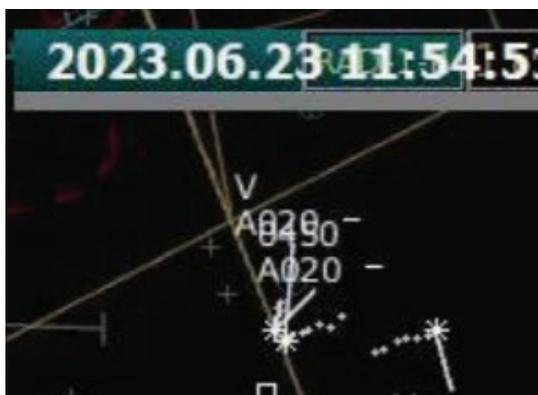
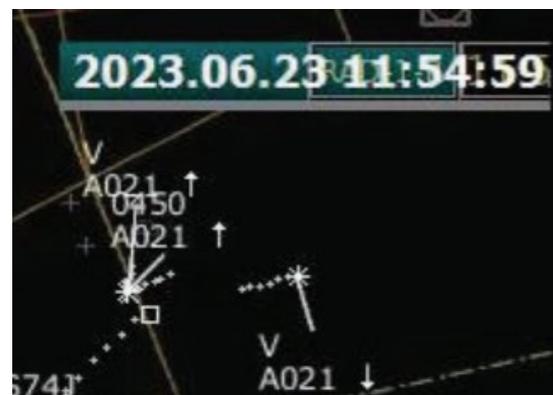
The contacts merged at the same altitude

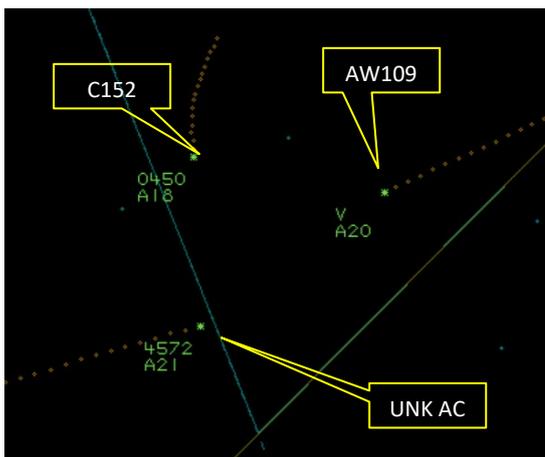
Figure 4

An analysis of the NATS radar replay was undertaken, the C152 could be identified with the Farnborough squawk and the AW109 could be positively identified from Mode S data. The C152 was on an approximate southerly heading and the AW109 was on a south-westerly heading, however, another non-airprox aircraft was also on a reciprocal heading to the AW109 at a similar level and it was undoubtedly this aircraft that the AW109 pilot reported seeing on their TAS in their

11 o'clock, see Figure 4. This unknown aircraft passed 0.7NM to the south of the AW109 (Figure 5).

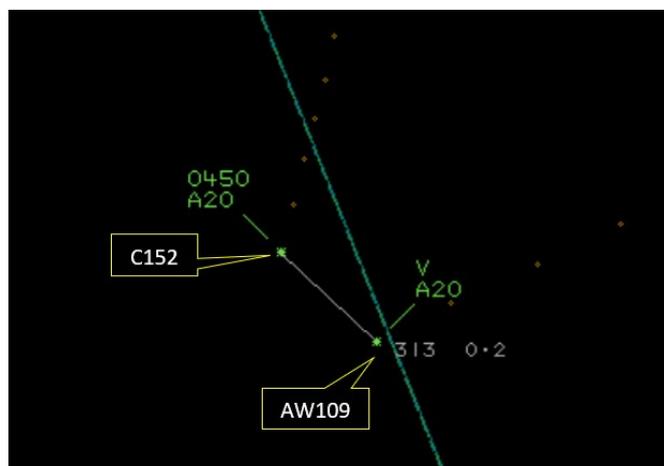
Figure 6 – 1154:59 CPA

CPA between the C152 and the AW109 occurred at 1154:59, see Figure 6.
