AIRPROX REPORT No 2023148

Date: 13 Jul 2023 Time: 1347Z Position: 5158N 00053W Location: IVO Little Horwood

PART A: SUMMARY OF INFORMATION REPORTED TO UKAB

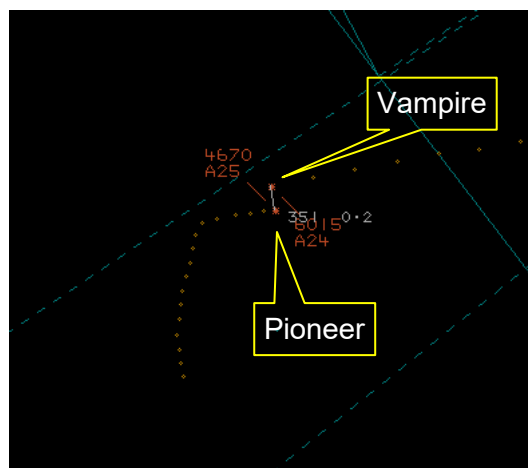
However, timely and very precise Traffic Information had been passed by the Farnborough controller to the pilot of the Vampire on the Pioneer, and acknowledged by the Vampire pilot when the aircraft were still over 6NM apart, but the pilot did not report visual. The Traffic Information was repeated when both aircraft were passing each other less than 1NM apart at which point the Vampire pilot reported being visual with the Pioneer.

CPA 100ft V/0.2NM H 1347:26
