### **AIRPROX REPORT No 2023157**

Date: 20 Jul 2023 Time: 1326Z Position: 5209N 00034W Location: 5NM NNE Cranfield

## PART A: SUMMARY OF INFORMATION REPORTED TO UKAB

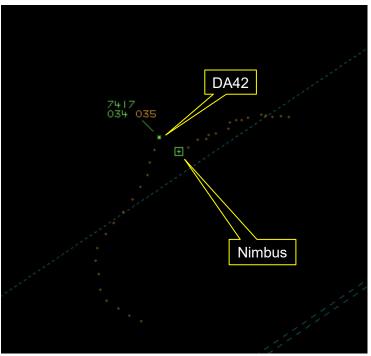
Figure 1 – radar CPA – ~25ft V/~0.1NM H

As the Nimbus had appeared on radar as a primary-only contact and had not been in receipt of a service from Cranfield, a non-surveillance unit, Traffic Information could not have been passed.

The DA42 and Nimbus pilots shared an equal responsibility for collision avoidance and not to operate in such proximity to other aircraft as to create a collision hazard. If the incident geometry is considered as head-on or nearly so then both pilots were required to turn to the right.
