# **AIRPROX REPORT No 2023160**

Date: 26 Jul 2023 Time: ~1009Z Position: 5138N 00222W Location: 1NM SW of Wotton-under-Edge

# PART A: SUMMARY OF INFORMATION REPORTED TO UKAB

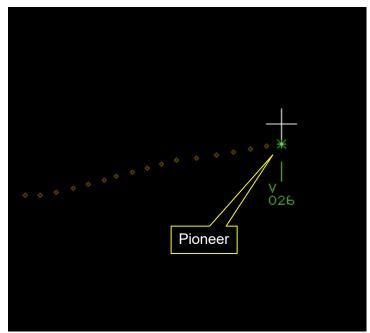
Figure 1 – CPA ~1009. White cross indicates reported position of Airprox

When assessing the risk, members considered the reports from the Pioneer pilot, the AFISO involved and available radar replays. They noted that the separation between the 2 aircraft had been greatly reduced and that, although the Pioneer pilot reported that they had visually acquired the Jabiru at a late stage and believing that the Jabiru pilot had performed an avoidance manoeuvre at the same time as they had, members accepted that safety had been much reduced but that a risk of collision had remained (**CF5**). Accordingly, members assigned a Risk Category B to this Airprox.

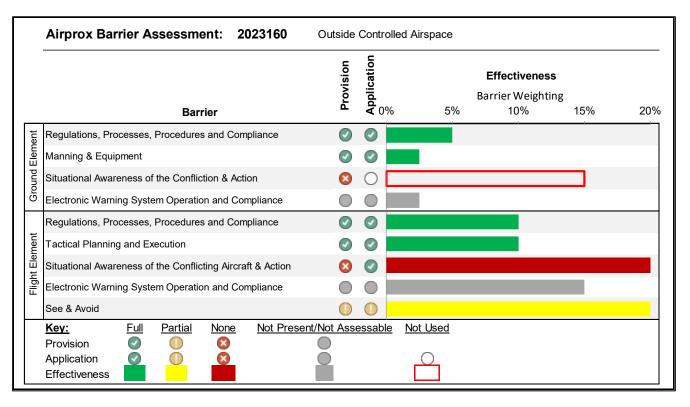
**Situational Awareness of the Confliction and Action** were assessed as **not used** because the Pioneer pilot had been operating outside the AOR of the Kemble AFISO.

**Situational Awareness of the Conflicting Aircraft and Action** were assessed as **ineffective** because the Pioneer pilot had no Situational Awareness of the Jabiru.

**See and Avoid** were assessed as **partially effective** because the Pioneer pilot achieved only a late sighting of the Jabiru.
