AIRPROX REPORT No 2023165

Date: 30 Jul 2023 Time: 1236Z Position: 5154N 00201W Location: 1NM East of Cheltenham

PART A: SUMMARY OF INFORMATION REPORTED TO UKAB

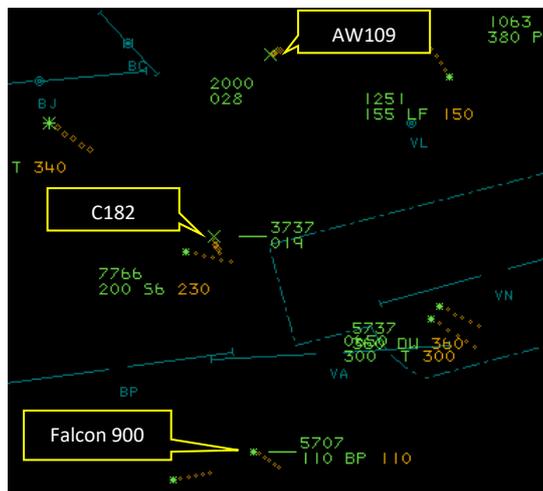
Figure 1 (1231:46). Position of the AW109 and C182 when the Falcon 900 contacted the Brize Norton Approach controller.

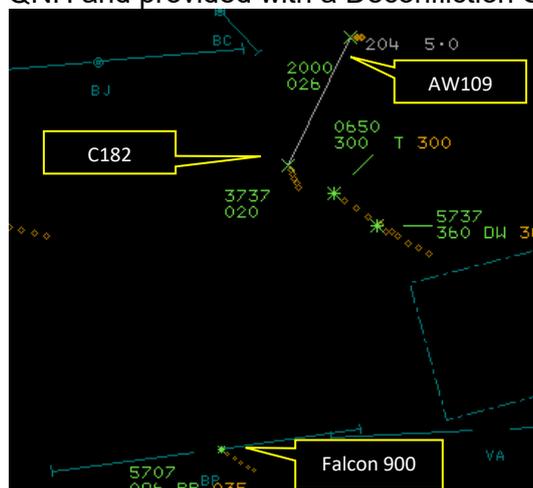
Figure 2 (1233:38). Separation between the C182 and AW109 fell below 5NM laterally.
 (Separation: 600ft V/5.0NM H)

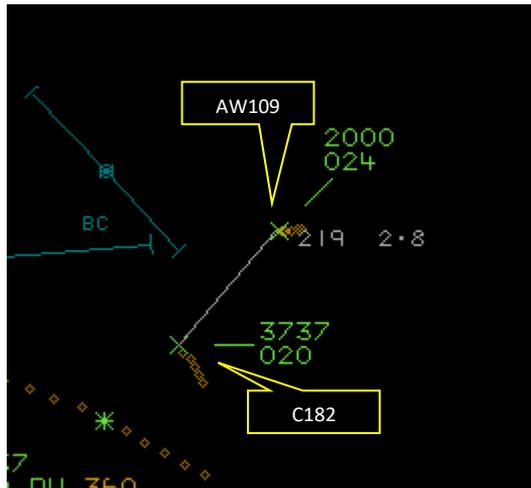
Figure 3 (1234:40). Brize Norton Approach controller commenced a landline call with Kemble regarding the Falcon 900 RNP approach.
 (Separation: 2.8NM)

As a result of the unknown traffic operating in the vicinity of Kemble and the Falcon 900 pilot's Deconfliction Service, the Brize Norton Approach controller informed the Falcon 900 pilot of an amended RNP approach path. At 1234:40, the Brize Norton Approach controller informed Kemble of the inbound and the amended routing.

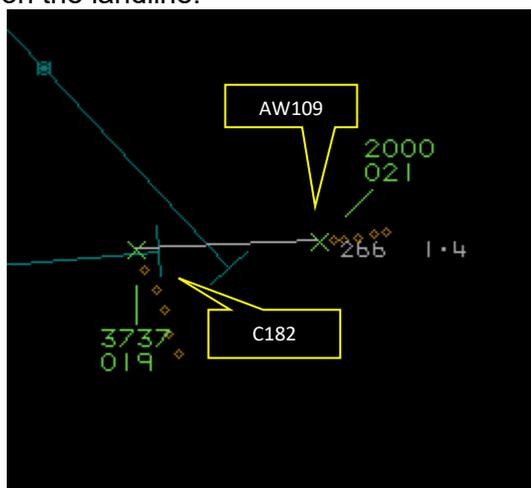
Figure 4 (1235:26). Traffic Information provided to the C182 on the AW109.
 (Separation: 1.4NM)

At 1235:26, the Brize Norton Approach controller provided Traffic Information to the C182 [pilot] on the AW109; *“Traffic east, one mile, tracking west, indicating similar level descending”*. The C182 [pilot] acknowledged the Traffic Information ; *“copied the traffic, thank you”*.

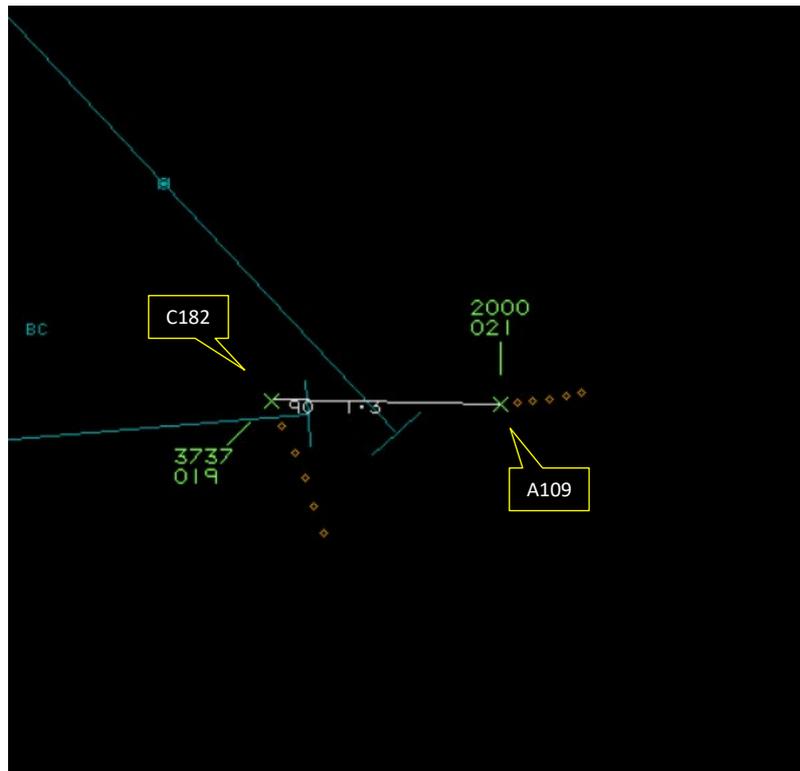
Figure 5 – CPA 1235:31 200ft V/1.3NM H

The AW109 and C182 pilots shared an equal responsibility for collision avoidance and not to operate in such proximity to other aircraft as to create a collision hazard.³ If the incident geometry is considered as converging then the C182 pilot was required to give way to the AW109.⁴
