**AIRPROX REPORT No 2023223**

Date: 23 Sep 2023 Time: 1148Z Position: 5049N 00038W Location: IVO Bognor Airfield

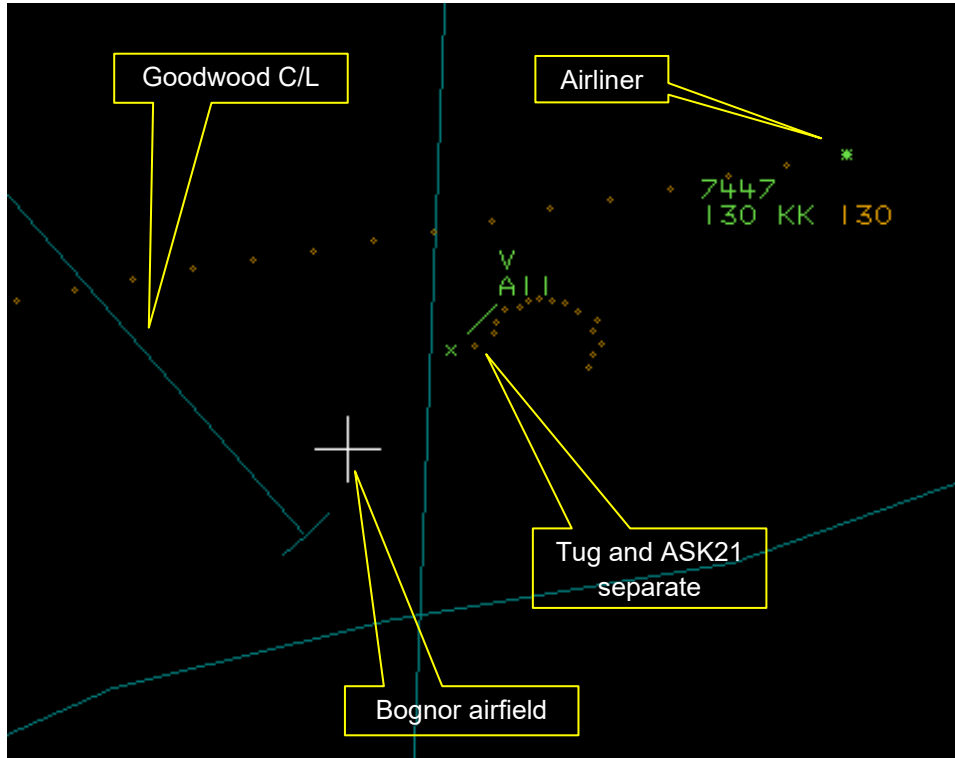
Figure 1: Radar snapshot at 1147:45 (CPA + 10sec) – 1min after the Eurofox (Tug) first appeared on radar. The ASK21 did not appear on radar.

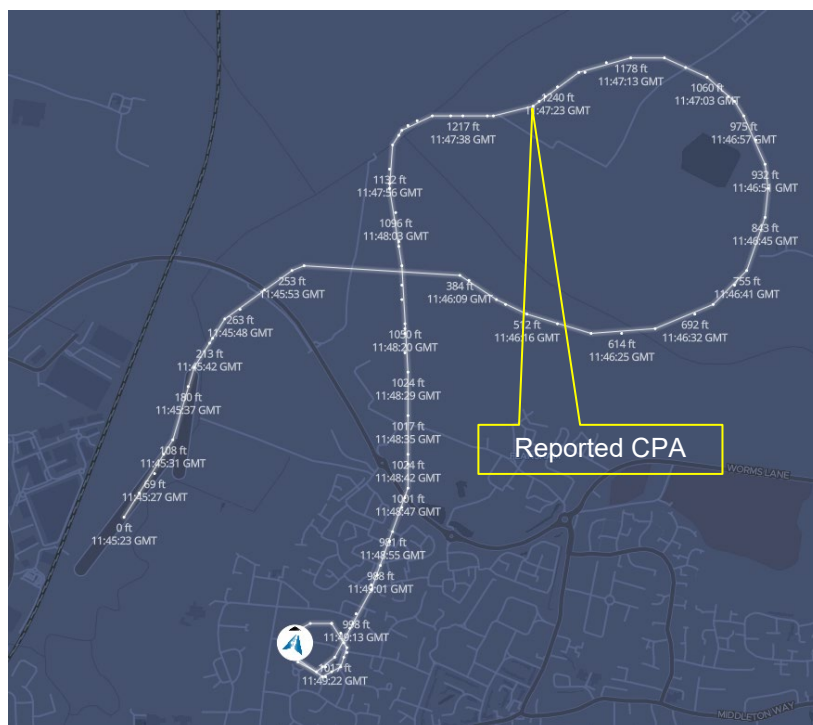
Figure 2: EC equipment track of the ASK21 from launch to CPA +~3 mins
