#### **AIRPROX REPORT No 2023235**

Date: 29 Sep 2023 Time: ~0824Z Position: 5217N 00022W Location: South of Grafham Water

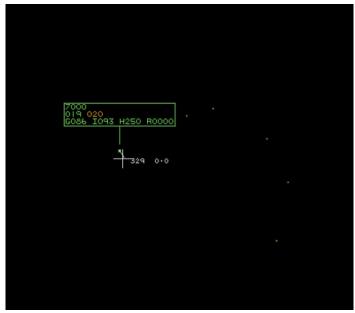
Figure 1 – Reported point at time 0824:27

An analysis of the NATS radar replay was undertaken for the period of the flight that the DA42 pilot had operated in the vicinity of Grafham Water. The unknown aircraft was not observed on radar at any point.
