AIRPROX REPORT No 2023257

Date: 25 Nov 2023 Time: 1029Z Position: 5120N 00018E Location: 2NM SE Brands Hatch

PART A: SUMMARY OF INFORMATION REPORTED TO UKAB

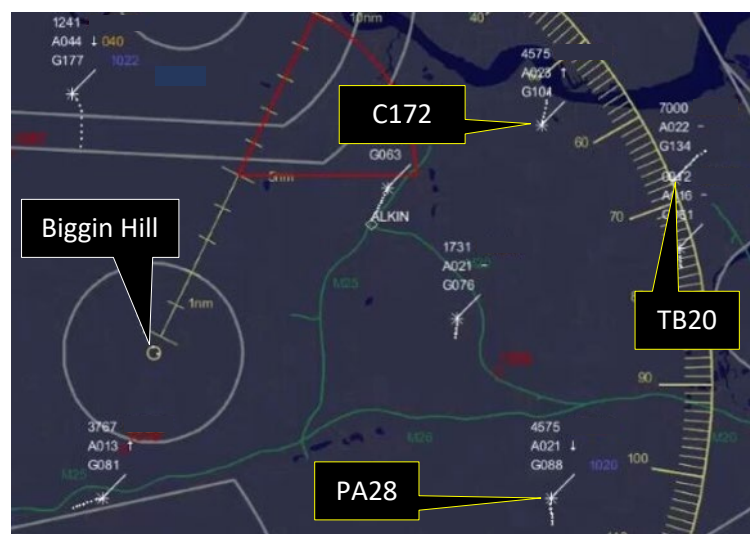
Figure 1 – 1026:05. The pilot of the TB20 had called the Biggin Hill controller approximately 3min before CPA.

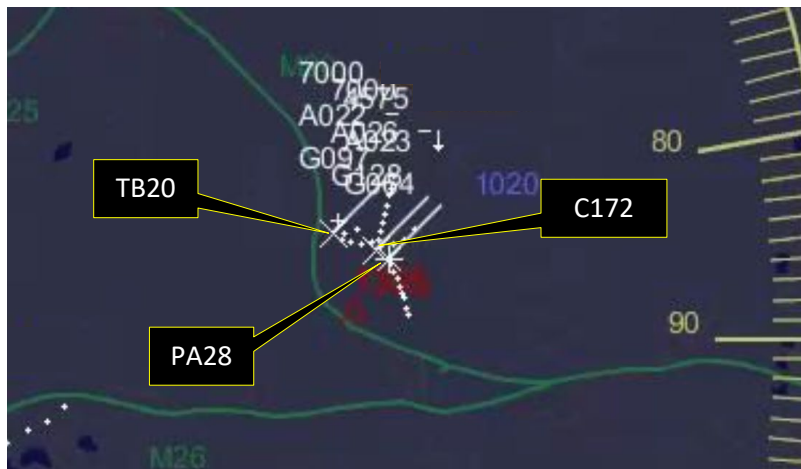
Figure 3 – 1029:26. After CPA.

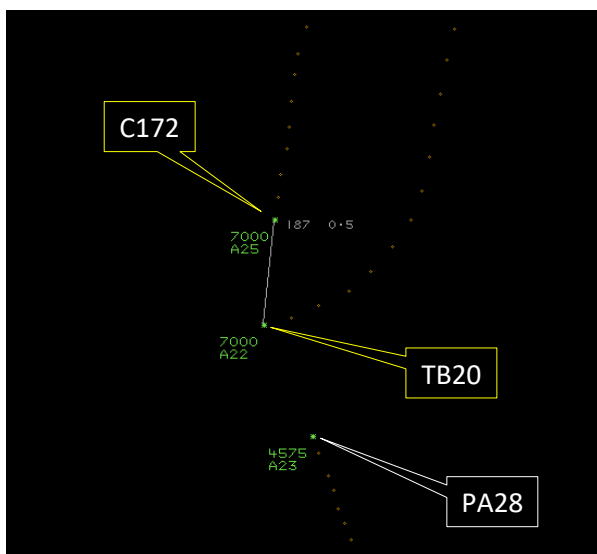
Figure 4 – 1029:07

An analysis of the NATS radar replay was undertaken. Both aircraft could be positively identified from Mode S data (see Figure 4). The separation between the C172 and TB20 was observed to have been 0.5NM at 1029:07. The separation decreased to 0.4NM on the next radar sweep (Figure 5) and this was assessed to have been CPA. The diagram was constructed and the CPA determined from the radar data.

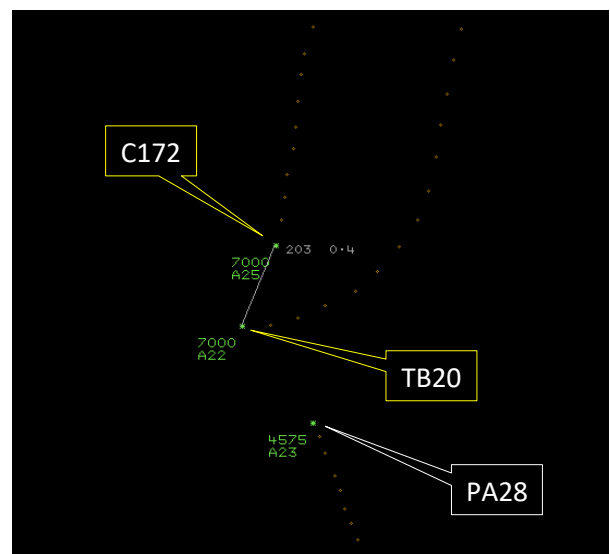
Figure 5 – CPA at 1029:11
