**AIRPROX REPORT No 2024007**

Date: 16 Jan 2024 Time: 1502Z Position: 5318N 00249W Location: 1NM SW of Hale Lighthouse

**PART A: SUMMARY OF INFORMATION REPORTED TO UKAB**

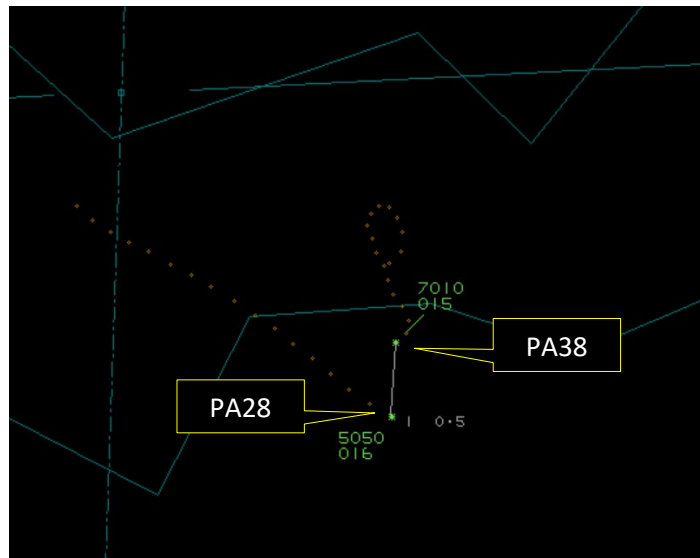
Figure 1 – Time 1502:10 CPA 100ft 0.5NM

The radar ATCO correctly followed the Letter of Agreement between Liverpool ATSU and Hawarden ATSU by giving an amended route to the southbound VFR local flight to avoid the [affected] airspace. Traffic information was passed to both [the PA28 and PA38 pilots]. [The PA38 pilot] reported the other aircraft in sight but [the PA28 pilot] did not report visual. The aircraft came within 0.5NM of each other and indicated 100ft vertical separation.

An analysis of NATS radar replay showed the routing of the PA28 and the left-hand orbit flown by the PA38 pilot downwind, with the CPA occurring as the PA38 exited the left turn and initiated the right-hand orbit (Figure 1).
