AIRPROX REPORT No 2024039

Date: 25 Mar 2024 Time: 1225Z Position: 5139N 00033W Location: 1NM NE St. Giles VRP

PART A: SUMMARY OF INFORMATION REPORTED TO UKAB

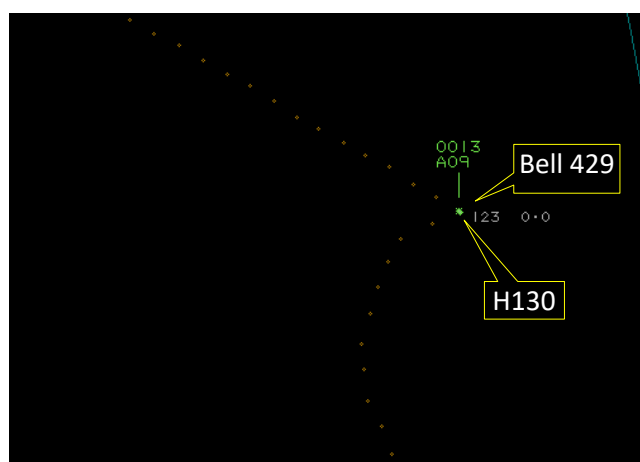
Figure 1 – CPA at 1224:48

An analysis of the NATS radar replay was undertaken. The Bell 429 could be positively identified from Mode S data. The H130 was identified by reference to the pilot's narrative report. In addition, the pilot of the Bell 429 kindly supplied GPS track data for their flight. The diagram was constructed and the separation at CPA determined from the separate sources.
