AIRPROX REPORT No 2024113

Date: 06 Jun 2024 Time: 1232Z Position: 5307N 00258W Location: 3NM South of Hawarden

PART A: SUMMARY OF INFORMATION REPORTED TO UKAB

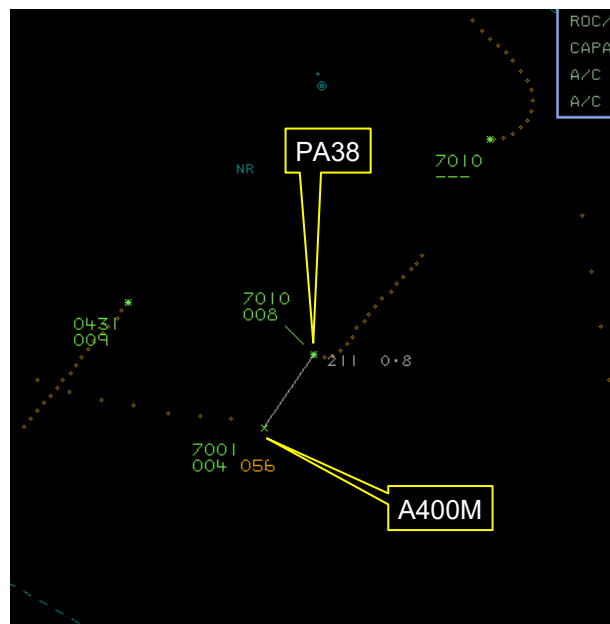
Figure 1: CPA at 1232:27 400ft V/0.8NM H
