**AIRPROX REPORT No 2024125**

Date: 17 Jun 2024 Time: 1248Z Position: 5100N 00204W Location: 4NM ENE Compton Abbas

**PART A: SUMMARY OF INFORMATION REPORTED TO UKAB**

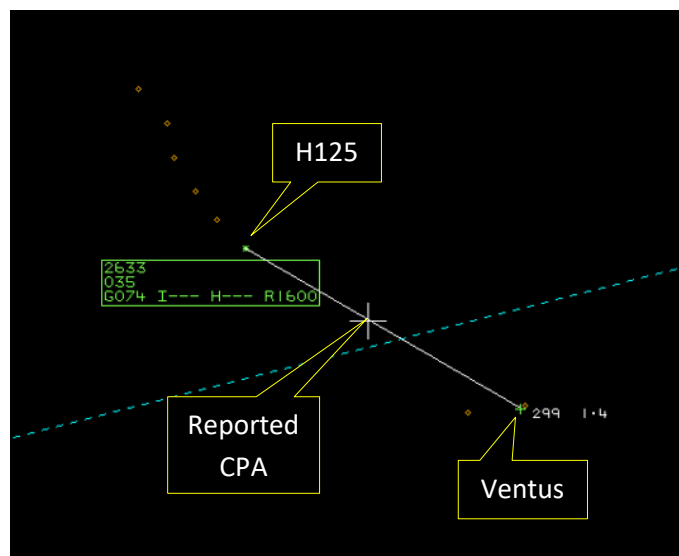
Figure 1 – Time 1247:44 separation 1.4NM

An analysis of the NATS radar replay was undertaken and the H125 was identified using Mode S data. The Ventus did not display on the radar, although at 1247:44 a primary radar return was seen, appearing to be heading west, but disappeared on the next radar sweep (Figure 1). The glider was identified by contacting the local gliding clubs and using ADS-B information.

The Ventus pilot supplied their flight profile information which provided altitudes AMSL and further position reports. The position for 1247:47 on the glider's log coincided with the primary target and direction seen at 1247:44 on the NATS radar replay (Figure 1).
