**AIRPROX REPORT No 2024129**

Date: 13 Jun 2024 Time: ~1126Z Position: 5051N 00045W Location: Goodwood

**PART A: SUMMARY OF INFORMATION REPORTED TO UKAB**

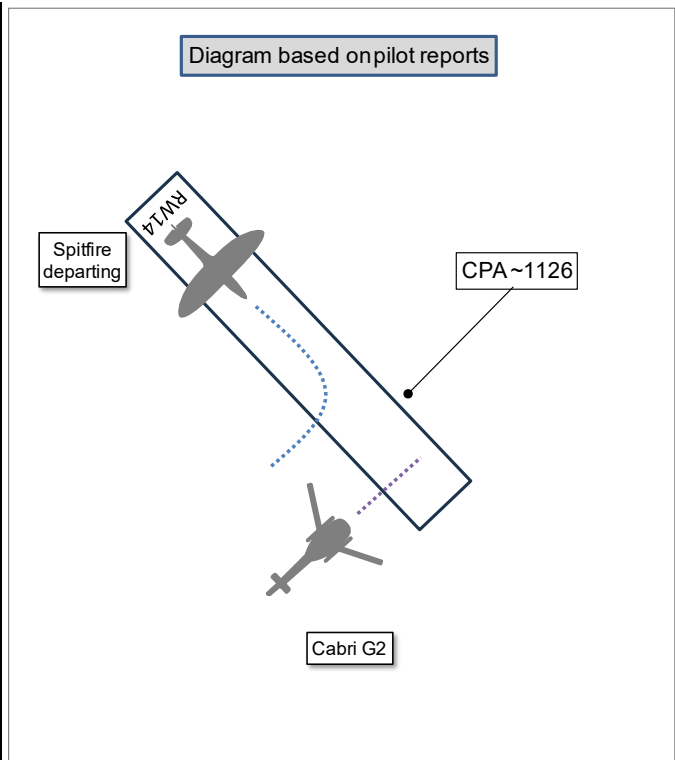
An analysis of the NATS radar replay was undertaken, but unfortunately neither aircraft could be seen. Therefore, the diagram at the top of the report was compiled using pilot reports only.

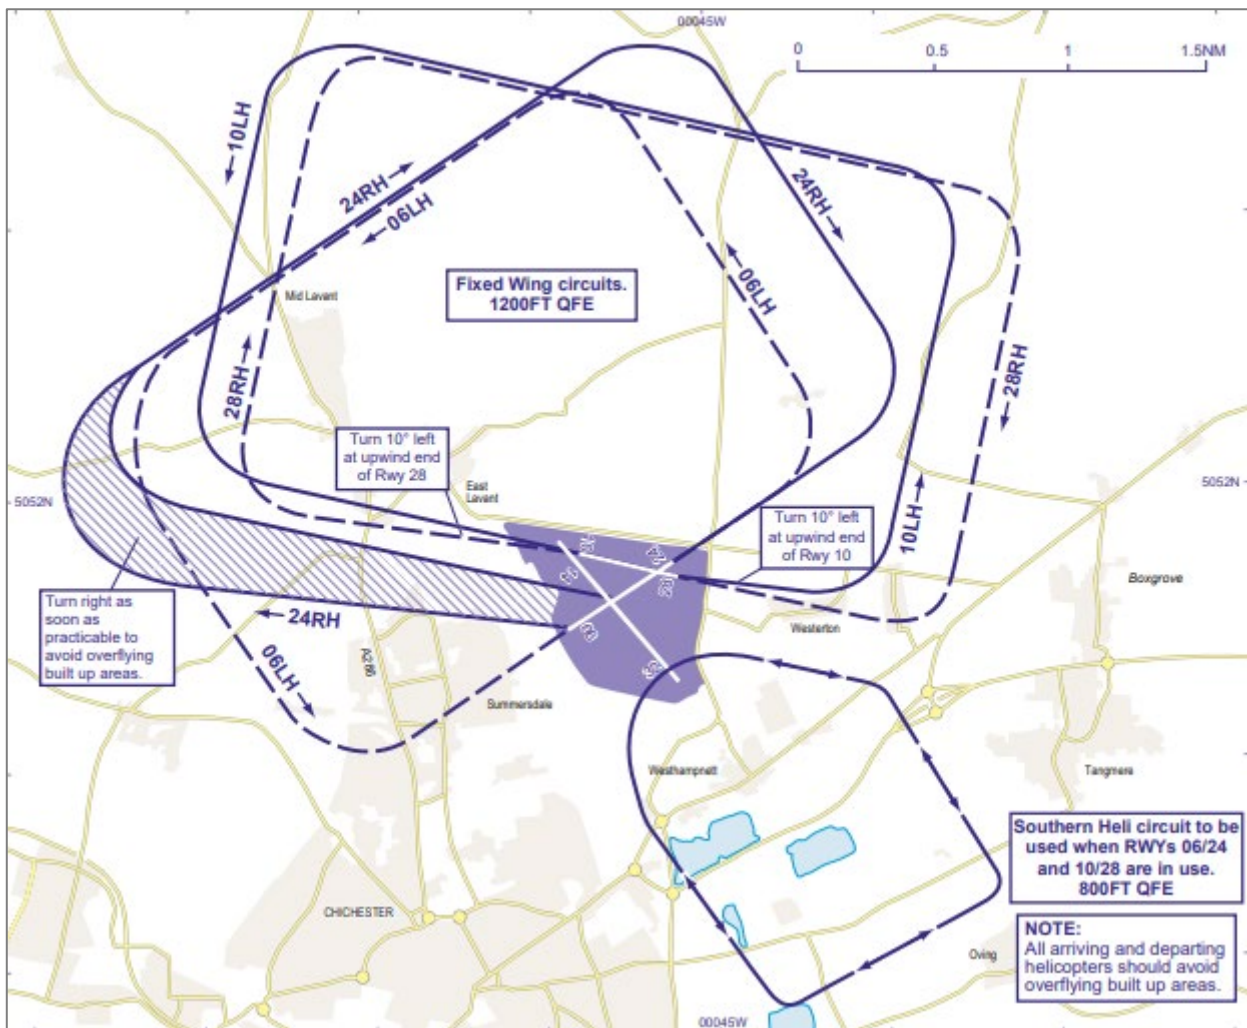
Figure 1 – Visual circuits at Goodwood.

Different circuit patterns exist for fixed wing aircraft and helicopters at Goodwood. Fixed wing aircraft departing Runways 14 and 32 must make their noise abatement turn at the upwind end of the runway, and not before, to avoid conflict with helicopter circuit traffic (see diagram below Noise Abatement Procedures - Fixed Wing / Heli Circuits).

The southern helicopter circuit shall be flown when Runways 06, 10, 24 and 28 are in use.  
The northern helicopter circuit shall be flown when Runways 14 and 32 are in use.

The Aerodrome was operating on RW24 for fixed-wing departures, and a helicopter was operating in accordance with the Southern Helicopter Circuit (SHC) procedure. The design of the SHC is such that it affords a geographical separation between fixed-wing movements on RWs 06,10,24 and 28, and rotary training traffic. There is an occasional requirement however, for fixed-wing movements to use RW14/32 for performance reasons, even though the wind may be favouring one of the other runways.
