AIRPROX REPORT No 2024281

Date: 18 Nov 2024 Time: 1251Z Position: 5117N 00000W Location: 3NM SSW Biggin Hill

PART A: SUMMARY OF INFORMATION REPORTED TO UKAB

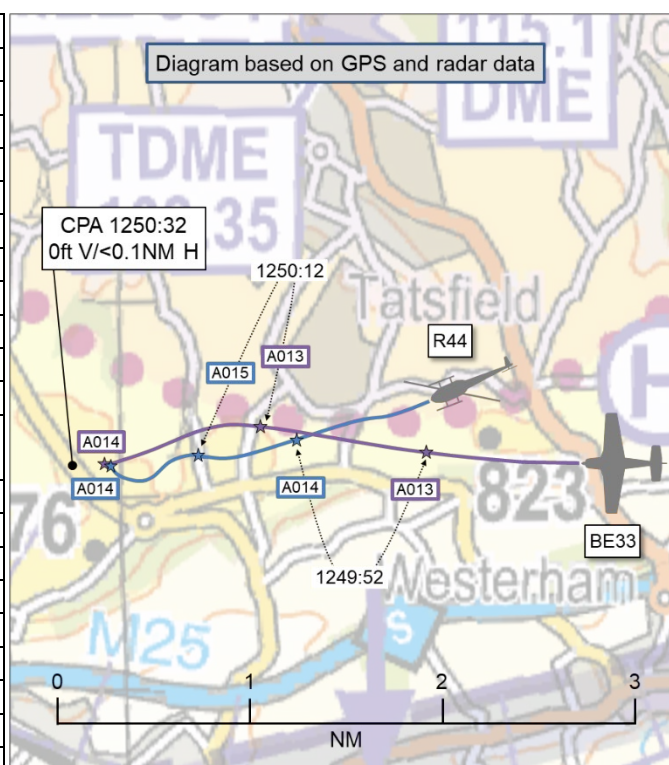
Recorded	Aircraft 1	Aircraft 2
Aircraft	R44	BE33
Operator	Civ Comm	Civ FW
Airspace	London FIR	London FIR
Class	G	G
Rules	VFR	VFR
Service	Basic	Basic
Provider	Biggin Approach	F'borough LARS E
Altitude/FL	1400ft	1400ft
Transponder	A, C, S	A, C, S
Reported		
Colours	Red	Red, white
Lighting	Strobe, nav, landing, strobes	Nav, strobes, beacon
Conditions	VMC	VMC
Visibility	>10km	5-10km
Altitude/FL	500ft AGL	500ft
Altimeter	QNH (1012hPa)	QNH (1027hPa)
Heading	"NW"	265°
Speed	90kt	150kt
ACAS/TAS	PowerFLARM	Not fitted
Alert	Alert	N/A
Separation at CPA		
Reported	0ft V/150m H	0ft V/150m H
Recorded	0ft V/<0.1NM H

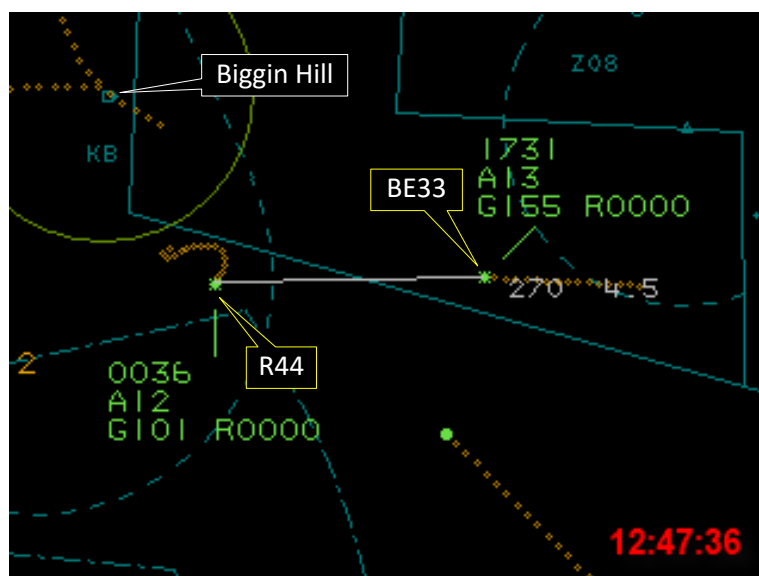
Figure 1

The pilot of [the R44] informed Biggin Hill Tower (KB-TWR) at 1247:11 they were *"clear at Hurley Lodge"* with their next turning points established and going via Westerham [to their destination]. The pilot then requested approval to *"run through the south-western edge of the zone?"*. This was approved, followed by Traffic Information at 1247:36: *"we have got a Helimed [...] indicating one thousand three hundred feet routeing opposite direction to yourself, and coming up behind we have got traffic working Farnborough Radar indicating one thousand three hundred feet routeing westbound"*. The pilot responded: *"That's all copied, thank you, [R44 C/S]"*. (see Figure 1).

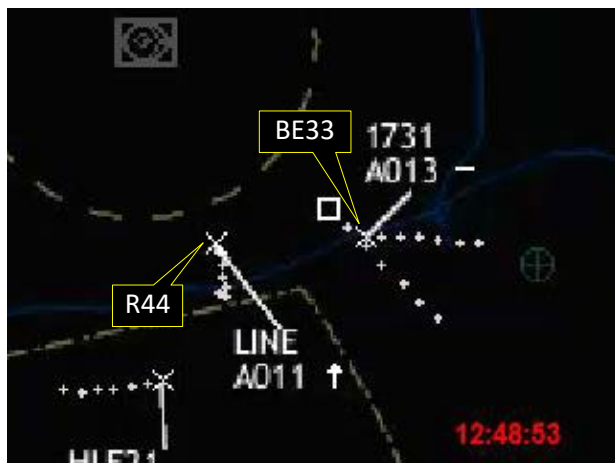
Figure 2 – Farnborough Radar

At 1248:31, the LF-LARS controller provided Traffic Information to the pilot of [the BE33]: *"traffic ahead of you by about a mile and a half manoeuvring, believed to be rotary, just left of your eleven o'clock slightly below, keep a very good lookout."* The pilot initially didn't respond. When prompted, the information was passed again at 1248:53: *"traffic ahead of you, one mile, left-to-right, similar level, believed to be rotary, keep a very good lookout."* The pilot responded, *"we have him in sight sir, thank you very much"*. (see Figures 2 and 3).

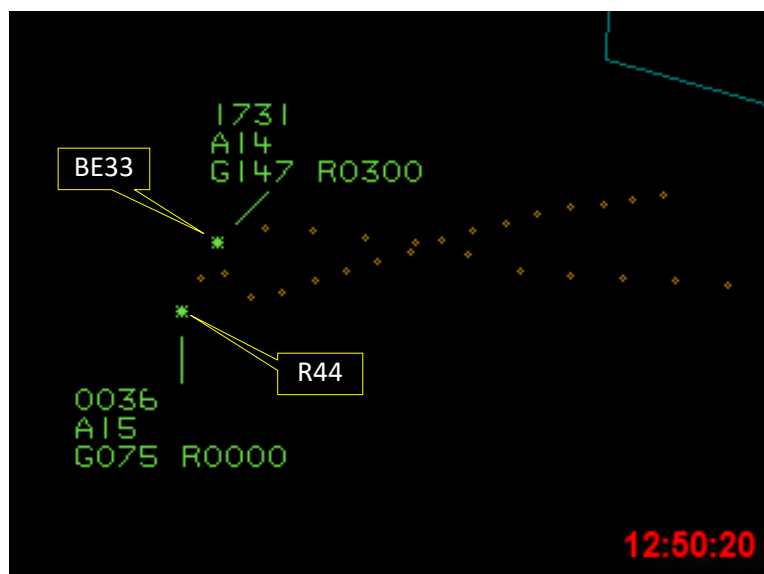
Figure 4

[The pilot of the R44] then turned right onto a northerly track before turning immediately south on the next radar update (1250:20) (Figure 4).

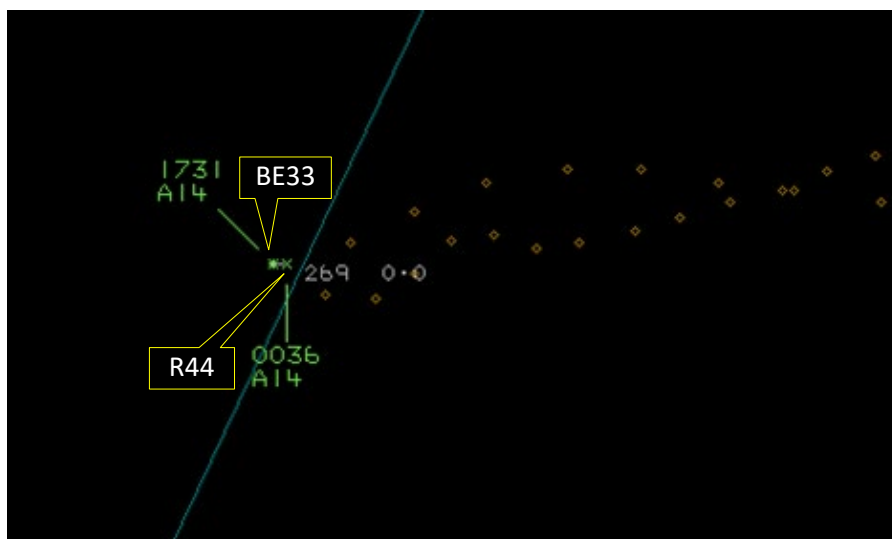
Figure 5 – CPA at 1250:32

The Closest Point of Approach occurred at 1250:32 and was recorded on multi-track radar as 0.0NM and 0ft (Figure 5) as [the R44] passed behind [the BE33].

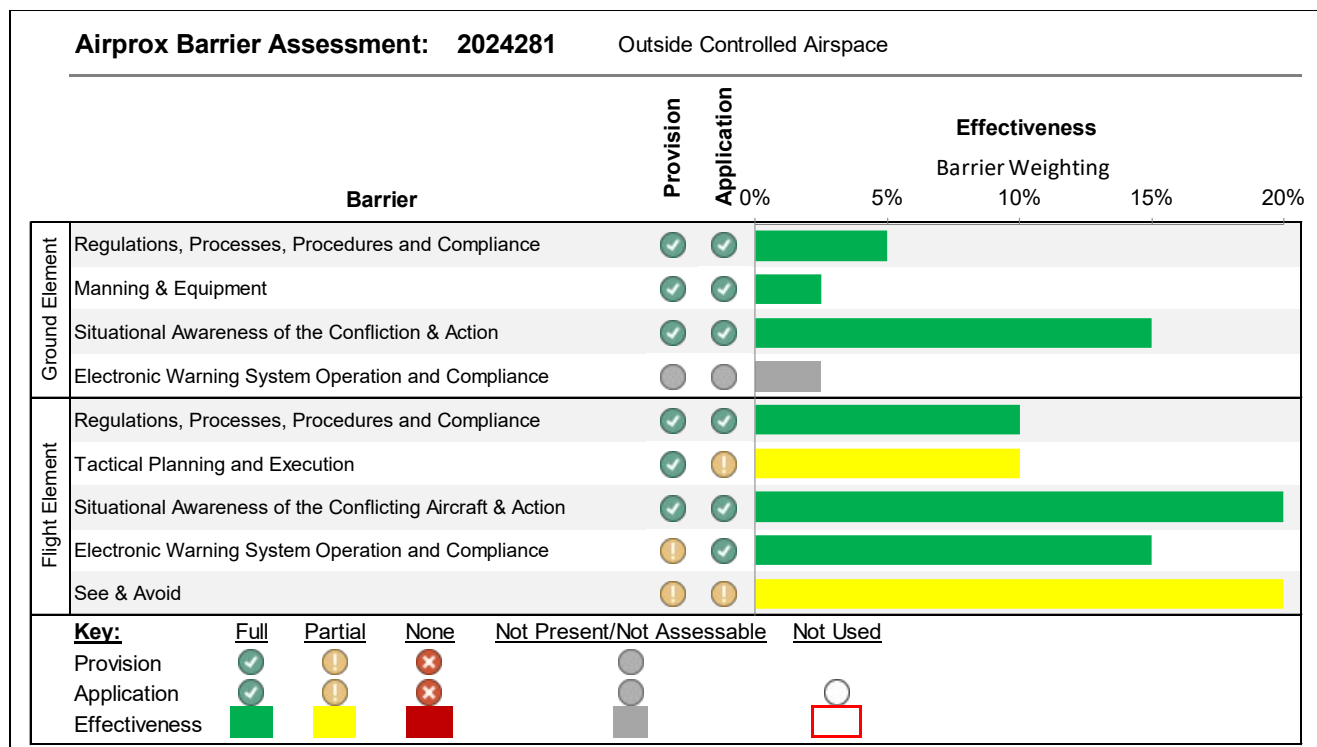
Tactical Planning and Execution was assessed as **partially effective** because the pilot of the BE33 had sighted the R44 at distance but had not adapted their dynamic plan sufficiently to have executed the overtake manoeuvre correctly.

See and Avoid were assessed as **partially effective** because the pilot of the BE33 had not allowed sufficient distance from the R44 during the overtaking manoeuvre to assure safe separation.
