AIRPROX REPORT No 2024282

Date: 06 Nov 2024 Time: 1302Z Position: 5711N 00200W Location: 3NM E Bridge of Don

PART A: SUMMARY OF INFORMATION REPORTED TO UKAB

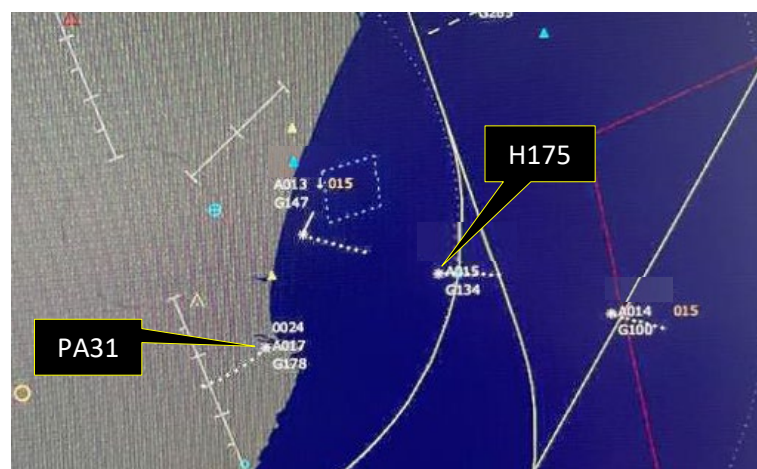
Figure 1 - 1301:25

1301:25 The PA31 crossed the line that was 35° from the runway centreline at which point the arc manoeuvre was complete.

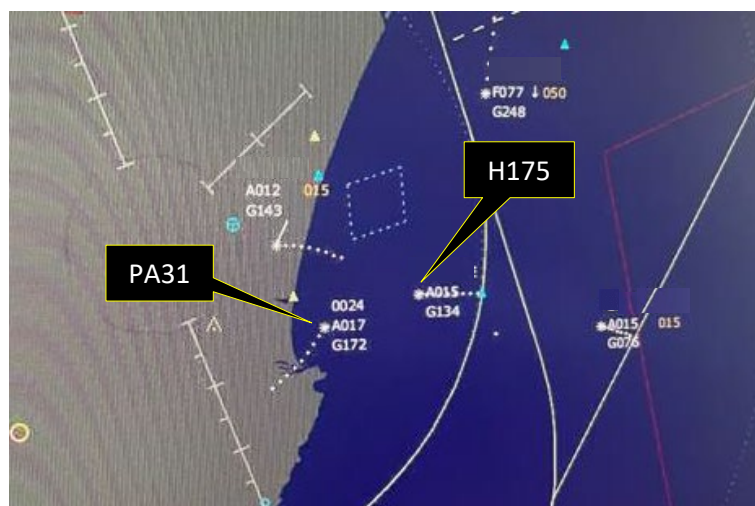
Figure 2 - 1301:43

1301:43 The PA31 was tracking 035° with the H175 bearing 080° at range 3NM from the PA31, Mode C still indicated 200ft vertical distance was present.

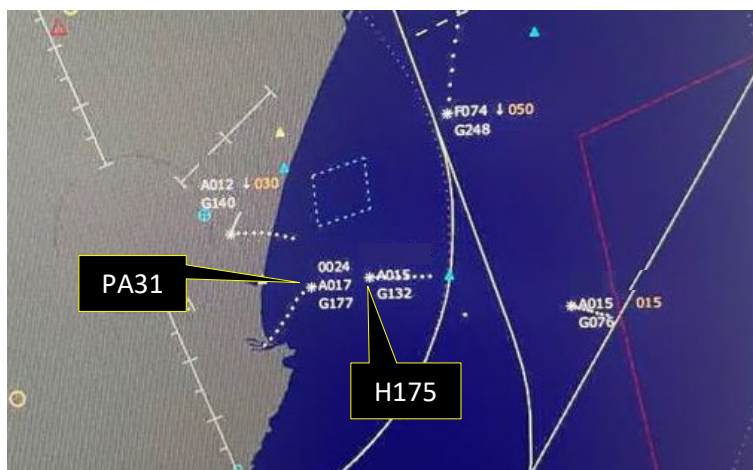
Figure 3 - 1301:53

1301:53 The track of the PA31 indicated a right turn had commenced.

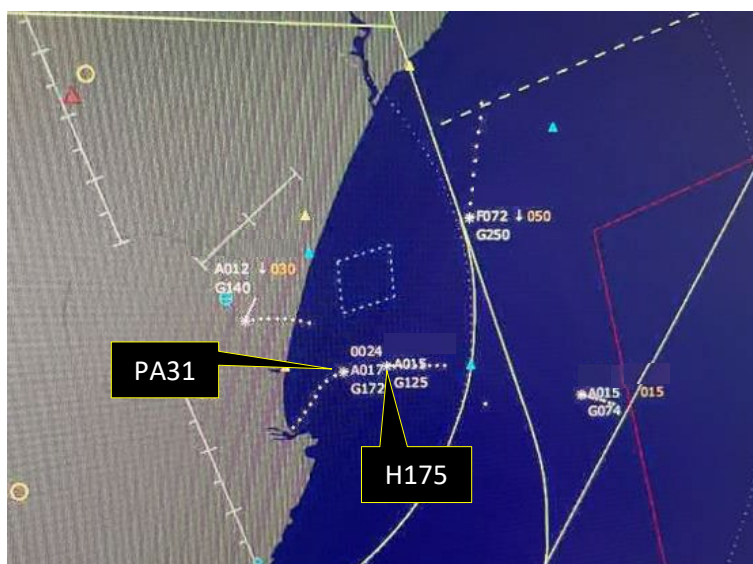
Figure 4 - 1302:00

1302:00 The PA31 was in a right turn at 1700ft, turning through approximately 090° with the H175 1.3NM east of the PA31 at 1500ft.

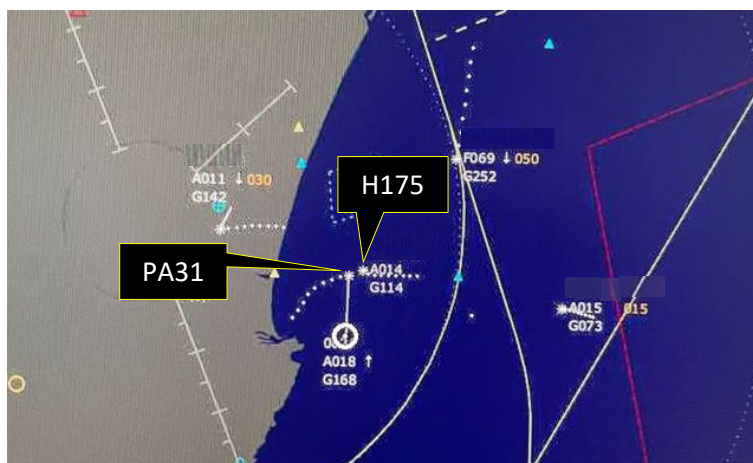
Figure 5 - 1302:04

The two aircraft were 0.6NM apart with the PA31 still in a right turn with Mode C indicating 1800ft.

The H175 had commenced a right turn with Mode C indicating 1400ft.

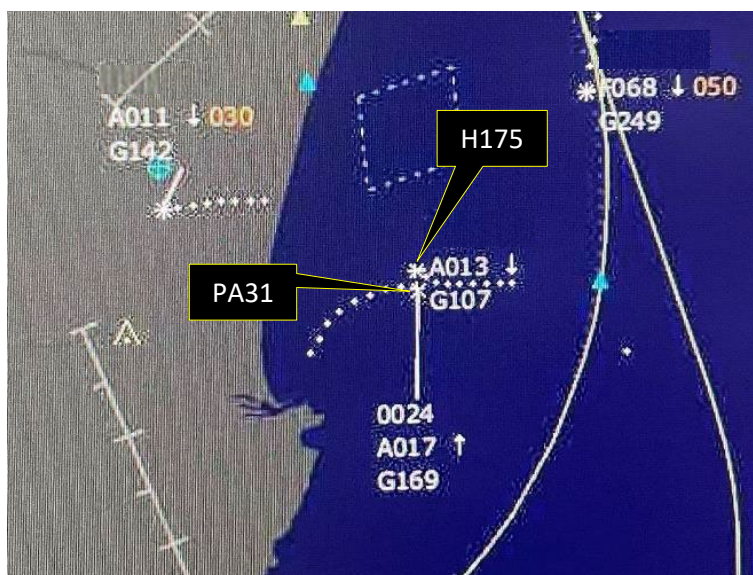
Figure 6 - 1302:21

1302:21 Closest Point of Approach (CPA) occurred (0.2NM H/400ft V).

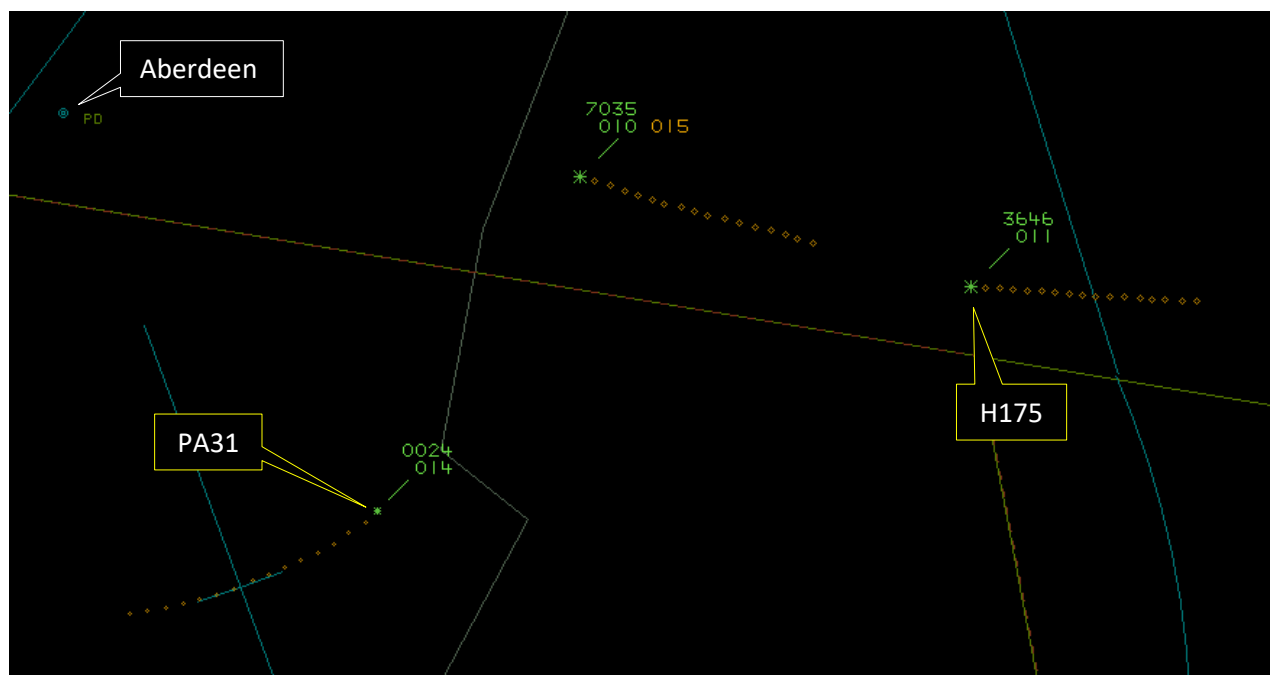
Figure 7

An analysis of the NATS radar replay was undertaken and both aircraft could be positively identified from Mode S data (Figure 7).

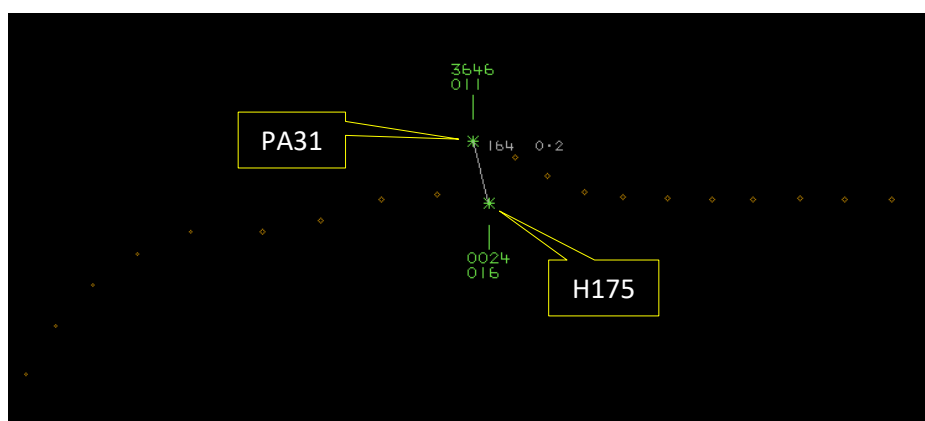
Figure 8 – CPA at 1302:20

The aircraft were depicted on the radar replay as having been flown at Flight Levels. A suitable correction was applied to determine their altitudes. The pilot of the PA31 kindly supplied GPS track data for their flight. The diagram was constructed and the separation determined by combining the data sources.
