**AIRPROX REPORT No 2025001**

Date: 02 Jan 2025 Time: ~1454Z Position: 5153N 00210W Location: Gloucester Airfield

**PART A: SUMMARY OF INFORMATION REPORTED TO UKAB**

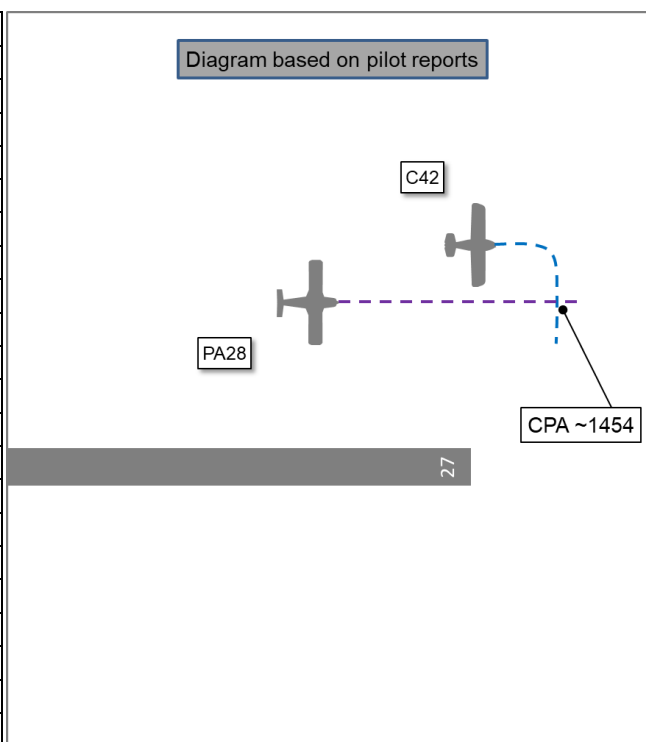
**THE C42 PILOT** reports a conflicting aircraft joining direct downwind for RW27RH, the C42 pilot had joined overhead and had been late downwind for RW27RH. The conflicting aircraft made an orbit for spacing as directed by Gloster ATC. The C42 pilot was following the aircraft on long final and about to turn base for RW27RH when the PA28 flew over them from right-to-left in close proximity.

During the above exchange it is believed (following evidence taken at interview, viewing of video evidence, SkyDemon tracks submitted by the C42 pilot and the RT transcript) that the C42 pilot had been visual with the PA28(B), as they had flown a relatively wide downwind leg, “cut the corner” between downwind and base leg, flying a short diagonal leg. At the same time the PA28(A) pilot

had seen the PA28(B) on final approach and made the assumption that the PA28(B) was the C42. As the C42 pilot flew the diagonal route between downwind and base leg, the PA28(A) pilot flew over the top of the C42 as they continued downwind. The C42 and PA28(A) pilots were not visual with each other until the Airprox was actually happening and by that time no avoidance action would have been possible. Both pilots report the risk of collision to be high.

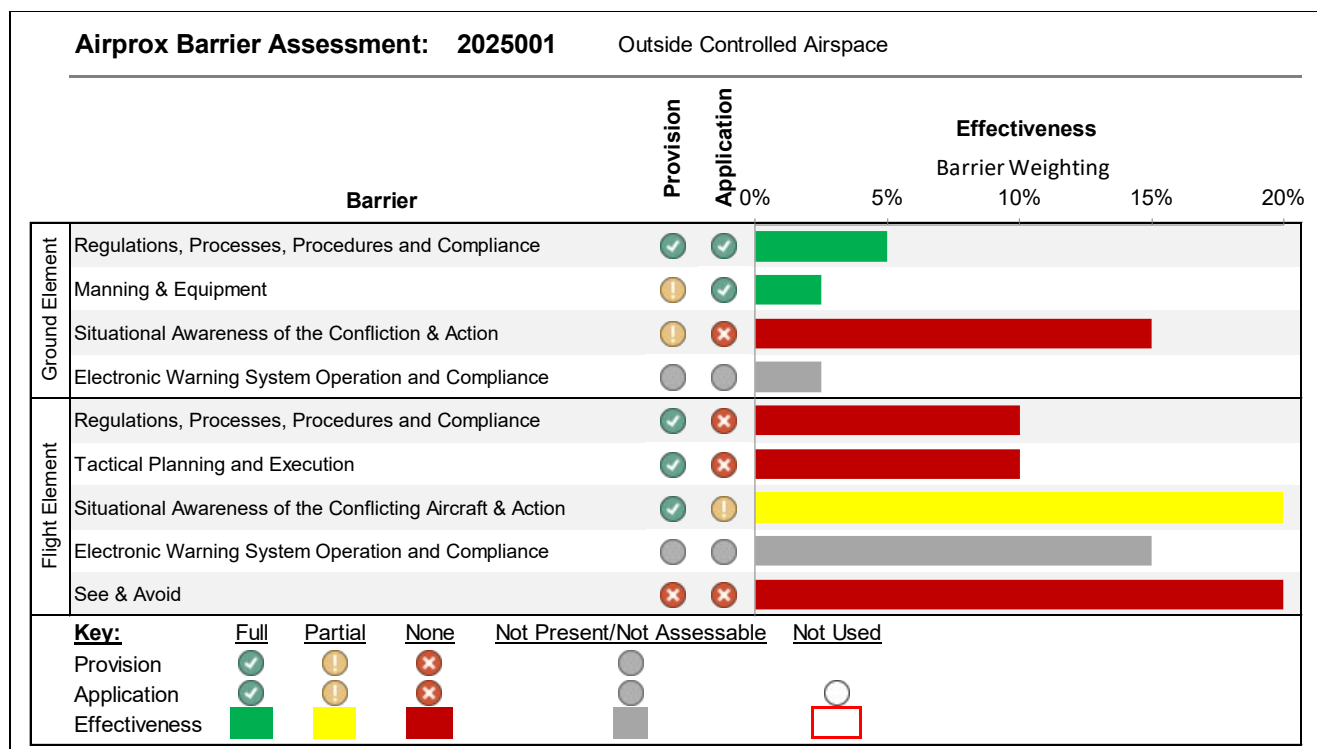
**Situational Awareness of the Confliction and Action** were assessed as **ineffective** because the Gloster Tower controller's focus had been on the aircraft requesting take-off as a second had approached for landing whilst the Airprox-involved aircraft had both been downwind.

**Regulations, Processes, Procedures and Compliance** were assessed as **ineffective** because the PA28(A) pilot, having mis-identified the PA28(B) as the C42, had not complied with the circuit pattern priority instruction issued by the Gloster Tower controller.

**Tactical Planning and Execution** was assessed as **ineffective** because the PA28(A) pilot had not followed the aircraft ahead of them as directed by the Gloster Tower controller.

**Situational Awareness of the Conflicting Aircraft and Action** were assessed as **partially effective** because the C42 pilot had inaccurate situational awareness of the position of the PA28(A) and the PA28(A) pilot, having misidentified the PA28(B) as the C42, had inaccurate situational awareness and could have sought clarity from the Gloster Tower controller.

**See and Avoid** were assessed as **ineffective** because both the C42 and PA28(A) had been obscured from the other pilot leading to effective non-sighting by both ahead of the CPA.
