**AIRPROX REPORT No 2025003**

Date: 14 Jan 2025 Time: ~1054Z Position: 5107N 00303W Location: IVO Durleigh reservoir

**PART A: SUMMARY OF INFORMATION REPORTED TO UKAB**

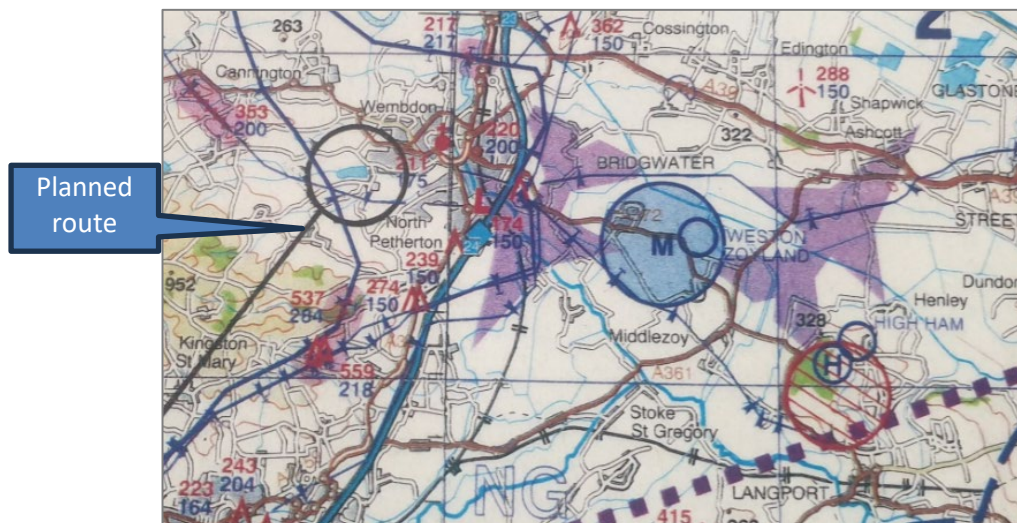
Figure 1

[Figure 1 shows] the navigational route, routinely used, associated with the area of this Airprox. There is a small lake circled to the west of Bridgwater where the Airprox is reported to have occurred. The map shows no area to avoid, such as a bird sanctuary, nor was there a NOTAM on this or any other day to notify any UAV activity.

The QFI was operating in accordance with SOPs and within the MAA/CAA regulations and, as the aircraft was on a military task, this was a military flight. The flight was a navigational instructional sortie which involved flying at 500ft AGL for some parts of the sortie. [The routes will be] reviewed in light of this investigation.

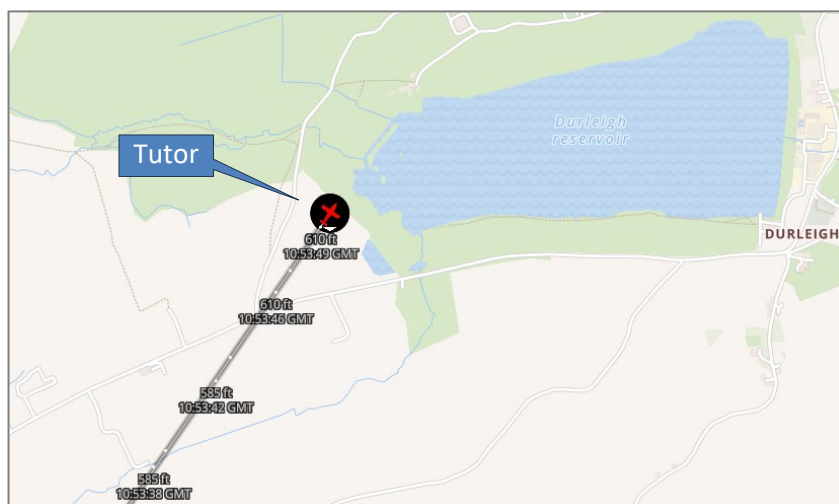
Figure 2 – The position of the Tutor at 1053:50

An analysis of ADS-B data was undertaken and the track and altitude of the Tutor was observed (Figure 2). The pilot of the Mini 3 Pro kindly supplied GPS track data for their flight. The diagram was constructed by combining the data sources.

The maximum height attained by the Mini 3 Pro during its flight had been 124ft above its takeoff point (the elevation of which is 115ft AMSL).

Whilst the GPS data included elapsed flight time, it did not include UTC. Consequently, the exact moment of CPA could not be determined. However, at the reported time of CPA, the height of the Mini 3 Pro had been 40ft AGL (terrain elevation 107ft) and the altitude of the Tutor had been 610ft AMSL. Therefore the vertical separation at the reported time of CPA had been 463ft but this could not be verified. The horizontal separation at the reported time of CPA had been less than 20m but this could not be verified.
