**AIRPROX REPORT No 2025005**

Date: 25 Jan 2025 Time: 1535Z Position: 5214N 00253W Location: Shobdon

**PART A: SUMMARY OF INFORMATION REPORTED TO UKAB**

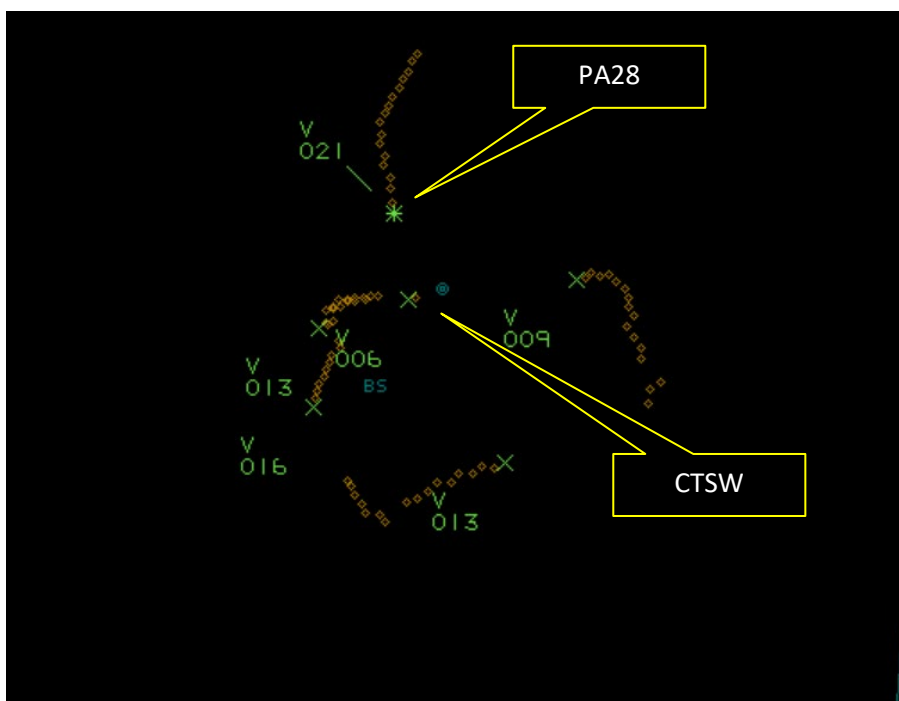
Figure 1 – 1534:36

An analysis of the NATS radar replay was undertaken. Both aircraft could be seen and identified using Mode S data. The PA28 could be seen joining the circuit from the north in an overhead join. At 1534:36 the CTSW first appeared on the radar replay, in SSR only, indicating FL006 (altitudes on the radar replay shown in flight levels), see Figure 1. The radar indicated that there were at least 4 other aircraft in the visual circuit.

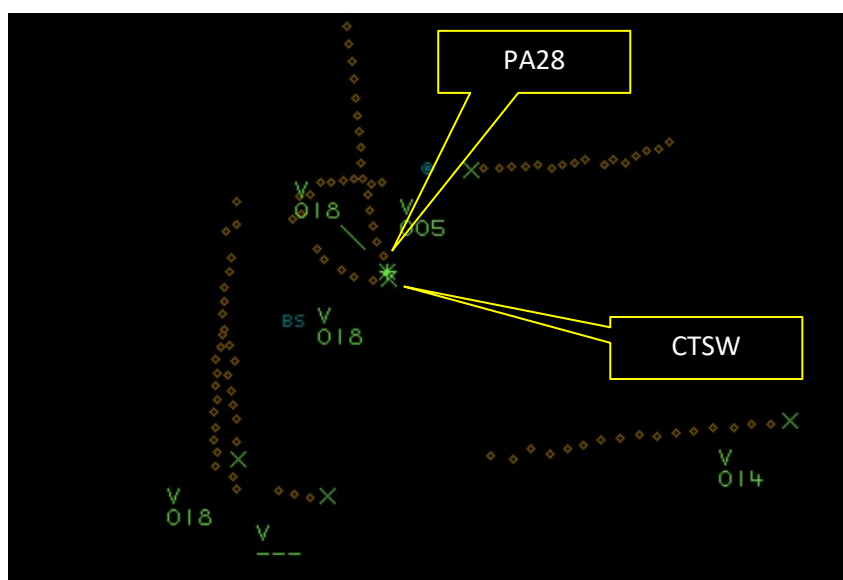
Figure 2 – 1535:32, Radar CPA

The CTSW could be seen to turn onto a westerly heading, climbing to FL018 as the PA28 descended to FL018, until CPA at 1535:32 when radar separation indicated <0.1NM with both aircraft indicating FL018.

When determining the risk, members considered the reports from both pilots together with the radar screenshots. The PA28 pilot's estimate of the separation had been less than 20ft and the pilot had reported that they had not seen the CTSW in time to take any action. The CTSW pilot reported more separation, but still, members thought that the pilot had probably seen the PA28 at the last possible moment as the radar also indicated very little vertical or lateral separation, albeit that it may have had a degree of time lag. The Board therefore agreed that the separation between the two aircraft had been at the bare minimum with a serious risk of collision (**CF8**); Risk Category A.
