**AIRPROX REPORT No 2025009**

Date: 30 Jan 2025 Time: 1535Z Position: 5311N 00417W Location: ivo Brynsiencyn

**PART A: SUMMARY OF INFORMATION REPORTED TO UKAB**

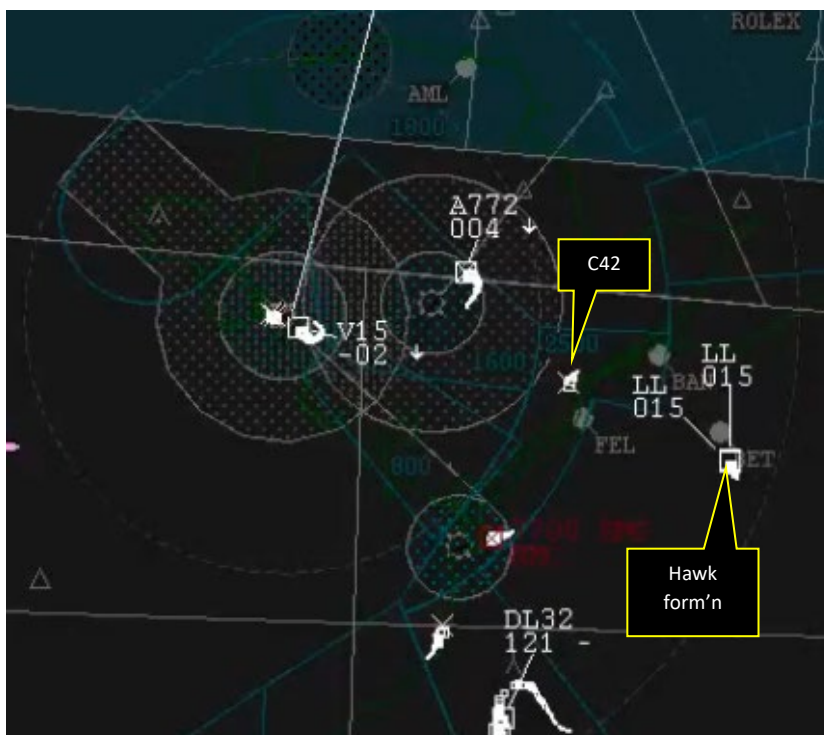
Figure 1 (1532:52). Generic Traffic Information provided to the Hawk formation.

At 1532:45, the Hawk formation contacted Valley Approach. As per the Flying Order Book the Valley Approach controller responded with generic Traffic Information regarding Menai Strait traffic *“Traffic Felinheli north 1 mile, tracking southwest, slow moving, no height information”*. The Hawk formation acknowledged the Traffic Information with *“not sighted”* and then proceeded to provide their pre-assigned Mode 3A code along with intentions for a visual recovery.

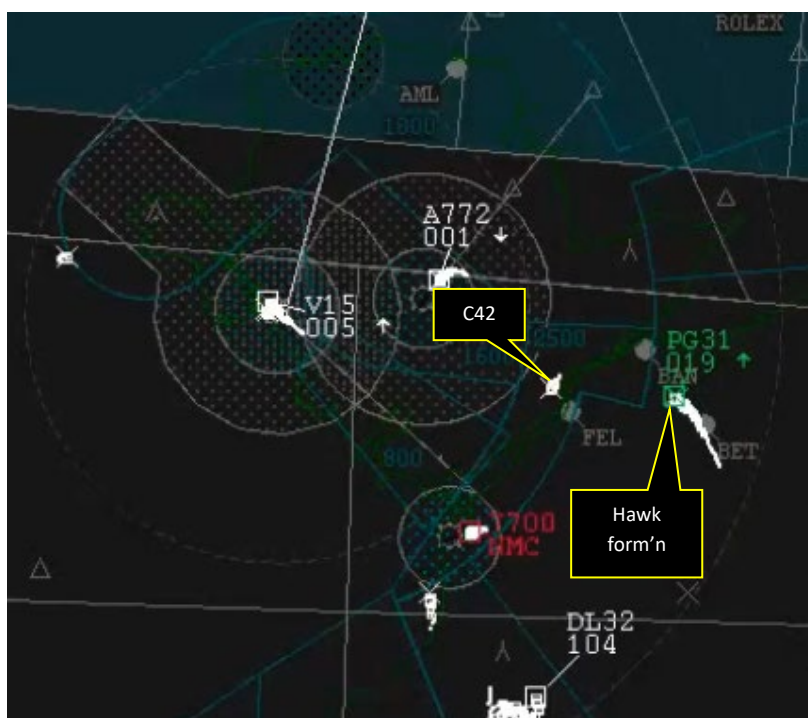
Figure 2 (15:33:24). Updated Traffic Information provided to the Hawk formation.

The Valley Approach controller approved the 2000ft transit and followed this with updated Traffic Information at 1533:24, “*previously called traffic west 4 miles tracking southwest, slow moving, no height information*”. Again, the Hawk formation report “*not sighted*”.

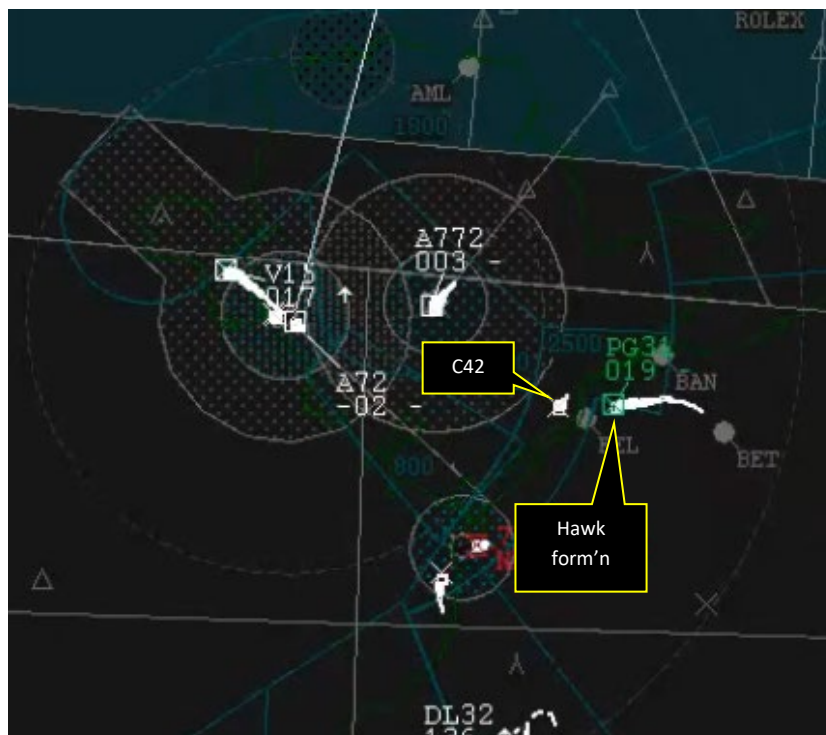
Figure 3 (1534:04). Updated Traffic Information provided to the Hawk formation.

At 1534:04, updated Traffic Information was passed, “*previously called traffic 12 o’clock, 2 miles, crossing right left ahead slow moving*”, with the Hawk formation reporting “*not sighted*”. At 1534:45, the Hawk formation report visual with the traffic.

CPA was recorded at 1535:00 with 0.0NM horizontal separation, whilst vertical assessment by the Hawk [pilot] was 150ft.
