AIRPROX REPORT No 2025010

Date: 31 Jan 2025 Time: 1307Z Position: 5247N 00240W Location: Shawbury

PART A: SUMMARY OF INFORMATION REPORTED TO UKAB

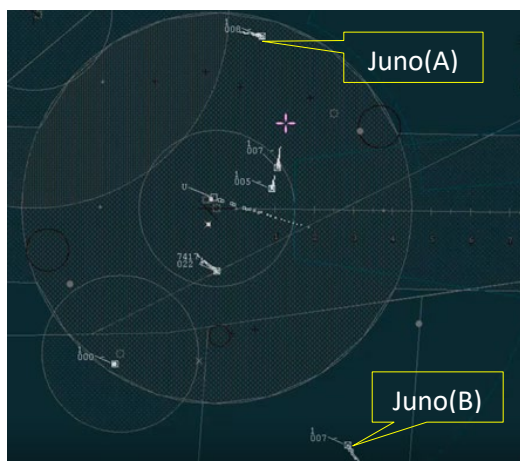
Figure 1 1303:17 - Relative positions following Juno(A) requesting join.

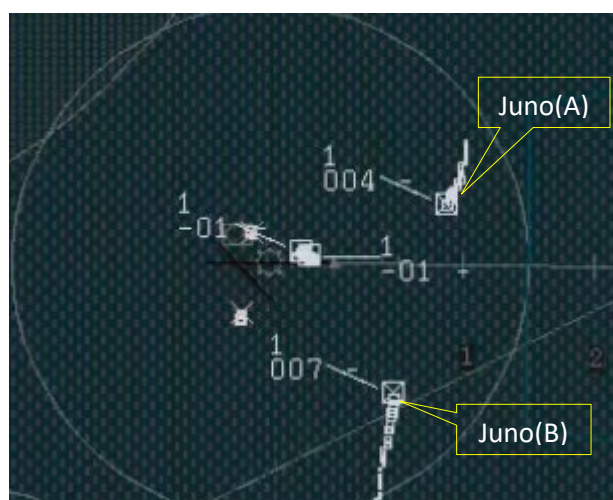
Figure 2 Time 1306:25 - Relative positions following Juno(A) positioning call.

At 1306:25, Juno(A) pilot transmitted a blind positioning call of *“final South Point”*.

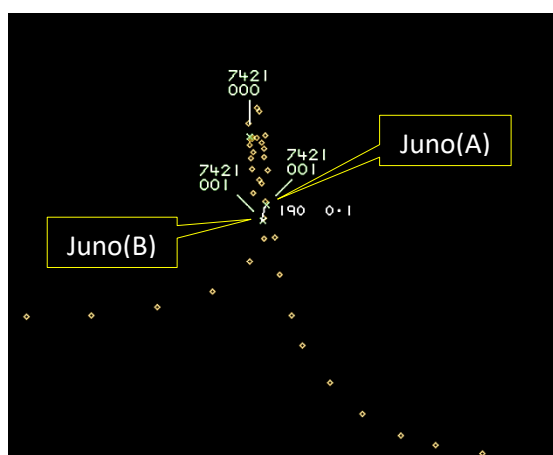
An analysis of the NATS radar replay was undertaken and both aircraft were identified using Mode S data. Juno(A) had been approaching Shawbury from the east, and Juno(B) from the west. CPA was assessed to have occurred at 1307:15 with 0.1NM lateral separation and co-altitude (Figure 3).

Figure 3 CPA 1307:15

It was seen, on the radar replay, that Juno(A) and Juno(B) merged again 8sec later, 100ft lower, co-altitude and 0.1NM apart, which placed them at 50ft AGL as reported by both pilots.

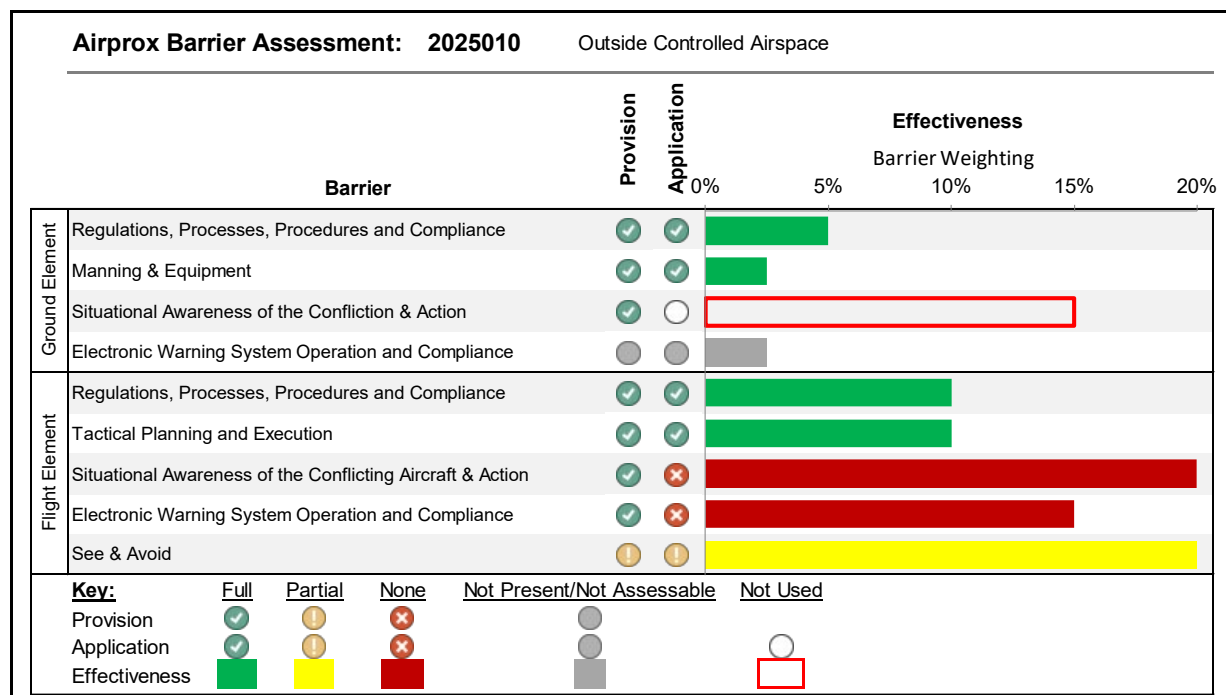
Situational Awareness of the Confliction and Action were assessed as **not used** because the Shawbury controller was not required to position inbound aircraft once they had made their relevant RT communications and self-positioned in accordance with the Shawbury procedures.

Situational Awareness of the Conflicting Aircraft and Action were assessed as **ineffective** because the Juno(A) pilot had generic situational awareness of the Juno(B) aircraft positioned behind them and the Juno (B) pilot had had no situational awareness of the presence or position of Juno(A).

Electronic Warning System Operation and Compliance were assessed as **ineffective** because Juno(A)'s TAS had not alerted as expected and the Juno(B) pilot had not identified or assimilated alerts from their TAS.

See and Avoid were assessed as **partially effective** because the Juno(B) pilot had only sighted Juno(A) during the latter stages of their approach.
