AIRPROX REPORT No 2025011

Date: 05 Feb 2025 Time: 1344Z Position: 5231N 00253W Location: Long Mynd

PART A: SUMMARY OF INFORMATION REPORTED TO UKAB

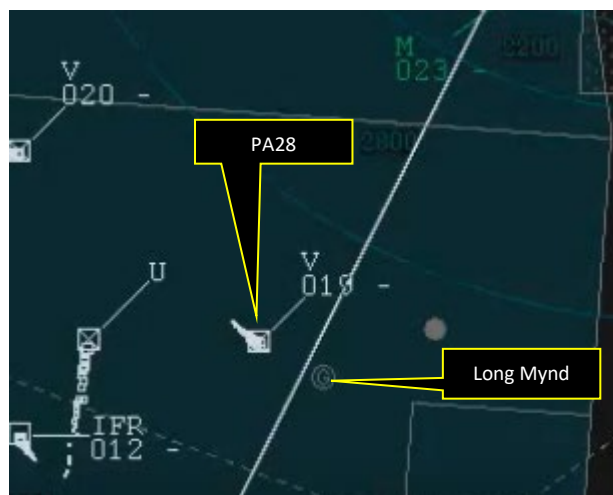
Figure 1: (1342:57). PA28 pilot contacted Shawbury Zone.

At 1342:57, the PA28 pilot contacted Shawbury Zone. The pilot provided their VFR flight intentions, reported level at 2600ft on 1037hPa and requested a Basic Service. Additionally, they reported hearing what was believed to have been a stuck microphone on the frequency and that they were only just able to receive the Shawbury Zone controller. The Shawbury Zone controller issued a Mode 3A Code, provided the Shawbury QNH of 1038hPa and provided a Basic Service.

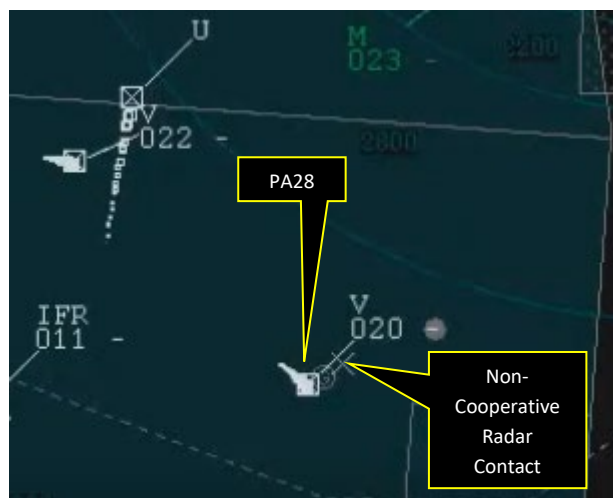
Figure 2: (1343:41). Non-cooperative radar contact displayed.

At 1343:41, a non-cooperative (primary) radar contact was displayed in the vicinity of Long Mynd Gliding Site.

At 1343:58, the PA28's Mode 3A Code changed to the code previously issued and the PA28 pilot reported it as set alongside reading back the Shawbury QNH at 1344:05. During this period, a further non-cooperative (primary) radar contact was displayed to the SW of the PA28 in the vicinity of Long Mynd. Both radar contacts remained within proximity of Long Mynd and only displayed for a brief period of approximately 20sec before fading from radar.

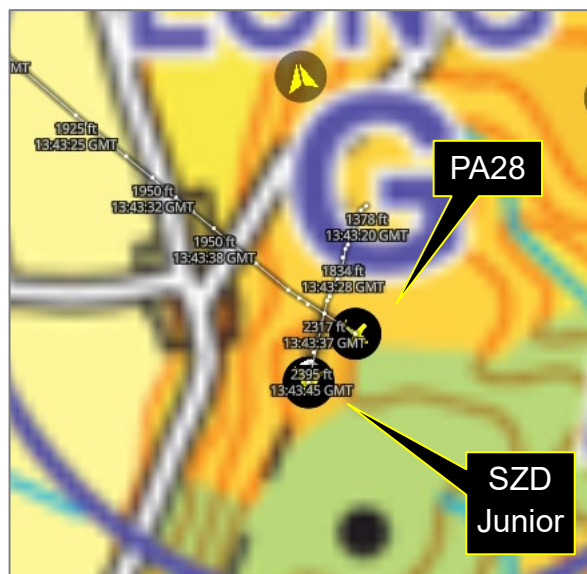
Figure 3: From the CAAs Airspace Analyser Tool at CPA. The SZD Junior is shown at 2400ft (SPS) and the PA28 is at 2000ft (SPS). QNH 1038hPa = +25hPa = +675ft. Therefore: the SZD Junior had been at 3075ft and the PA28 at 2675ft.

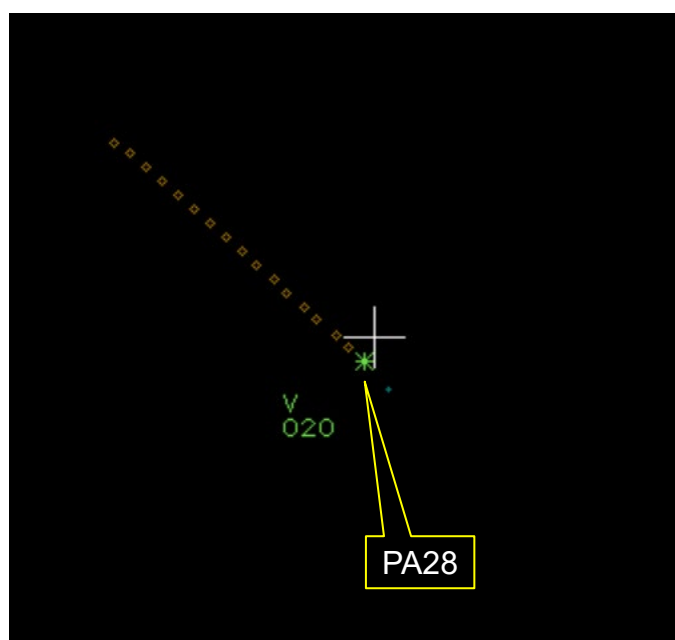
Figure 4: At CPA - 1343:50. The white cross marks Long Mynd airfield. The PA28 is shown at 2000ft (SPS), equating to 2675ft on QNH.

The PA28 did not display the Shawbury conspicuity squawk until approximately 35sec after CPA

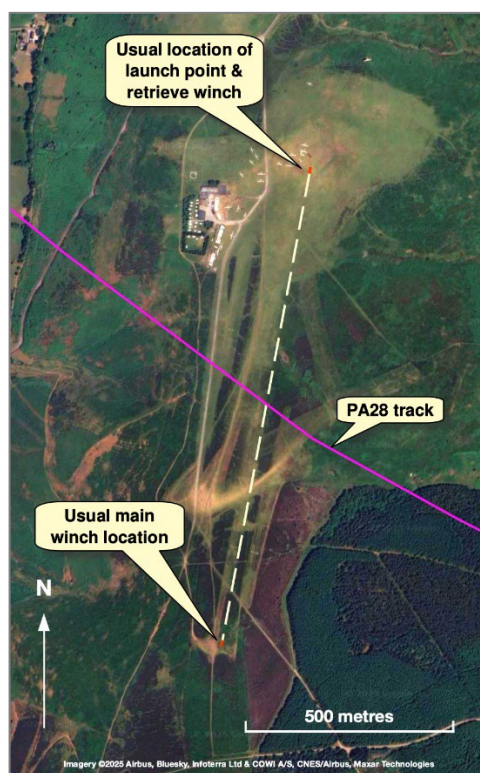
Figure 5: Showing this site's usual airfield configuration for the wind conditions at that time, with the take-off and landing direction along the top of the ridge.

A glider being winch-launched achieves a climb angle of 45° and an initial climb rate in excess of 4000fpm within 10sec of starting its ground roll. The maximum winch launch altitude permitted at Long Mynd is 3000ft AAL (4411ft AMSL), as listed in the AIP and marked on VFR charts, but it's likely that this launch achieved an altitude of about 1500ft AAL (2900ft AGL), after which the glider flew a continuously-descending profile for the reported 5min duration flight, before landing back on the airfield close to the launch point. Although neither pilot saw the other aircraft, CPA seems to have occurred at about the time that the glider released the launch cable, when nearly directly overhead the main winch.

In addition to the winch locations and cable run, Figure 5 also shows the ground track of the PA28 around the time of CPA, based on multilateration (MLAT) of its Mode S transponder returns. The provider of these data reports that “MLAT position calculations have a general accuracy of 10-100 metres”. Based on this ground track and usual winch positions, Figure 6 shows the probable relative positions of the two aircraft as the PA28 crossed the line of the winch cables, a couple of seconds after CPA. The droop shown for both the main winch cable and retrieve winch cable is illustrative, not exact.

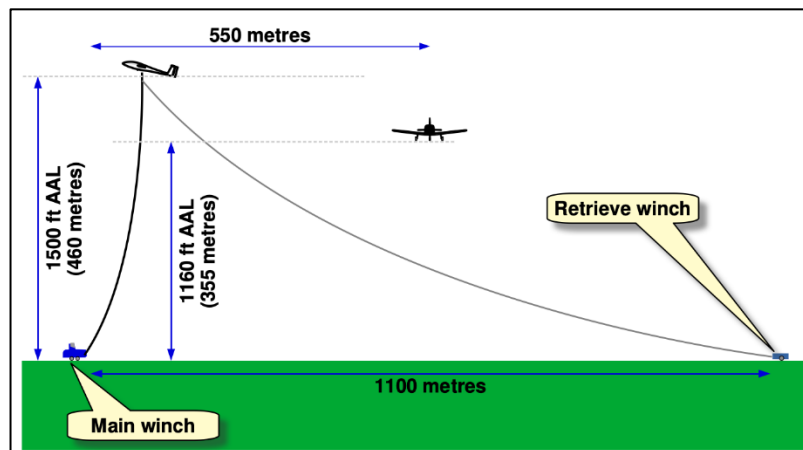
Figure 6: Probable relative positions of the two aircraft as the PA28 crossed the line of the winch cables.
