**AIRPROX REPORT No 2025012**

Date: 05 Feb 2025 Time: 1231Z Position: 5045N 00050W Location: 7NM SSW Goodwood

**PART A: SUMMARY OF INFORMATION REPORTED TO UKAB**

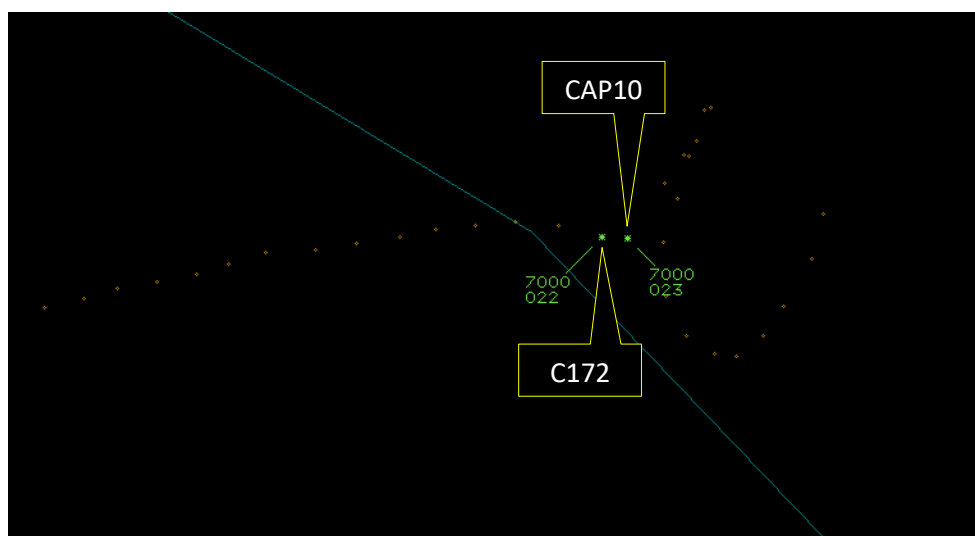
Figure 1 – CPA at 1230:31

An analysis of the NATS radar replay was undertaken and both aircraft could be positively identified from Mode S data (Figure 1). The diagram was constructed and the separation determined from the radar data.

The C172 and CAP10 pilots shared an equal responsibility for collision avoidance and not to operate in such proximity to other aircraft as to create a collision hazard.<sup>1</sup> If the incident geometry is considered as converging then the CAP10 pilot was required to give way to the C172.<sup>2</sup>
