**AIRPROX REPORT No 2025013**

Date: 29 Jan 2025 Time: 1035Z Position: 5220N 00045W Location: Orlington, Northants

**PART A: SUMMARY OF INFORMATION REPORTED TO UKAB**

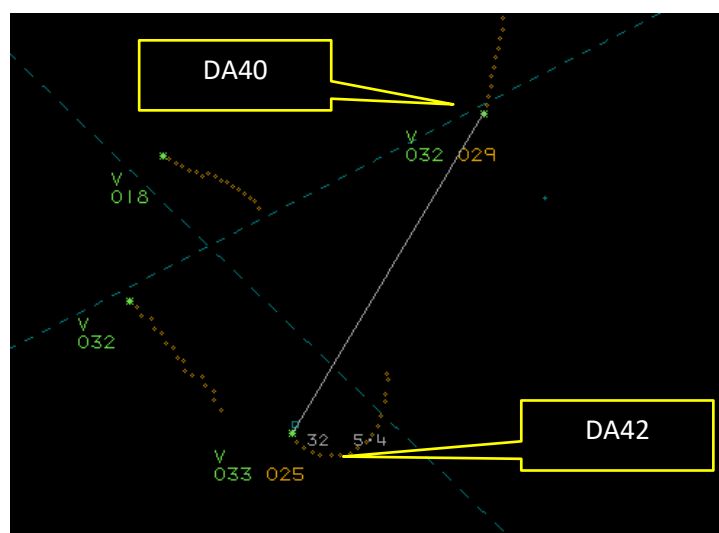
Figure 1: 1034:05

An analysis of the NATS radar replay was undertaken. Both aircraft could be seen and identified using Mode S data. Both aircraft were squawking 7000 and at 1034:05 were 5.4NM apart (Figure 1).

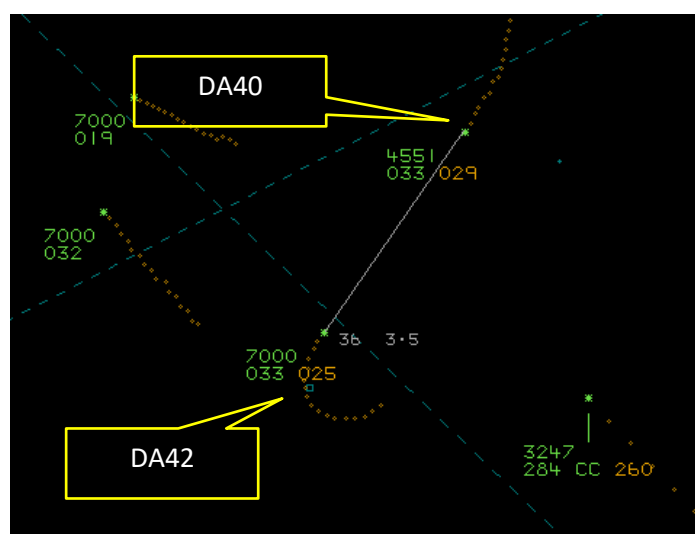
Figure 2 – 1034:32

By 1034:32 the two aircraft were head to head at a range of 3.5NM, both indicating FL033.

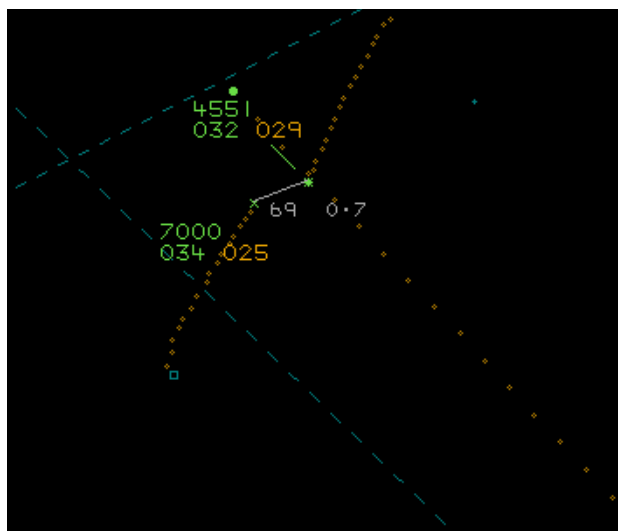
Figure 3 – 1035:16

The two aircraft continued to close, albeit slightly offset, until 1035:16 (Figure 3) when the DA40 pilot began to descend. CPA occurred at 1035:24 with radar separation measured as 0.4NM and 800ft.

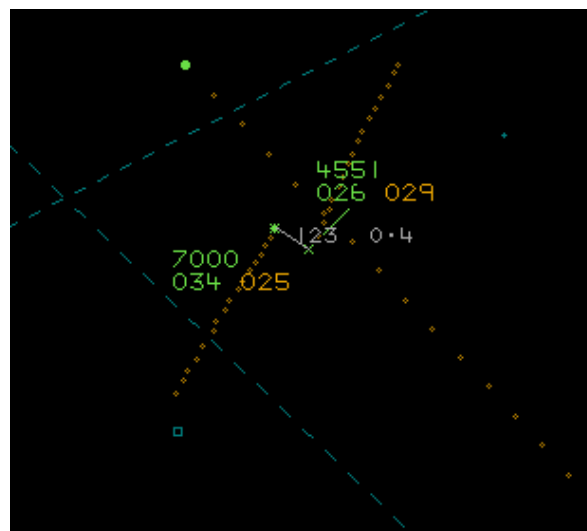
Figure 4 – 1035:24, CPA

When determining the risk of the Airprox, the Board considered the reports from both pilots together with the radar screenshots. Neither pilot had seen the other aircraft, but the DA40 pilot had taken action based upon the information that they had received from the TAS. Members agreed that this had been the correct course of action which had resulted in 800ft separation and could therefore be considered to be normal operations in Class G airspace. Accordingly, they agreed that there had been no risk of collision; Risk Category E.
