AIRPROX REPORT No 2025020

Date: 28 Feb 2025 Time: 1022Z Position: 5048N 00249W Location: 15NM Southwest Yeovilton

PART A: SUMMARY OF INFORMATION REPORTED TO UKAB

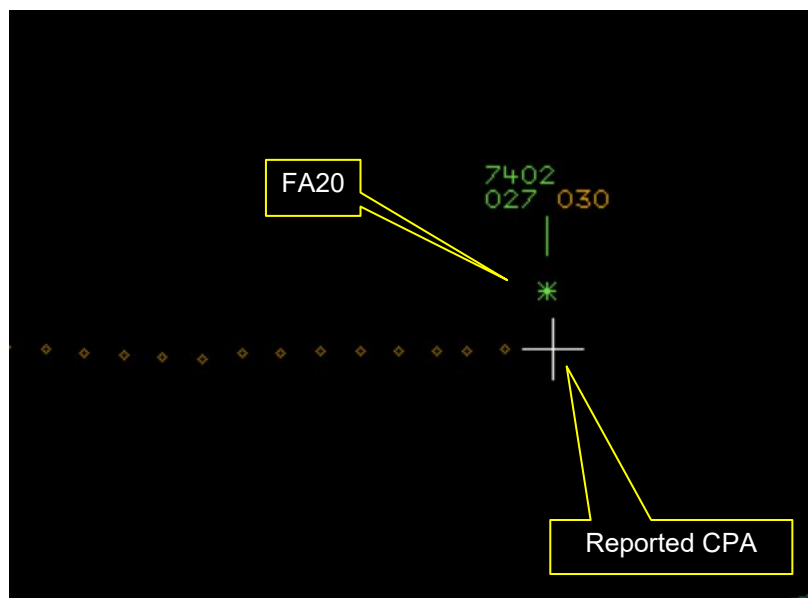
Figure 1: At 'CPA' 1021:48 – Paramotor not seen on radar. FA20 initiated a left turn as described at 1021:44.

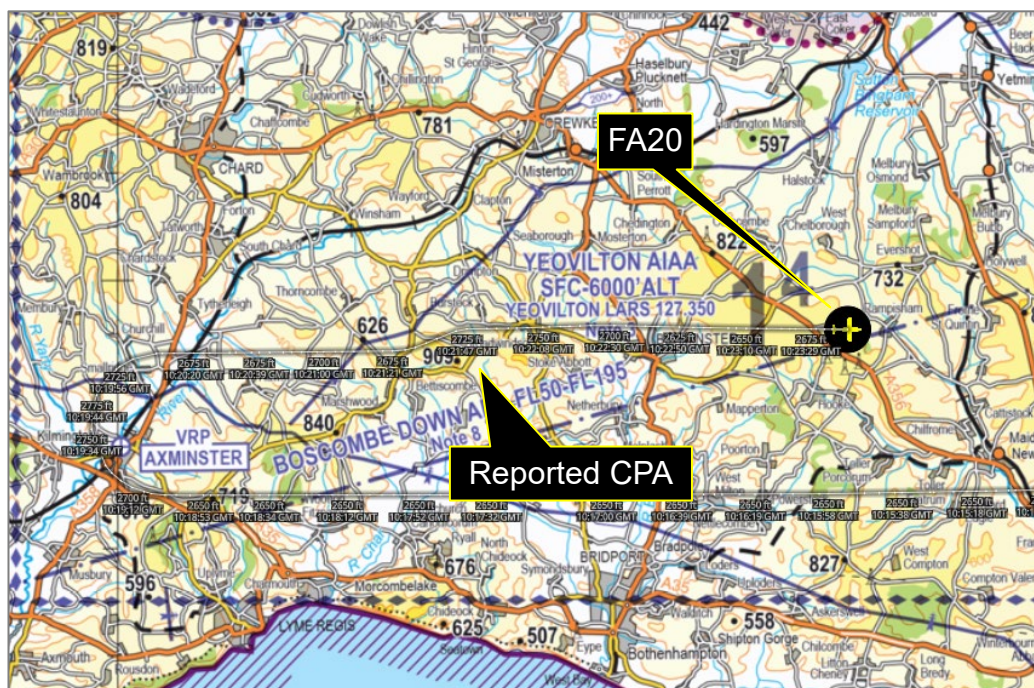
Figure 2: This extract from the CAAs Airspace Analyser shows the path to and from the point at which the FA20 turned left to avoid the paramotor. The paramotor did not show on this system.
