**AIRPROX REPORT No 2025023**

Date: 01 Mar 2025 Time: 1152Z Position: 5053N 00129W Location: 6NM SW Southampton

**PART A: SUMMARY OF INFORMATION REPORTED TO UKAB**

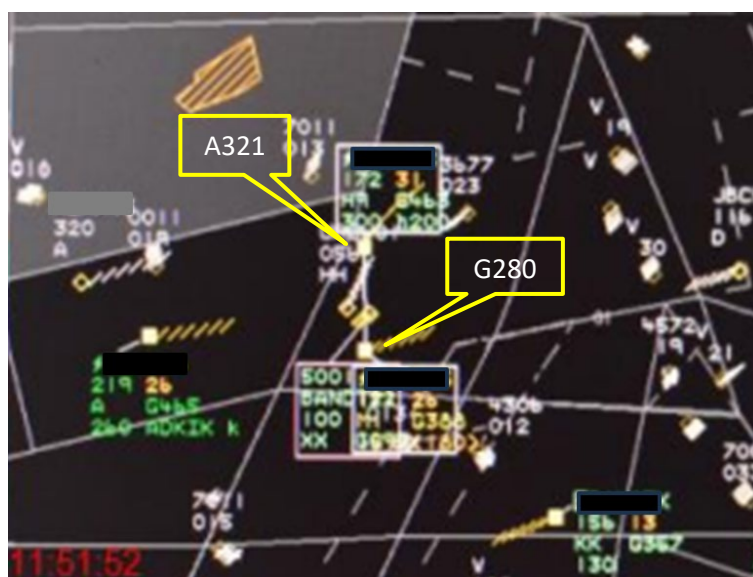
Figure 1

A low-level Short Term Conflict Alert (STCA) was displayed to the WOR T [controller] at 1151:52, at which time the Mode S Selected Flight Level (SFL) of [G280 C/S] was also displayed in the Track Data Block (TDB) showing FL180, however this was not immediately visible as there was garbling with an unrelated track.

The WOR T [controller] moved the TDB to assess the STCA activation. Coincident with this, another unrelated aircraft called onto frequency with the WOR T [controller]. Upon completion of this pilot calling onto frequency, the WOR T [controller] issued avoiding action to the pilot of [A321 C/S] to turn right onto a heading of 280° and expedite their climb to FL300 at 1152:01. At this time, the WOR P [controller] telephoned the TC SW controller to see if [G280 C/S] was still with them and was informed they were not. The pilot of [A321 C/S] read back the instruction, however, did not repeat the “avoiding action” element; the WOR T [controller] reiterated that the instruction was avoiding action.

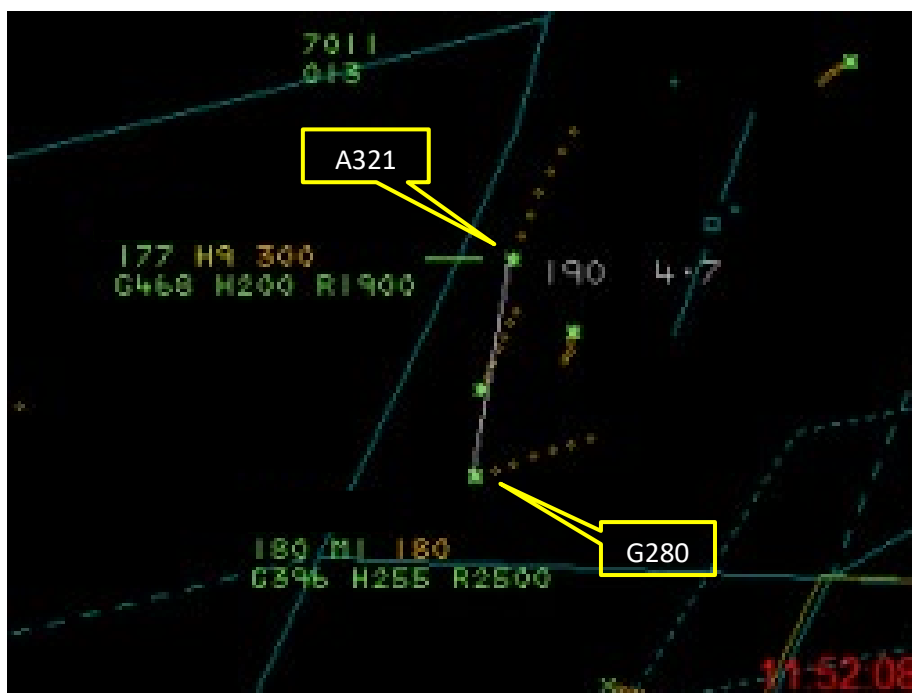
Figure 2 - Separation minima were eroded during the avoiding action instruction, at 1152:08.

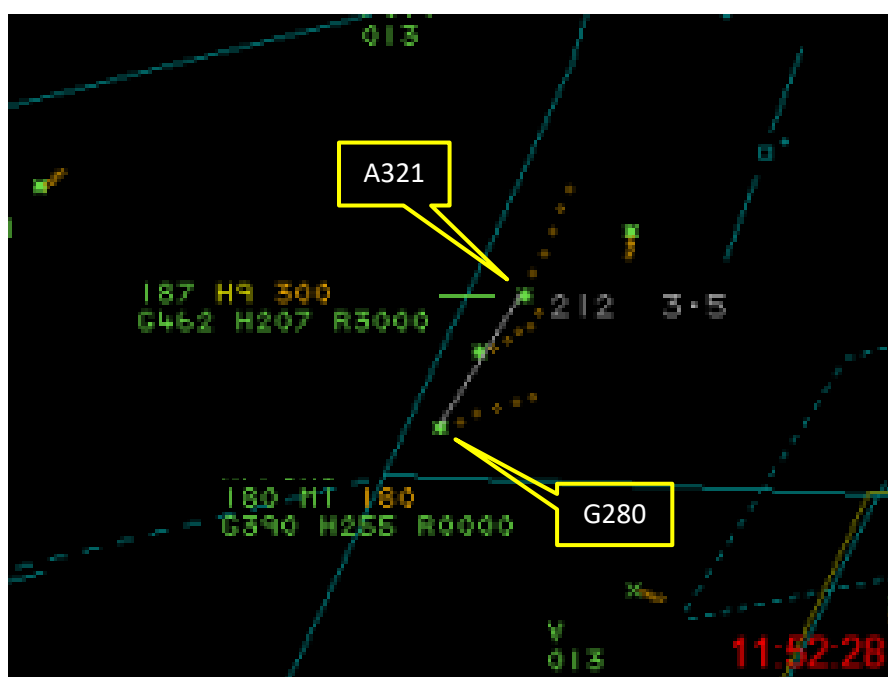
The pilot of an unrelated aircraft, [A319 C/S], called onto frequency and was responded to by the WOR T [controller], minimum separation occurred during this R/T exchange. Minimum separation occurred at 1152:28 and was recorded on the Multi-track system as 3.5NM and 700ft where 5NM or 1000ft were required.

Figure 3 - CPA
