AIRPROX REPORT No 2025024

Date: 05 Mar 2025 Time: ~1203Z Position: 5319N 00144W Location: ivo Camphill

PART A: SUMMARY OF INFORMATION REPORTED TO UKAB

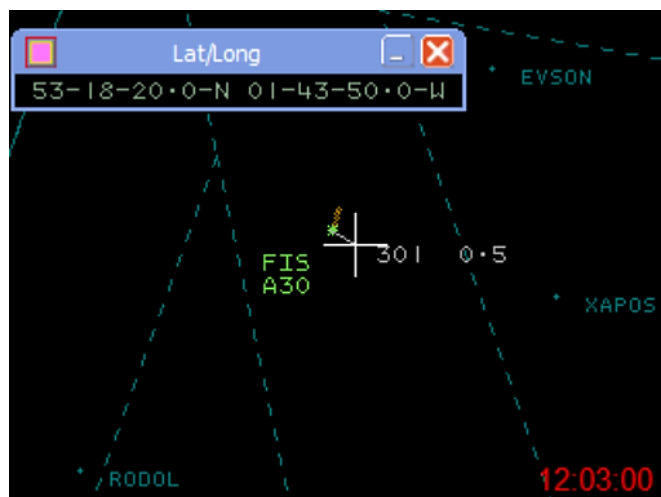
Figure 2 Time 1203:00

[The C152] passed to the northwest of the Lat/Long position of Camphill gliding site at 1203:00 (Figure 2); there were no other radar returns in the vicinity at this time, as such it was not possible to determine the closest point of approach between [the C152] and [the SZD-50].

The SZD-50 was not visible on radar, however, it appeared on ADS-B tracking software and the pilot provided a navigation file for the flight. Using the combined radar and ADS-B data, CPA was assessed to have been at 1203:00 with approximately 194ft vertical and less than 0.1NM separation.
