AIRPROX REPORT No 2025026

Date: 07 Mar 2025 Time: 1801Z Position: 5143N 00011E Location: 1.3NM east of North Weald

PART A: SUMMARY OF INFORMATION REPORTED TO UKAB

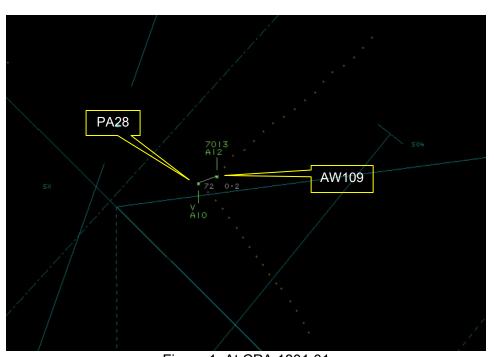
Figure 1: At CPA 1801:01

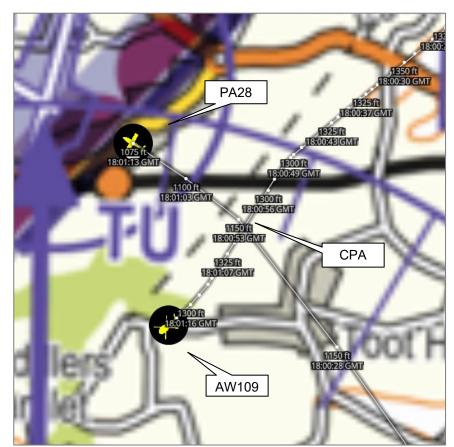
Both aircraft were tracked via radar and identified through Mode S data. Although the AW109 pilot has no recollection of encountering other traffic in this area at this time, the aircraft can be seen (Figure 2) to have made a turn to the left before passing behind the PA28 and then continuing on their original path.

Figure 2: AW109 showed as having manoeuvred behind the crossing PA28
