**AIRPROX REPORT No 2025029**

Date: 16 Mar 2025 Time: ~1336Z Position: 5122N 00102W Location: SW of Mortimer

**PART A: SUMMARY OF INFORMATION REPORTED TO UKAB**

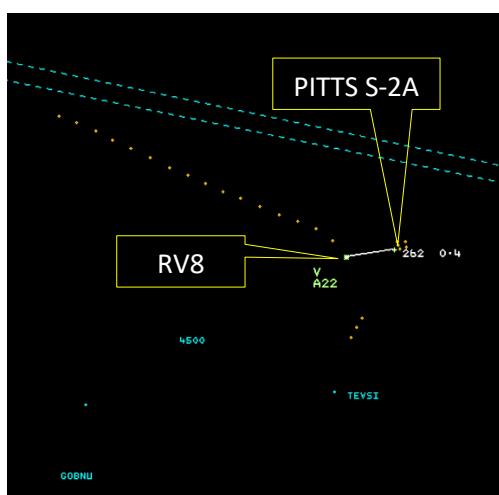
Figure 1 Time 1335:55

An analysis of the NATS radar replay was undertaken and the RV8 was positively identified using Mode S data. The RV8 was seen making a slight right turn away from the Pitts S-2A manoeuvring area at 1335:55 with an indicated separation of 0.4NM (Figure 1).

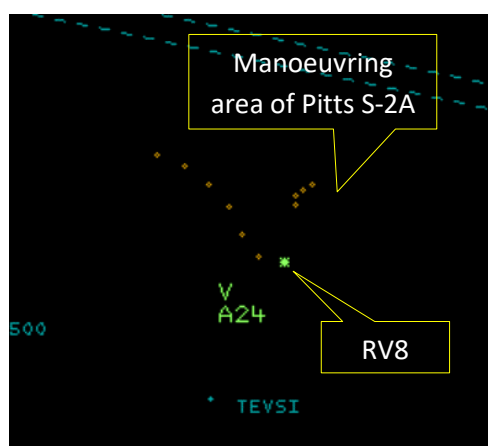
Figure 2 Time 1336:07 Pitts S-2A primary return lost

They then made a left turn shortly afterwards. A primary track was seen that correlated with the manoeuvring Pitts S-2A. CPA was assessed to have been at approximately 1336 and the separation could not be ascertained (Figure 2).
