AIRPROX REPORT No 2025032

Date: 11 Mar 2025 Time: 1038Z Position: 5158N 00201W Location: 3.5NM NE Cheltenham

PART A: SUMMARY OF INFORMATION REPORTED TO UKAB

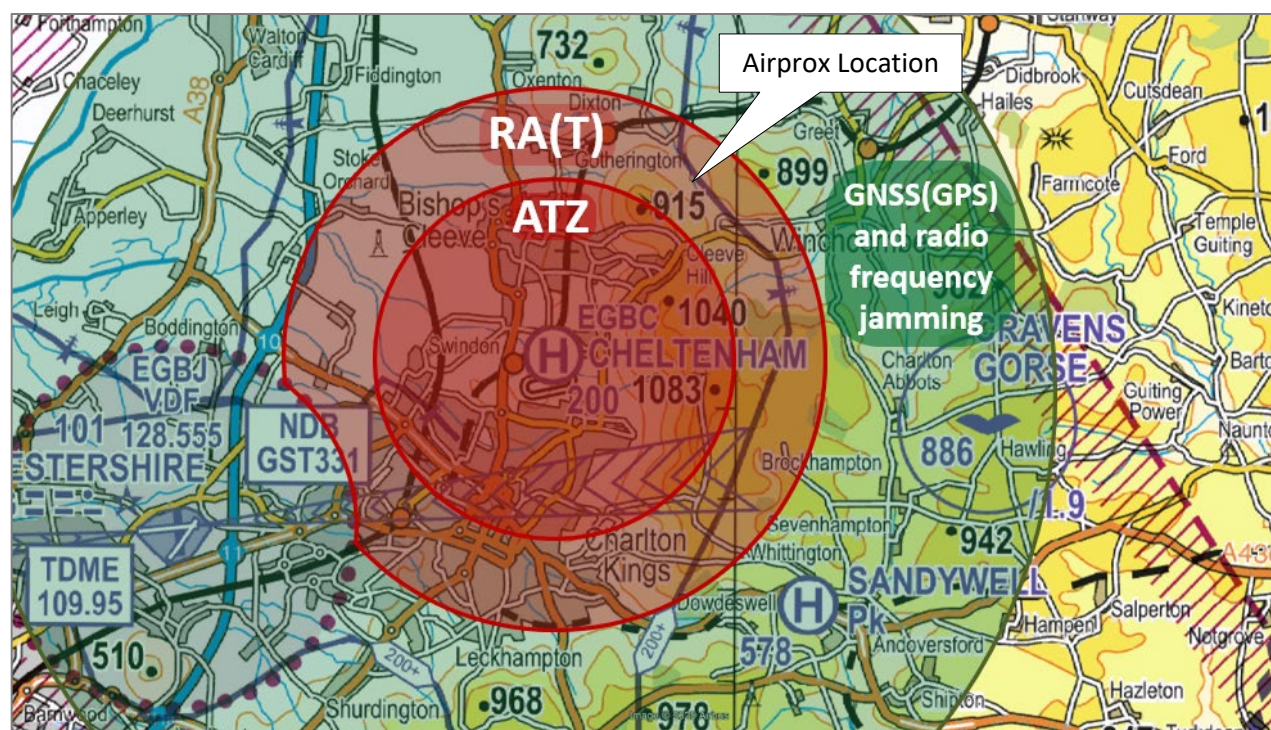
Figure 1 – Active NOTAMs

A NOTAM for the activation of a Temporary Restricted Area RA(T) at Cheltenham:

J0386/25: Temporary restricted area activated
 Q) EGTG/QRCA/IV/BO/AW/000/030/5155N00207W003
 RESTRICTED AREA (TEMPORARY) ACTIVE (CHELTENHAM HELIPORT)
 WI AN AREA BOUNDED BY: THE CLOCKWISE ARC OF A CIRCLE RADIUS 3NM CENTRED 515533N 0020316W BTN 515515N 0020805W - 515331N 0020649W THEN THE ANTICLOCKWISE ARC OF A CIRCLE RADIUS 2NM CENTRED 515339N 0021002W BTN 515331N 0020649W - 515515N 0020805W.
 APPLIES TO ALL ACFT INCLUDING ANY SMALL BALLOON, ANY KITE, ANY UAS AND ANY PARACHUTE INCLUDING A PARASCENDING PARACHUTE OR PARAMOTOR.
 DOES NOT APPLY TO ANY ACFT FLYING IN ACCORDANCE WITH EXCEPTIONS STATED IN THE AIC.
 CTC FREQ 121.180(CALLSIGN: CHELTENHAM TOWER). AIC M 011/2025 WITH CHART, REFERS.
 FURTHER DETAILS WWW.NATS.AERO/AIS.
 RESTRICTION OF FLYING REGULATIONS MADE UNDER ARTICLE 239 OF THE AIR NAV ORDER 2016.
 AR-2024-8556/AO1
 LOWER: Surface, UPPER: 3,000 Feet AMSL
 FROM: 11 Mar 2025 10:15 GMT (10:15 UTC) TO: 14 Mar 2025 20:00 GMT (20:00 UTC)

A NOTAM for the establishment of an ATZ at Cheltenham:

B0290/25: Aerodrome traffic zone (ATZ) activated
 Q) EGTG/QAZCA/IV/NBO/AE/000/022/5156N00203W003
 TEMPO ATZ ESTABLISHED SFC TO 2000FT AGL/2200FT AMSL WI 2NM RADIUS: 515533N 0020316W (CHELTENHAM HELIPORT). SITE NOTIFIED FOR THE PURPOSE OF RULE 11 OF THE RULES OF THE

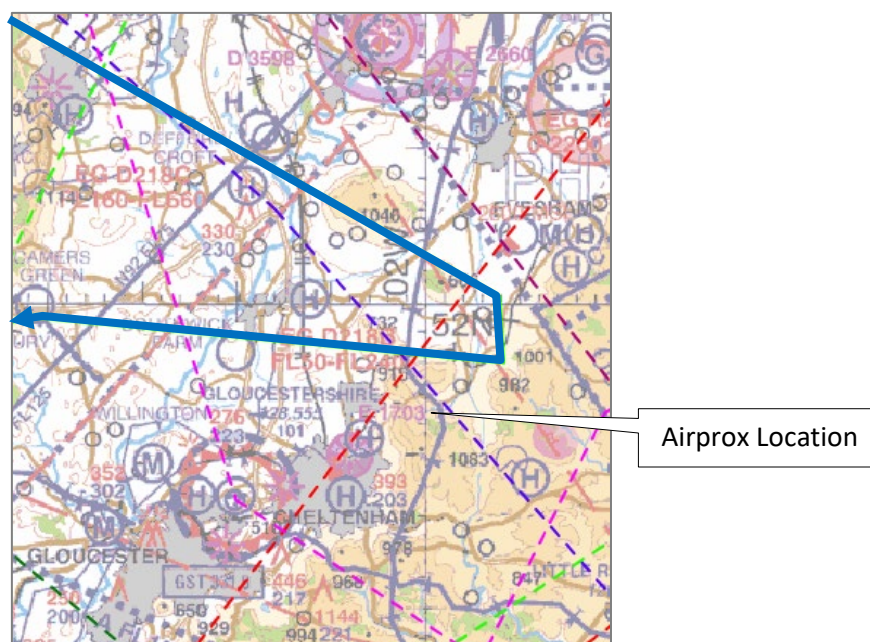
Figure 2 – The planned route of the Typhoon (highlighted in blue) taken from CADS.

An entry in CADS for the flight of the Typhoon (planned to be conducted at an MSD of 250ft) provided the following route:

The Typhoon pilot was unaware of the activity at Cheltenham as the NOTAM was not displayed on their mission planning system. Operation support specialists are responsible for loading NOTAMS and a review is underway to establish the reasons for error during this process. The pilot believed it was appropriate to operate on Low Level Common despite being within the published provision of Brize Norton LARS. Given the Typhoon operating height of 250ft, it's possible that communications with Brize Norton were impossible. Had the pilot been aware of the NOTAM, they would have either avoided the area or contacted Cheltenham Tower directly. Typhoon is not equipped with TCAS, but the pilot refers to on-board radar SA which augmented an earlier visual detection. The R66's relatively small size may have led the Typhoon pilot to believe that they avoided by a greater margin than the assessed CPA.

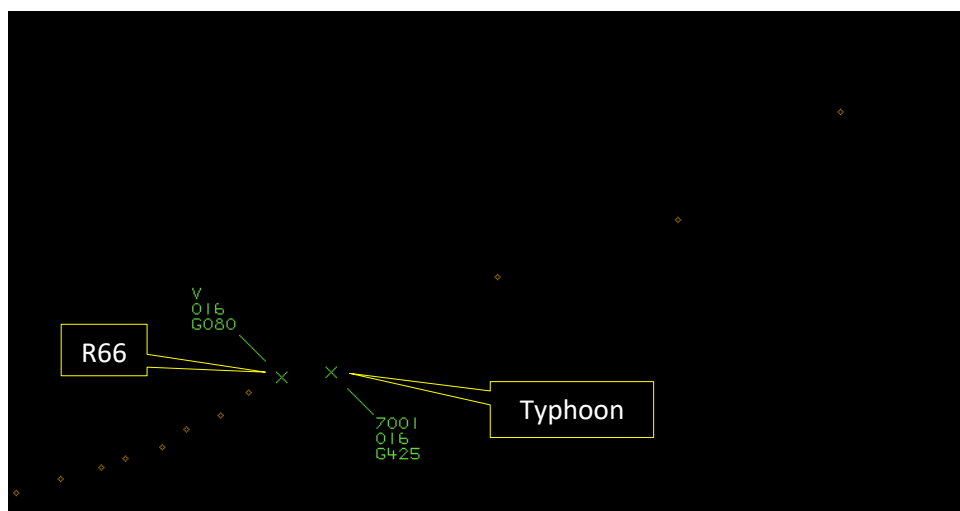
Figure 3

An analysis of the NATS radar was undertaken and both aircraft could be positively identified from Mode S data (Figure 3). The aircraft were depicted on the radar replay as having flown at Flight Levels. A suitable correction was applied to determine their altitudes.

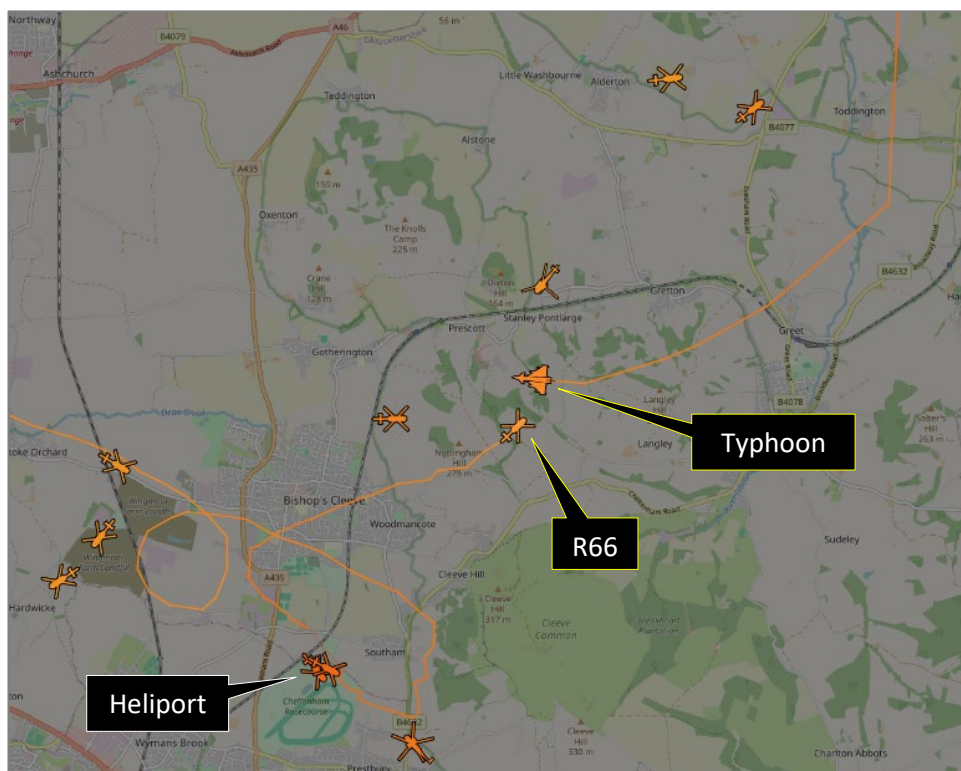
Figure 4 – CPA at 1038:23

An analysis of ADS-B data was undertaken and the tracks of the R66 and Typhoon were observed (Figure 4).

The diagram was constructed and the separation at CPA determined by combining the various data sources.
