AIRPROX REPORT No 2025033

Date: 15 Mar 2025 Time: 1355Z Position: 5318N 00143W Location: ivo Camphill

PART A: SUMMARY OF INFORMATION REPORTED TO UKAB

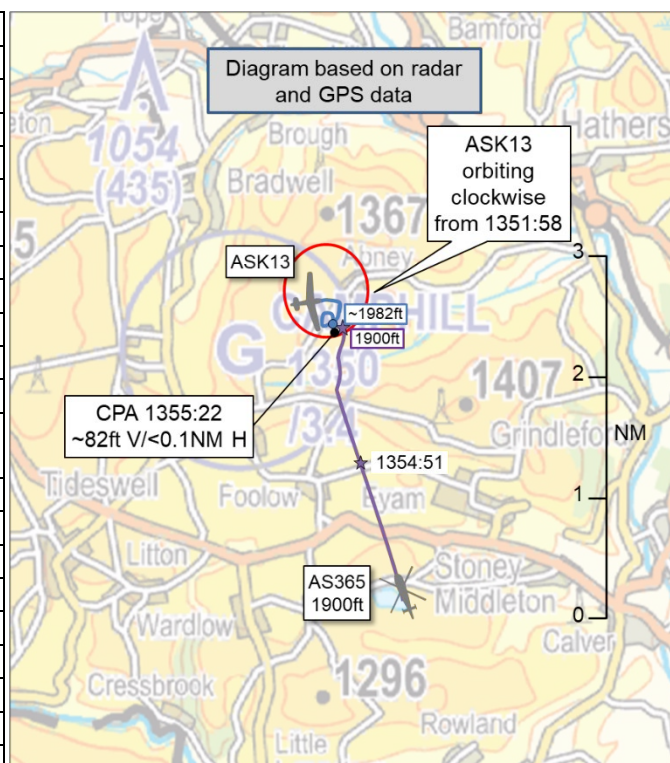
An analysis of the NATS radar replay was undertaken and the AS365 was positively identified using Mode S data. A primary contact was also seen on radar in the vicinity of the reported Airprox as the AS365 passed to the east of Camphill, but this did not match the GPS track supplied by the ASK13 pilot.

Further analysis of ADS-B tracking sources positively identified the ASK13 and the CPA was assessed to have occurred at 1355:22 with less than 0.1NM lateral and approximately 82ft vertical separation based on combined radar and GPS data. At this time, the ASK13 pilot was in a clockwise manoeuvre, after which it was seen to turn onto approximately north prior to making a left turn onto downwind as described by the ASK13 pilot in their report. The ASK13 pilot did not report sighting the AS365 until after CPA. The AS365 was following a similar track to the ASK13 and was seen to pass ahead of the ASK13 to the north, after which time their tracks were diverging.

Between 1352:26 and 1355:46 the glider descended from 2335 to 1974ft AMSL while executing five 360° turns to the right; an average of one complete turn every 40sec (during which interval an aircraft approaching at 145kt would cover 1.6NM). The pilot of a circling glider must look for aircraft approaching from every direction, and although continuous turning facilitates 360° lookout, it also leaves the pilot unsighted in any specific direction for about half the time. After rolling out of the final right-hand turn on a northerly heading, at 1355:54 the student instructor then initiated a 180° turn to the left to join the downwind leg. The glider's crew first sighted the helicopter half way through this turn, at about 1356:02, as it passed left-to-right in front of and below them, at what they believe was its closest point of approach to the glider.
